Hazardous Building Materials Assessment

Wicks Tennis Club

202 Victoria Road
Rozelle NSW 2039

Inner West Council
April 2018

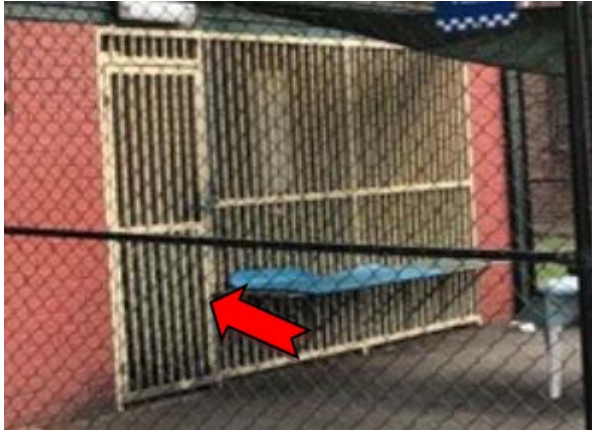
Photo 1. Exterior, throughout, doors and door frames – suspected lead-containing yellow upper paint system.

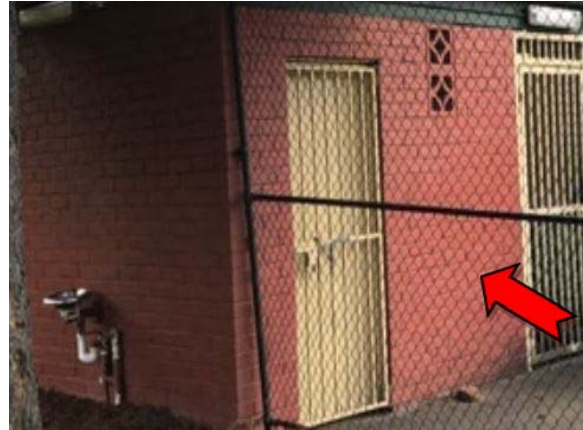
Photo 2. Exterior, throughout, walls – suspected lead-containing red upper paint system.

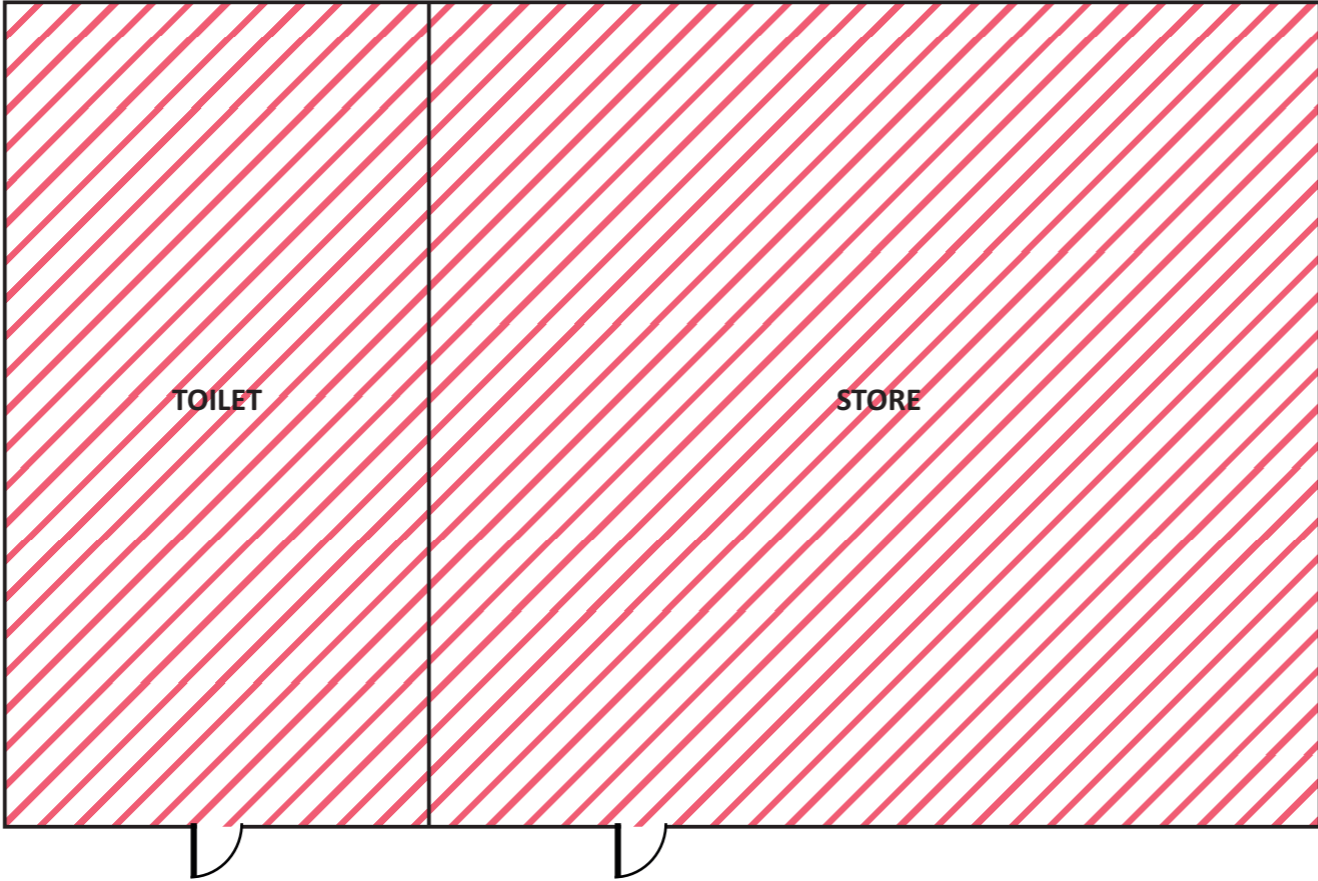
Wicks Park Tennis Building, Marrickville - Ground Level

- Non-friable asbestos was suspected in the form of fibre cement sheeting ceiling throughout the interior.
