# Hazardous Building Materials Assessment Simpson Park Toilets Campbell and Corkey Street St Peters NSW 2044

Inner West Council  
April 2018

Site Name: Simpson Park Toilets (CID - 333)

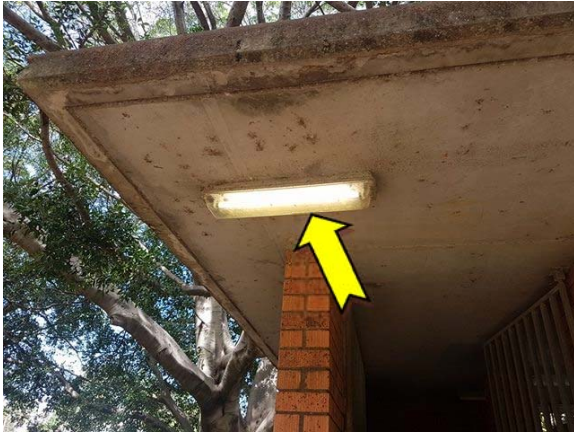
**Photo 1.** Exterior, throughout, single tube fluorescent light fitting – suspected PCB-containing capacitor.

- PCBs were suspected within the capacitors of the single tubed fluorescent light fittings located throughout the building.

- Electrical fittings suspected of containing PCB oil capacitors should be treated as containing PCB oils until such time as evidence suggest otherwise e.g. further assessed.
- Electrical fittings that contain or suspected to contain PCB oil-containing capacitors should be removed as hazardous/regulated waste under controlled working conditions prior to the demolition or refurbishment works in accordance with the *Polychlorinated Biphenyls Management Plan, Revised Edition April 2003*.
