Hazardous Building Materials Assessment

St Peters Town Hall

39 Unwins Bridge Road & Swain Street

Inner West Council
April 2018

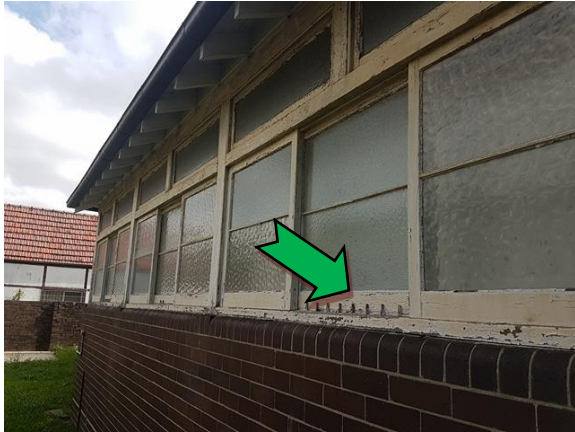
Photo 1. Exterior, throughout, window frames – non asbestos-containing window caulking.

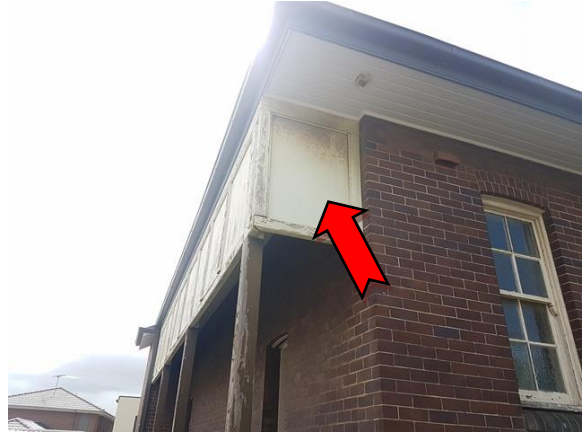
Photo 2. Exterior, west elevation, throughout, high level wall panels – suspected asbestos-containing fibre cement sheeting.

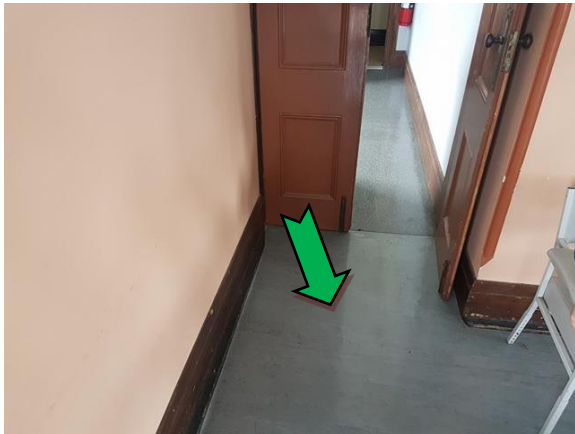
Photo 3. Interior, level 1, hall, grey floor coverings – suspected non asbestos-containing sheet vinyl.

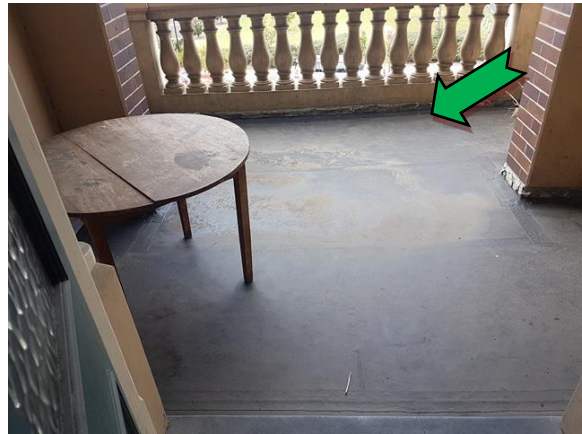
Photo 4. Interior, level 1, balcony, waterproof membrane – suspected non asbestos-containing bituminous material.

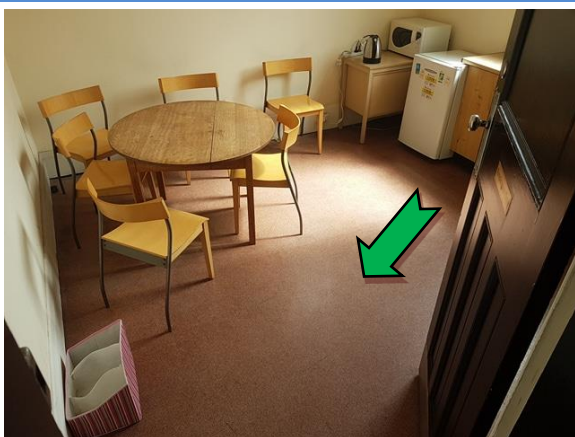
Photo 5. Interior, ground level, kitchen (STS), red floor coverings – non asbestos-containing floor tiles.

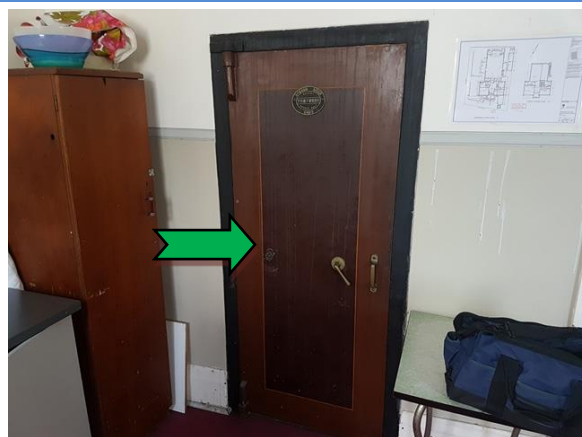
Photo 6. Interior, ground level, community room, strong room – suspected non asbestos-containing door insulation.

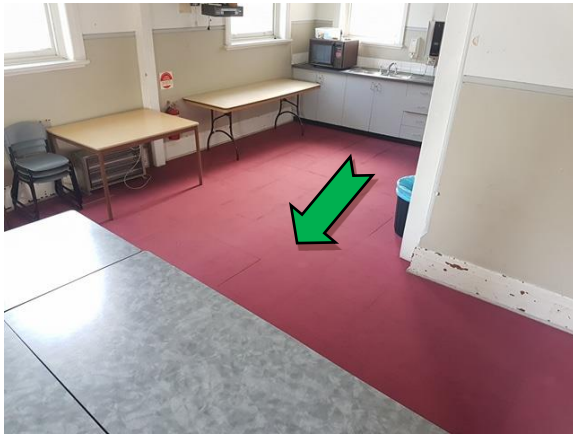
Interior, ground level	Community room, beneath carpet, to floor tiles	Floor coverings - red	Adhesive	Asbestos	Same as: 57722-013-001B	Assumed Negative	-	-	-	-	-	-	-	-	7
Interior, ground level	Entrance, electrical cupboard	Electrical backing board	Bituminous backing board	Asbestos	Not sampled: Age and appearance	Suspected Negative	-	-	-	-	-	Confirm status, suspected negative due to age and appearance.	-	-	8
Exterior	South western elevation	Hot water heater	Insulation material - internal	SMF	-	Suspected Positive	-	Low	Good	Low	1 unit	Maintain in current condition if to remain in-situ. Remove under controlled SMF conditions as per the Code of Practice for the Safe Use of Synthetic Mineral Fibres [NOHSC: 2006 (1990)].	-	-	9
Interior, level one	Kitchen	Hot water heater	Insulation material - internal	SMF	-	Suspected Positive	-	Low	Good	Low	1 unit	Maintain in current condition if to remain in-situ. Remove under controlled SMF conditions as per the Code of Practice for the Safe Use of Synthetic Mineral Fibres [NOHSC: 2006 (1990)].	-	-	10

Photo 7. Interior, ground level, community room, beneath carpet, red floor covering – assumed non asbestos-containing floor tiles.

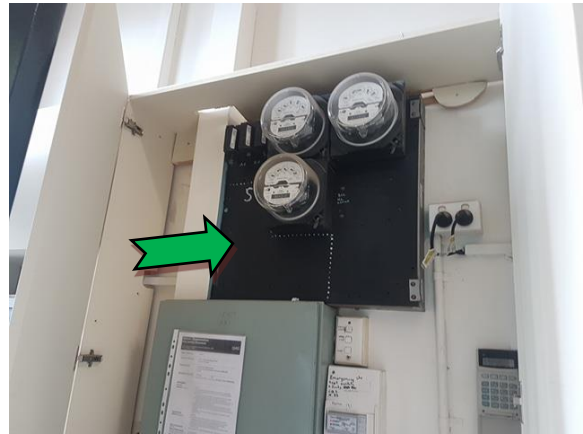
Photo 8. Interior, ground level, entrance, electrical cupboard – suspected non asbestos-containing bituminous backing board.

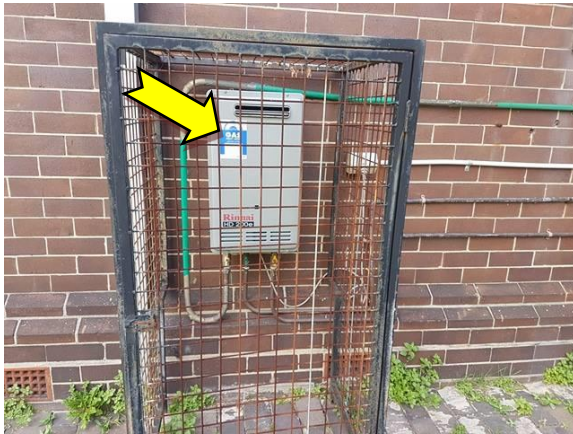
Photo 9. Exterior, south-west elevation, hot water heater – suspected SMF internal insulation.

- Suspected SMF was observed in the form of hot water heaters located to the south-western exterior of the building and throughout internal kitchen areas.

- SMF materials that are likely to be disturbed during any proposed demolition/refurbishment works should be handled in accordance with the *Code of Practice for the Safe Use of Synthetic Mineral Fibres* [NOHSC:2006(1990)]. If these materials are impacted upon by accident or by pre-planned works, the Inner West Council must be informed via the contact detailed within Section 7: *Accidental Disturbance of Known or Suspected Hazardous Building Materials*. Following disturbance, inspection by a competent person should be undertaken.

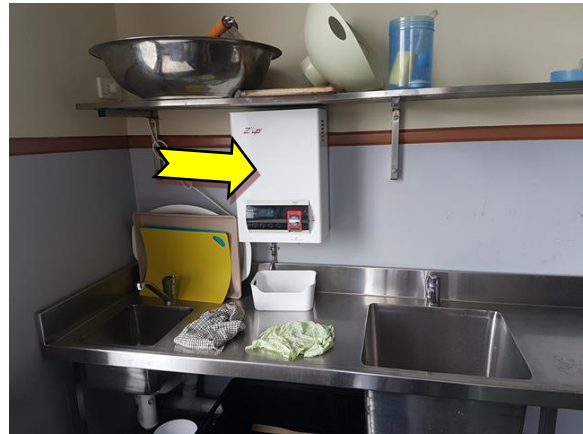
Photo 10. Interior, level 1, kitchen, hot water heater – suspected SMF internal insulation.

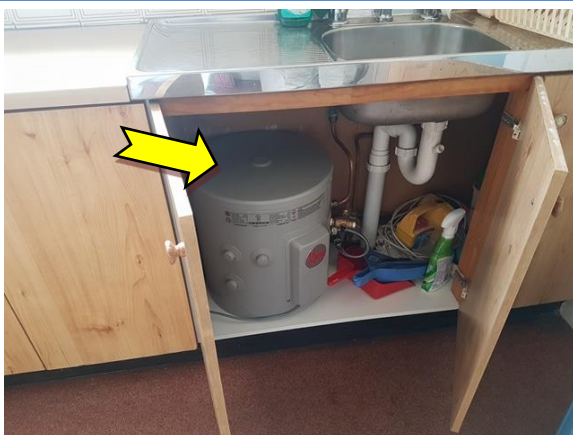
Photo 11. Interior, ground level, kitchen, hot water heater – suspected SMF internal insulation.

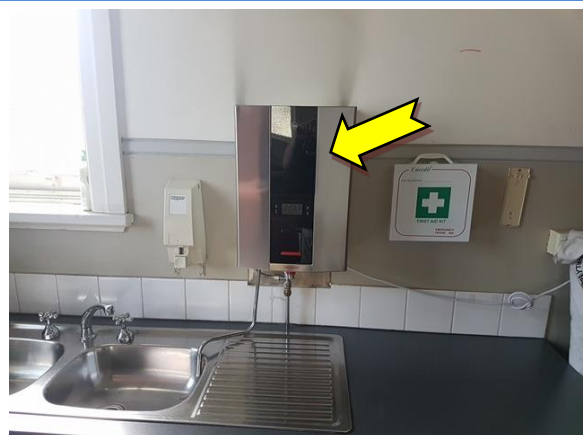
Photo 12. Interior, ground level, community room, kitchenette, hot water heater – suspected SMF internal insulation.

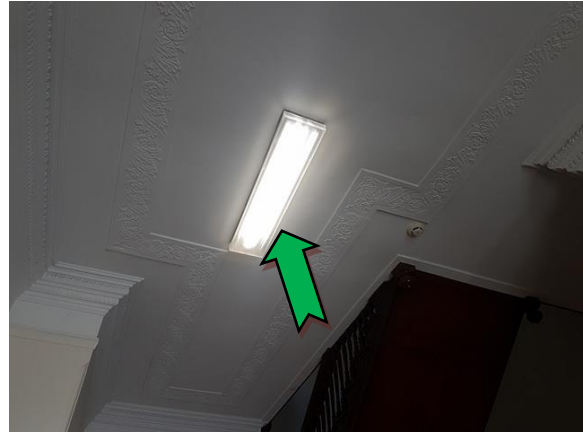
Photo 14. Interior, ground level, throughout, double tube fluorescent light fitting – suspected non PCB-containing capacitor.

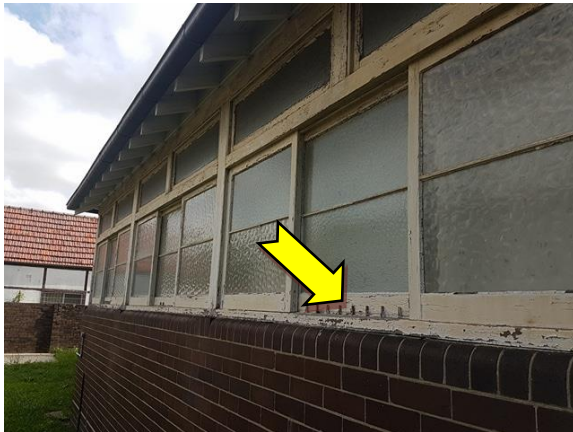
Photo 15. Exterior, throughout, window frames – cream upper coloured paint systems.

- Remove flaking lead containing paint to window surrounds throughout the property in accordance with AS4361.2-2017 Guide to Hazardous Paint Management and relevant legislation.

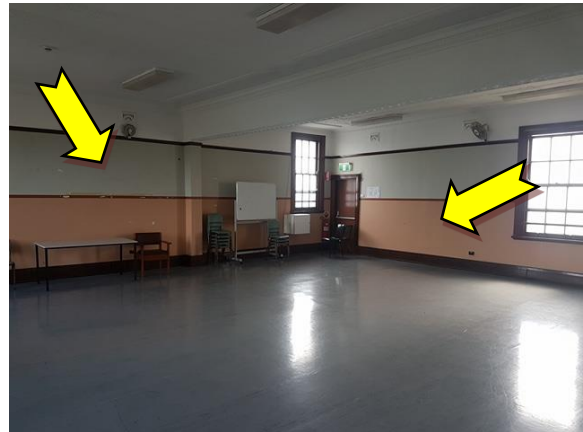
Photo 16. Interior, level 1, throughout, walls – suspected lead-containing cream, and pink upper coloured paint systems.

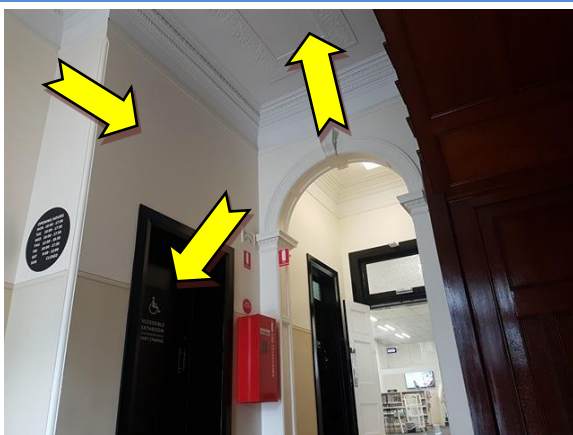
Interior, level one	Hall	Walls	Blue (light) - upper coloured paint system	Lead Paint - Swab	-	Suspected Positive	-	Low	Good	Low	50 m ²	Confirm status by quantitative test method, maintain in current condition, over paint with a lead-free paint as part of ongoing maintenance. Remove under controlled conditions in accordance with AS 4361.2:2017 Guide to hazardous paint management prior to renovation or demolition works.	-	-	16
Interior, ground level	Throughout	Walls	Cream - upper coloured paint system	Lead Paint - Swab	-	Suspected Positive	-	Low	Good	Low	500 m ²	Confirm status by quantitative test method, maintain in current condition, over paint with a lead-free paint as part of ongoing maintenance. Remove under controlled conditions in accordance with AS 4361.2:2017 Guide to hazardous paint management prior to renovation or demolition works.	-	-	17
Interior, ground level	Throughout	Ceiling	White - upper coloured paint system	Lead Paint - Swab	-	Suspected Positive	-	Low	Good	Low	300 m ²	Confirm status by quantitative test method, maintain in current condition, over paint with a lead-free paint as part of ongoing maintenance. Remove under controlled conditions in accordance with AS 4361.2:2017 Guide to hazardous paint management prior to renovation or demolition works.	-	-	17

Photo 17. Interior, ground level, throughout, walls, ceiling, doors and door frames – cream, white and black upper coloured paint systems.

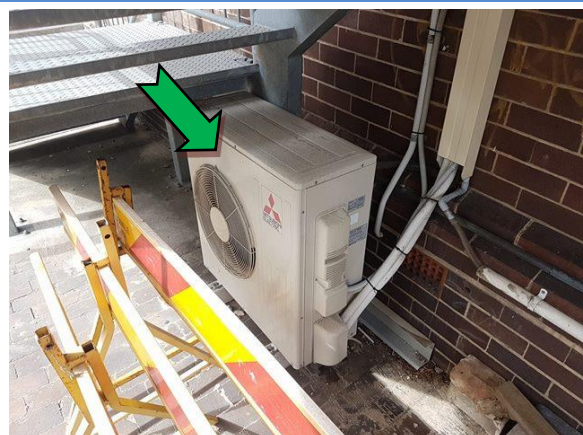
Photo 18. Exterior, ground level, air conditioning unit, unknown refrigerant – suspected non ozone depleting substance.

- No ODS-containing air conditioning units were identified or suspected during the Assessment.
