# Hazardous Building Materials Assessment

## Stone Villa

19 Railway Road,  
Sydenham NSW 2044

Inner West Council  
April 2018

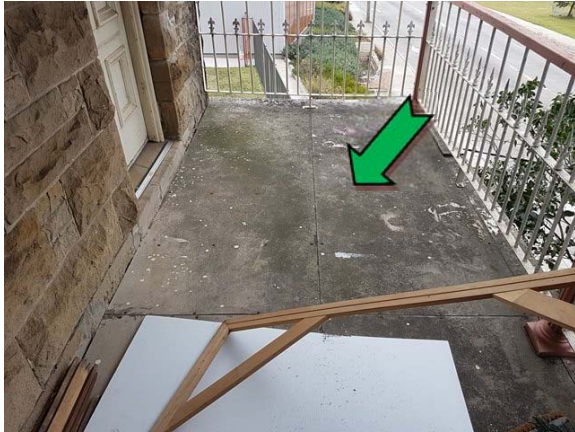
**Photo 1.** Exterior, level one, verandah, floor – non asbestos-containing compressed cement sheeting.

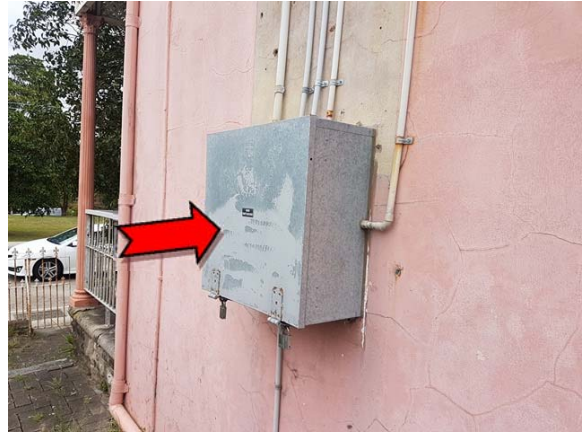
**Photo 2.** Exterior, ground level, south-east elevation, electrical box – suspected asbestos-containing bituminous backing board.

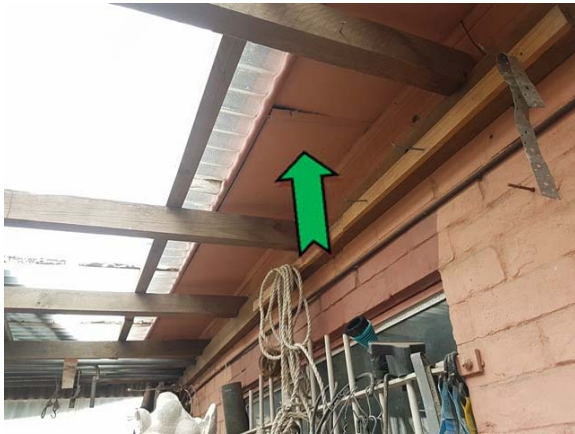
Area / Level	Room & Location	Feature	Item Description	Hazard Type	Sample No.	Sample Status	Friability	Disturb. Potential	Condition	Risk Status	Approx. Quantity	Recommendations & Comments	Control Priority	Reinspect Date	Photo No.
Exterior, Level 1	Verandah	Floor	Compressed cement sheeting	Asbestos	57722-141-001	Negative	-	-	-	-	-	-	-	-	1
Exterior, ground level	South-east elevation	Electrical backing board	Bituminous backing board	Asbestos	Not sampled: No access	Suspected Positive	Non-friable	Low	Good	Low	1 unit	Confirm status, label as containing asbestos and maintain in current condition if to remain in-situ. Remove under controlled non-friable asbestos removal conditions prior to refurbishment or demolition works by a Class B (non-friable) licensed asbestos removal contractor.	P4	Mar-23	2
Exterior, ground level	Shed, throughout	Eaves	Fibre cement sheeting	Asbestos	57722-141-005	Negative	-	-	-	-	-	-	-	-	3

**Photo 3.** Exterior, shed, eaves – non asbestos-containing fibre cement sheeting.

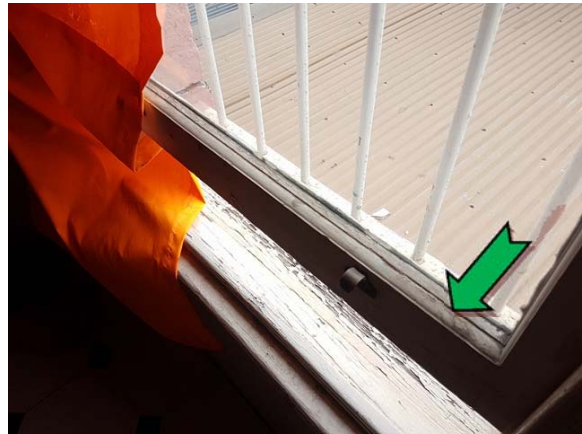
**Photo 4.** Interior, window frames, throughout – non asbestos-containing window caulking.

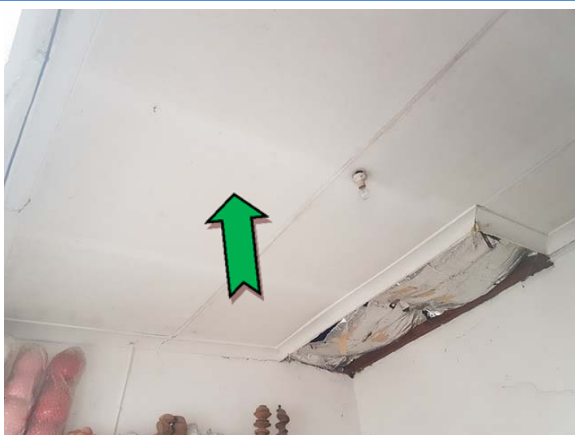
**Photo 5.** Interior, shed, ceiling, throughout – non asbestos containing fibre cement sheeting.

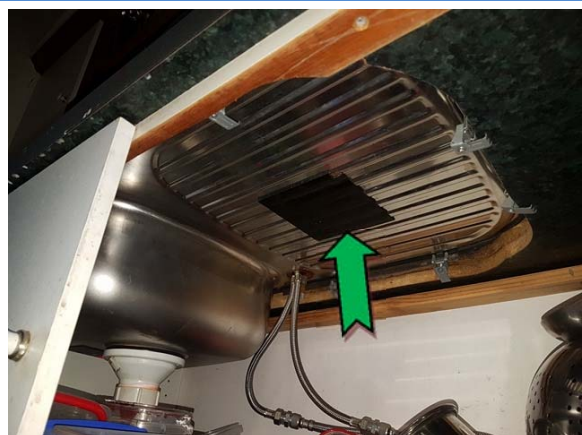
**Photo 6.** Interior, ground level, kitchen, under sink, sink pad – non asbestos-containing bituminous material.

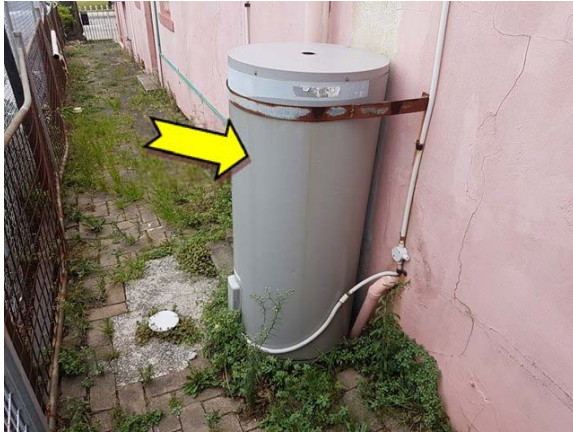
**Photo 7.** Exterior, east elevation, hot water heater – suspected SMF internal insulation material.

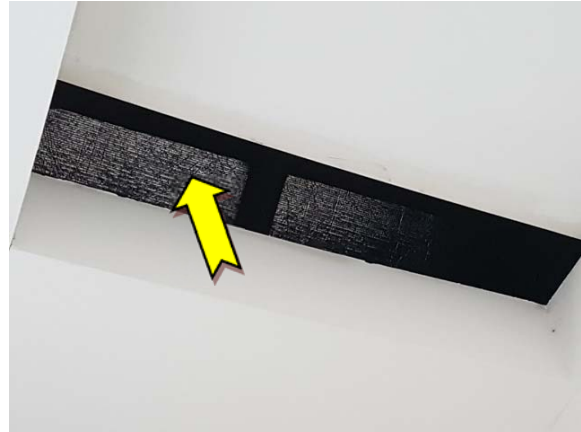
**Photo 8.** Interior, roof space, throughout, insulation – suspected SMF sarking insulation material.

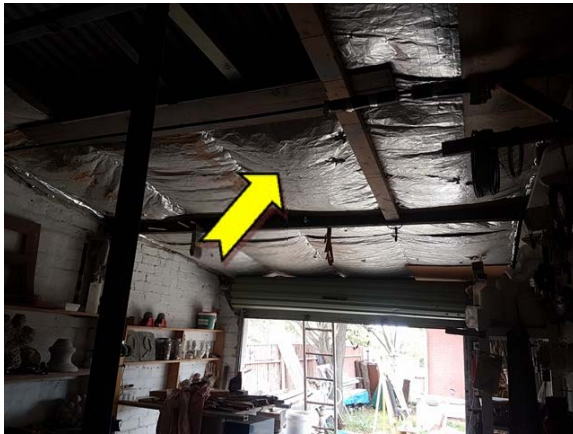
**Photo 9.** Interior, shed, throughout, insulation – suspected SMF sarking insulation material.

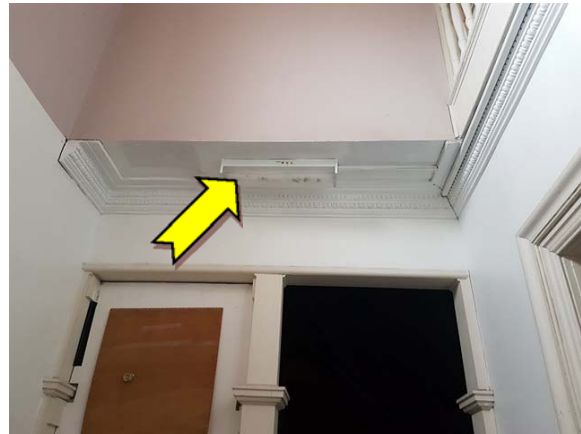
**Photo 10.** Interior, throughout, single tube fluorescent light fitting – suspected PCB-containing capacitor.

- Electrical fittings that contain or suspected to contain PCB oil-containing capacitors should be removed as hazardous/regulated waste under controlled working conditions prior to the demolition or refurbishment works in accordance with the *Polychlorinated Biphenyls Management Plan, Revised Edition April 2003*.

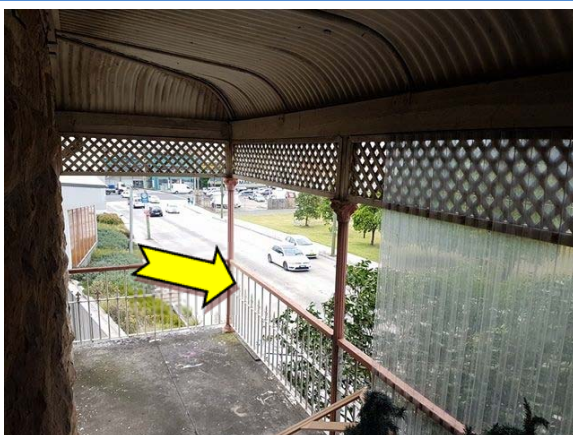
**Photo 11.** Exterior, level one, verandah, beams – suspected lead-containing pink and white upper coloured paint systems.

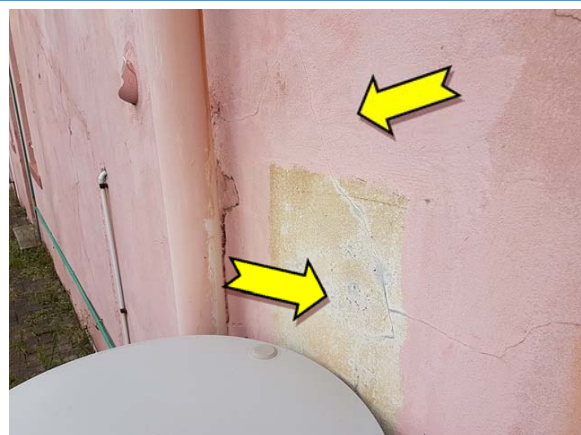
Area / Level	Room & Location	Feature	Item Description	Hazard Type	Sample No.	Sample Status	Friability	Disturb. Potential	Condition	Risk Status	Approx. Quantity	Recommendations & Comments	Control Priority	Reinspect Date	Photo No.
Exterior	Throughout	Walls	Pink - upper coloured paint system	Lead Paint - Swab	-	Suspected Positive	-	Low	Good	Low	1000m <sup>2</sup>	Confirm status by quantitative test method, maintain in current condition, over paint with a lead-free paint as part of ongoing maintenance. Remove under controlled conditions in accordance with AS 4361.2:2017 Guide to hazardous paint management prior to renovation or demolition works.	-	-	12
Exterior	Throughout	Walls	Cream - lower coloured paint system	Lead Paint - Swab	-	Positive	-	Low	Fair	Low	1000m <sup>2</sup>	Maintain in current condition, over paint with a lead-free paint as part of ongoing maintenance. Remove under controlled conditions in accordance with AS 4361.2:2017 Guide to hazardous paint management prior to renovation or demolition works.	-	-	12

**Photo 12.** Exterior, walls, throughout – lead-containing cream lower paint systems and suspected lead-containing pink upper paint systems.

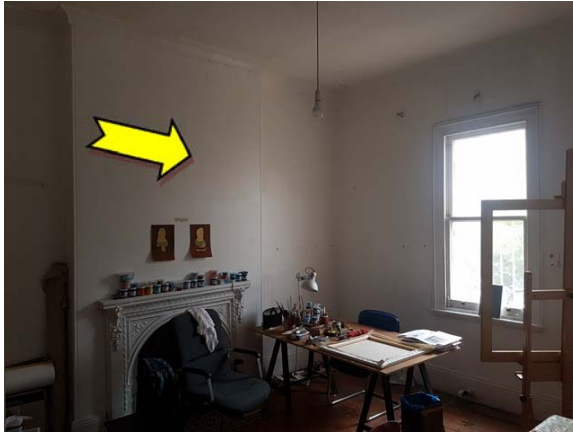
**Photo 13.** Interior, level one, walls – suspected lead-containing white upper paint systems.

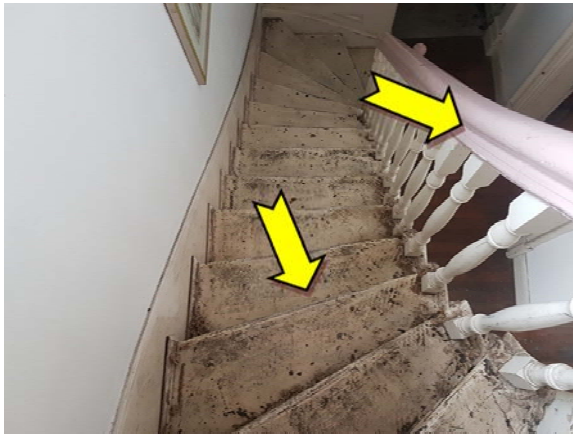
**Photo 15.** Interior, staircase, stairs and hand rail – lead-containing cream upper paint systems and suspected lead-containing pink upper paint systems.

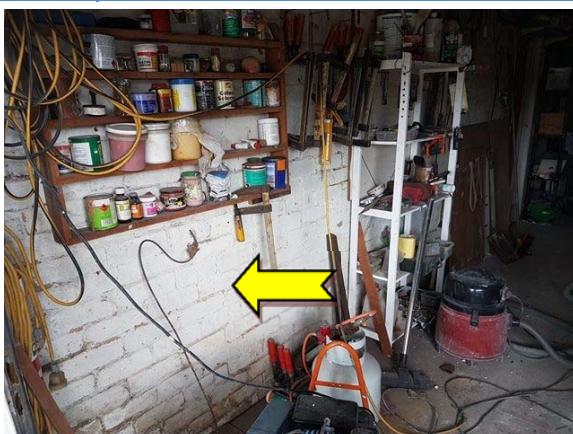
**Photo 17.** Interior, shed, walls – suspected lead-containing white upper paint systems.
