# Hazardous Building Materials Assessment Sydenham Green - Canteen Unwins Bridge Road & Railway Parade, Sydenham NSW 2044

Inner West Council  
April 2018

Job No.: 57722-142

Count ID: CID: 358

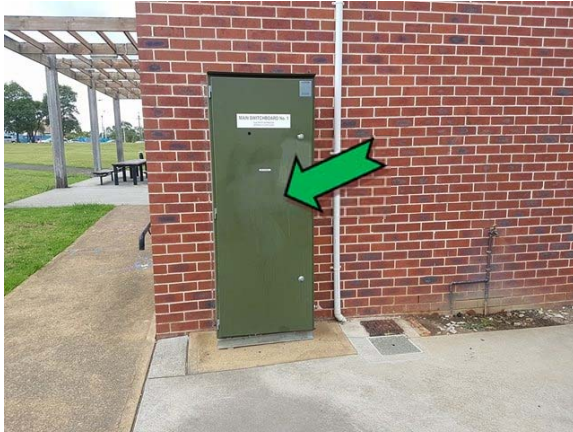
**Photo 1.** Exterior, north elevation, electrical backing board – suspected non asbestos-containing bituminous backing board.

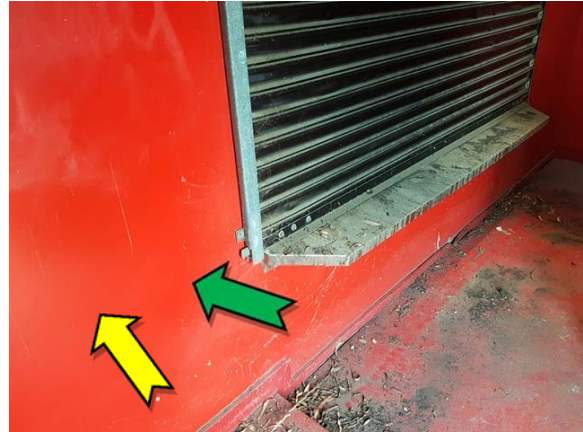
**Photo 2.** Interior, south elevation, wall – non asbestos-containing fibre cement sheeting and suspected lead-containing red upper paint systems.

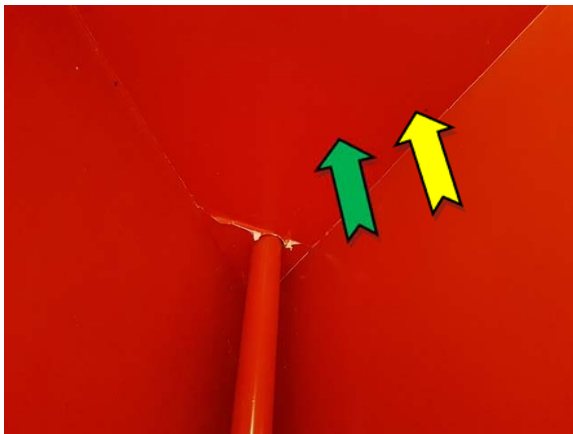
**Photo 3.** Interior, throughout, ceiling – assumed non asbestos-containing fibre cement sheeting and suspected lead-containing red upper paint system.

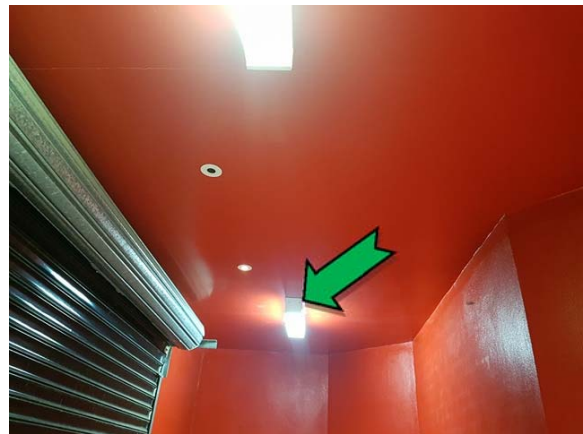
**Photo 4.** Interior, throughout, double tubed fluorescent light fittings – suspected non PCB-containing capacitors.

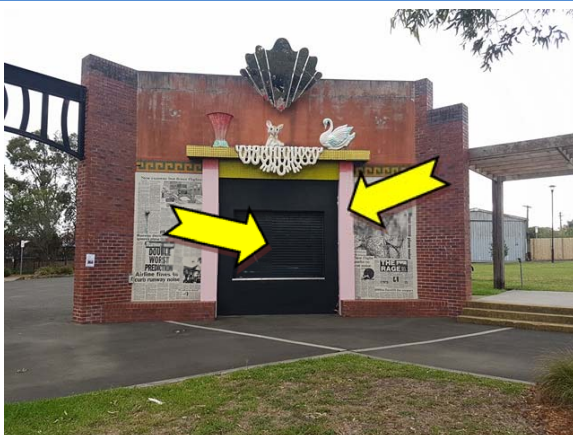
Exterior	South elevation	Wall	Black - upper coloured paint system	Lead Paint - Swab	-	Suspected Positive	-	Low	Good	Low	12m <sup>2</sup>	Confirm status by quantitative test method, maintain in current condition, over paint with a lead-free paint as part of ongoing maintenance. Remove under controlled conditions in accordance with AS 4361.2:2017 Guide to hazardous paint management prior to renovation or demolition works.	-	-	5
Exterior	South elevation	Wall	Pink - upper coloured paint system	Lead Paint - Swab	-	Suspected Positive	-	Low	Good	Low	6m <sup>2</sup>	Confirm status by quantitative test method, maintain in current condition, over paint with a lead-free paint as part of ongoing maintenance. Remove under controlled conditions in accordance with AS 4361.2:2017 Guide to hazardous paint management prior to renovation or demolition works.	-	-	5
Exterior	East elevation	Door and Frame	Black - upper coloured paint system	Lead Paint - Swab	-	Suspected Positive	-	Low	Good	Low	1 unit	Confirm status by quantitative test method, maintain in current condition, over paint with a lead-free paint as part of ongoing maintenance. Remove under controlled conditions in accordance with AS 4361.2:2017 Guide to hazardous paint management prior to renovation or demolition works.	-	-	6

**Photo 5.** Exterior, south elevation, wall – suspected lead-containing black and pink upper coloured paint systems.

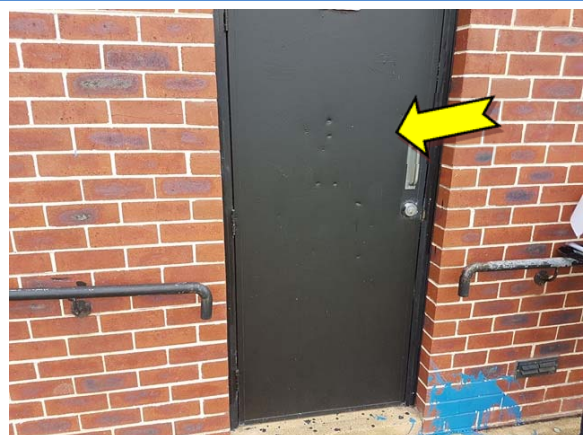
**Photo 6.** Exterior, east elevation, door – suspected lead-containing black upper paint system.
