Hazardous Building Materials Assessment Tempe Reserve – Blue Amenities / Change Rooms Holbeach Avenue, Tempe NSW 2044

Inner West Council
April 2018

Job No.: 57722-116

Count ID: CID: 370

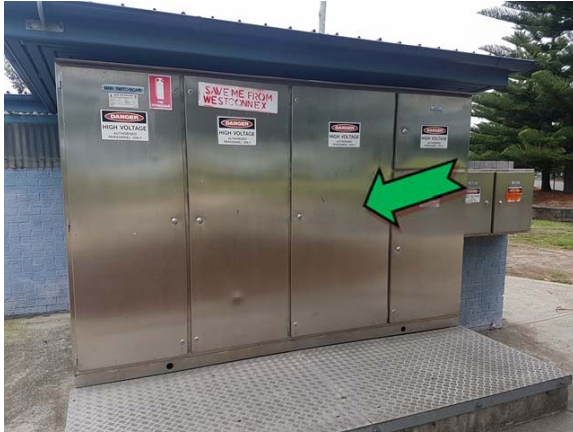
Photo 1. Exterior, north-east elevation, electrical backing board – suspected non asbestos-containing bituminous backing boards.

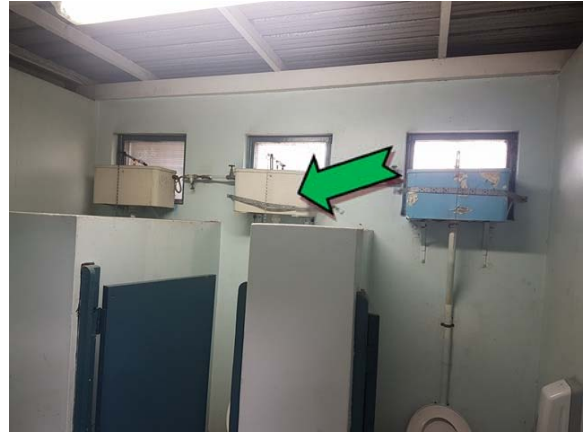
Photo 2. Interior, throughout, cisterns – non asbestos-containing moulded fibre cement.

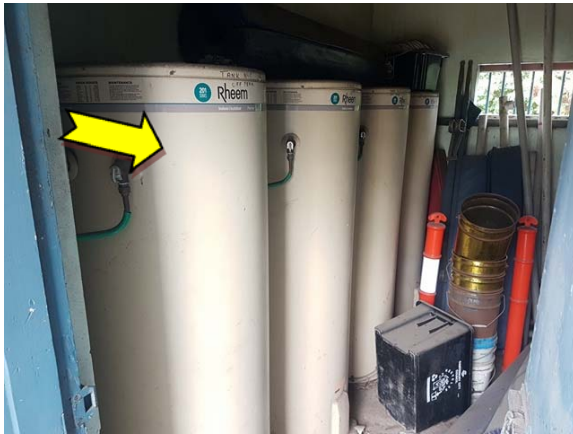
Photo 3. Interior, store room, hot water heaters – suspected SMF internal insulation material.

- SMF internal insulation material was suspected within the hot water heaters located in the store room at the time of the Assessment.

- SMF materials that are likely to be disturbed during any proposed demolition/refurbishment works should be handled in accordance with the *Code of Practice for the Safe Use of Synthetic Mineral Fibres* [NOHSC:2006(1990)]. If these materials are impacted upon by accident or by pre-planned works, the Inner West Council must be informed via the contact detailed within Section 7: *Accidental Disturbance of Known or Suspected Hazardous Building Materials*. Following disturbance, inspection by a competent person should be undertaken.

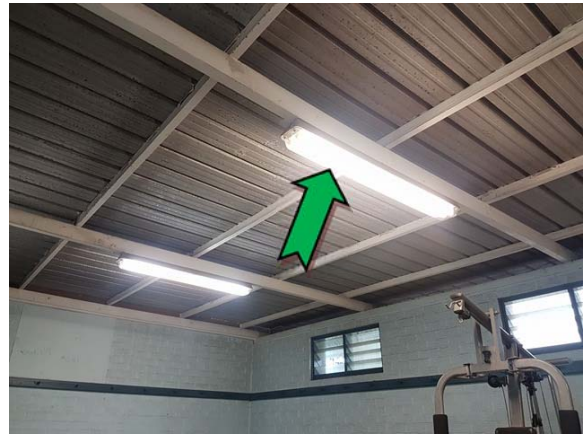
Photo 4. Interior, throughout, double tube fluorescent light fitting – suspected non PCB-containing capacitors.

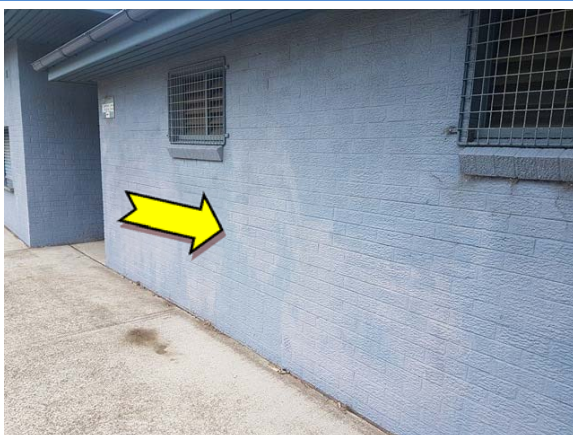
Exterior	Throughout	Walls	Blue - upper coloured paint system	Lead Paint - Swab	-	Suspected Positive	-	Low	Good	Low	500m ²	Confirm status by quantitative test method, maintain in current condition, over paint with a lead-free paint as part of ongoing maintenance. Remove under controlled conditions in accordance with AS 4361.2:2017 Guide to hazardous paint management prior to renovation or demolition works.	-	-	5
Exterior	Throughout	Doors	Blue - upper coloured paint system	Lead Paint - Swab	-	Suspected Positive	-	Low	Good	Low	20m ²	Confirm status by quantitative test method, maintain in current condition, over paint with a lead-free paint as part of ongoing maintenance. Remove under controlled conditions in accordance with AS 4361.2:2017 Guide to hazardous paint management prior to renovation or demolition works.	-	-	6
Interior	Female & Male Toilets	Walls	Blue (light) - upper coloured paint system	Lead Paint - Swab	-	Suspected Positive	-	Low	Fair	Low	80m ²	Confirm status by quantitative test method, maintain in current condition, over paint with a lead-free paint as part of ongoing maintenance. Remove under controlled conditions in accordance with AS 4361.2:2017 Guide to hazardous paint management prior to renovation or demolition works.	-	-	7

Photo 5. Exterior, throughout, walls – suspected lead-containing blue upper paint systems.

- The *LeadCheck* paint swab method can detect lead in paint at concentrations of 0.5% and above, and may indicate lead in some paint films as low as 0.2%. As paint with a lead content greater than 0.1% by dry weight is now considered to be lead-containing, Prensa recommends confirming status of suspected LCP identified during the Assessment by quantitative test method.

- The safest method of dealing with LCP is to replace or remove the items in their entirety that have LCP on them and replace them with new items that do not contain lead. This allows the items to be disposed of as regular building or demolition unsegregated waste in accordance with the NSW Environment Protection Authority (EPA) *Waste Classification Guidelines 2014 Part 1 – Classifying Waste*. The advantage of this method is the reduction in labour requirements to remove the lead paint and also this reduces the risk to workers from exposure to lead dust or fumes. If the removal of the LCP or coatings is the preferred or required option this may generate significant amounts of potential hazardous waste. This waste must be removed, collected and disposed of by an appropriately licensed contractor under controlled conditions that minimises the release to air, water and soil. Disposal of lead waste must be disposed of as hazardous waste at an approved waste facility.

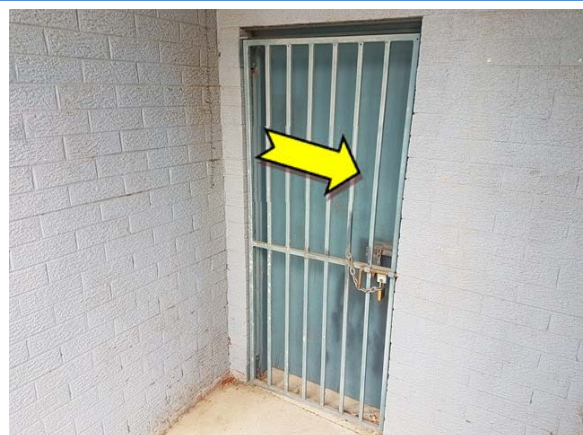
Photo 6. Exterior, throughout, doors – suspected lead-containing blue upper paint systems.

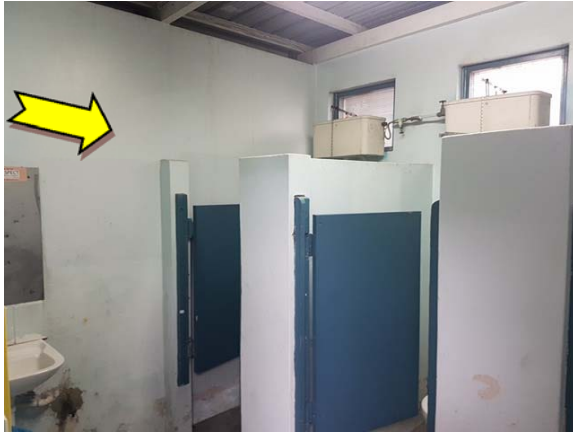
Photo 7. Interior, female and male toilets, walls – suspected lead-containing light blue upper paint systems.

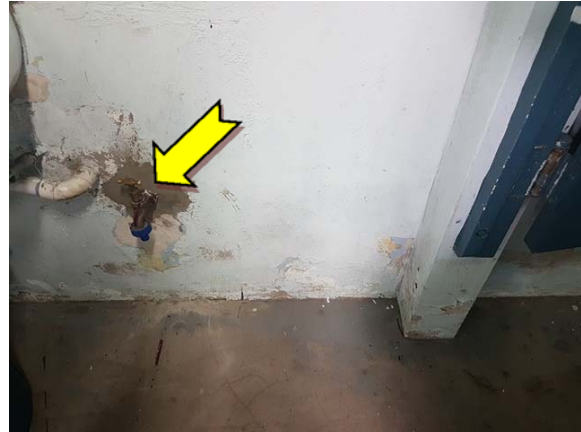
Interior	Female & Male Toilets	Walls	Green (light) - lower coloured paint system	Lead Paint - Swab	-	Suspected Positive	-	Low	Fair	Low	80m ²	Confirm status by quantitative test method, maintain in current condition, over paint with a lead-free paint as part of ongoing maintenance. Remove under controlled conditions in accordance with AS 4361.2:2017 Guide to hazardous paint management prior to renovation or demolition works.	-	-	8
Interior	Canteen, North & West elevation	Wall	Blue (dark) - upper coloured paint system	Lead Paint - Swab	-	Suspected Positive	-	Low	Fair	Low	20m ²	Confirm status by quantitative test method, maintain in current condition, over paint with a lead-free paint as part of ongoing maintenance. Remove under controlled conditions in accordance with AS 4361.2:2017 Guide to hazardous paint management prior to renovation or demolition works.	-	-	9
Interior	Canteen, east elevation	Wall	White - upper coloured paint system	Lead Paint - Swab	-	Suspected Positive	-	Low	Good	Low	20m ²	Confirm status by quantitative test method, maintain in current condition, over paint with a lead-free paint as part of ongoing maintenance. Remove under controlled conditions in accordance with AS 4361.2:2017 Guide to hazardous paint management prior to renovation or demolition works.	-	-	9

Photo 8. Interior, female and male toilets, walls – suspected lead-containing light green lower paint systems.

- LCP was suspected in the form of light green lower paint systems to the walls throughout the female and male toilet walls at the time of the Assessment.

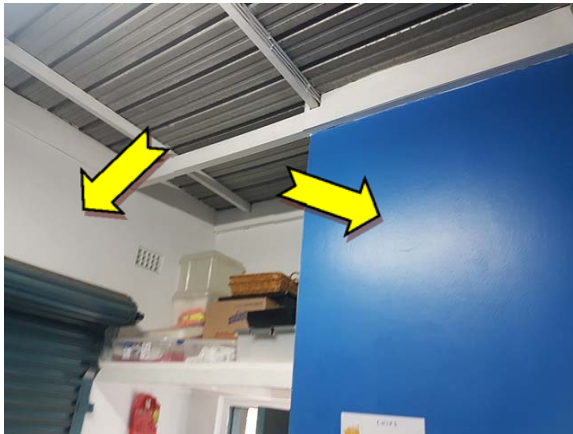
Photo 9. Interior, canteen, throughout, walls – suspected lead-containing white and dark blue upper coloured paint systems.
