Hazardous Building Materials Assessment Tempe Reserve – Robyn Webster Building Holbeach Avenue, Tempe NSW 2044

Inner West Council
April 2018

Job No.: 57722-113

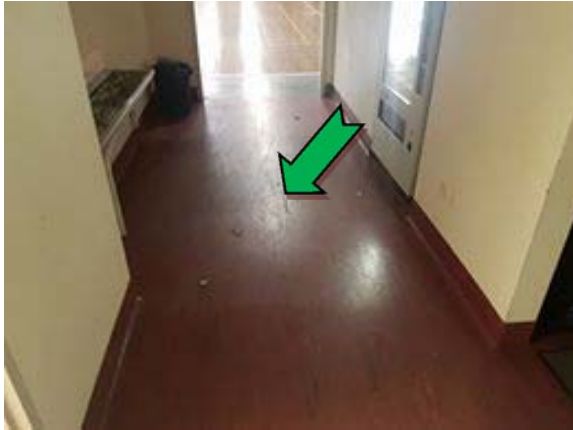
Photo 1. Interior, corridor to kiosk, red floor coverings – suspected non asbestos-containing sheet vinyl.

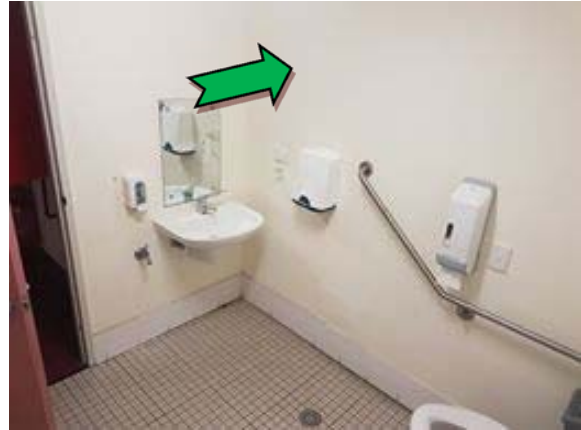
Photo 2. Interior, bathroom, walls – non asbestos-containing fibre cement sheeting.

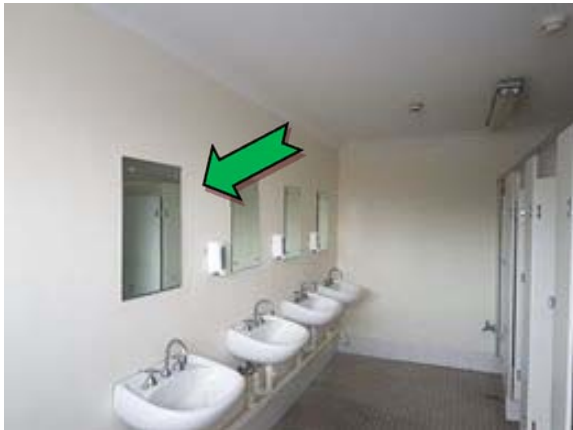
Photo 3. Interior, male and female change rooms, walls – assumed non asbestos-containing fibre cement sheeting.

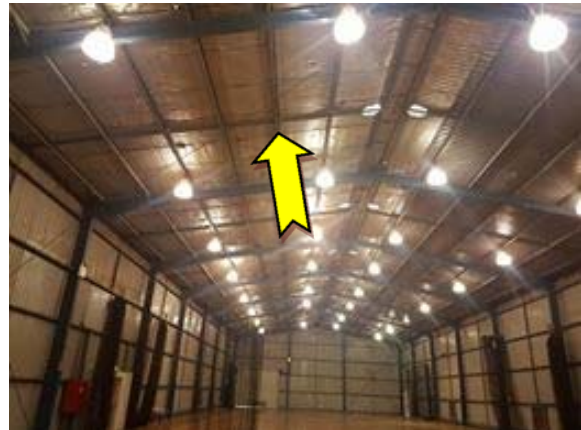
Photo 4. Interior, south elevation, to ceiling – suspected SMF sarking insulation material.

- SMF sarking insulation was suspected to the roof throughout the building.

- SMF materials that are likely to be disturbed during any proposed demolition/refurbishment works should be handled in accordance with the *Code of Practice for the Safe Use of Synthetic Mineral Fibres* [NOHSC:2006(1990)]. If these materials are impacted upon by accident or by pre-planned works, the Inner West Council must be informed via the contact detailed within Section 7: *Accidental Disturbance of Known or Suspected Hazardous Building Materials*. Following disturbance, inspection by a competent person should be undertaken.

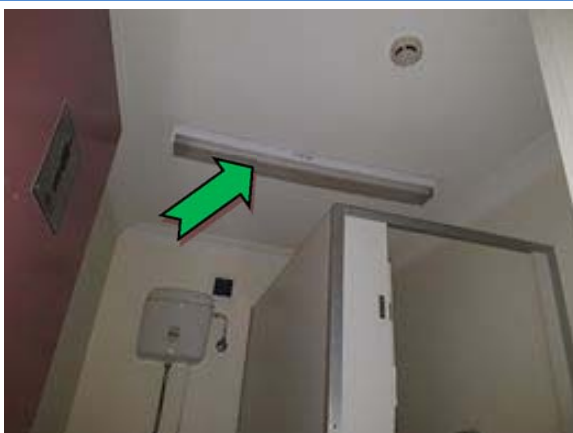
Photo 5. Interior, throughout, single tubed fluorescent light fittings – suspected non PCB-containing capacitors.
