# Hazardous Building Materials Assessment

## Kendrick Park Toilets

#### Tempe NSW 2044

Inner West Council  
April 2018

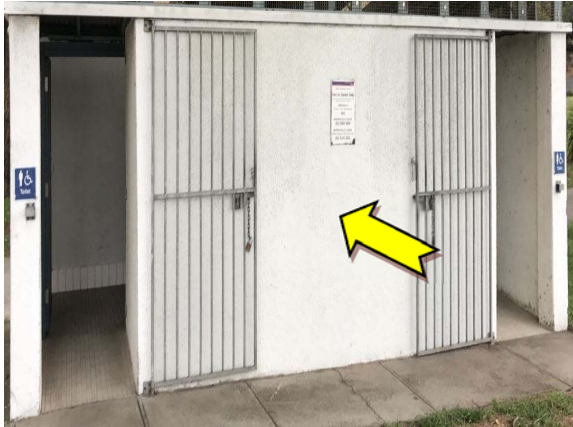
**Photo 1.** Exterior, throughout, wall - suspected lead-containing cream upper paint system.

- LCP was suspected in cream upper coloured paint systems to walls to the exterior and exterior of the site.

- The *LeadCheck* paint swab method can detect lead in paint at concentrations of 0.5% and above, and may indicate lead in some paint films as low as 0.2%. As paint with a lead content greater than 0.1% by dry weight is now considered to be lead-containing, Prensa recommends confirming status of suspected LCP identified during the Assessment by quantitative test method.

- The safest method of dealing with LCP is to replace or remove the items in their entirety that have LCP on them and replace them with new items that do not contain lead. This allows the items to be disposed of as regular building or demolition unsegregated waste in accordance with the NSW Environment Protection Authority (EPA) *Waste Classification Guidelines 2014 Part 1 – Classifying Waste*. The advantage of this method is the reduction in labour requirements to remove the lead paint and also this reduces the risk to workers from exposure to lead dust or fumes. If the removal of the LCP or coatings is the preferred or required option this may generate significant amounts of potential hazardous waste. This waste must be removed, collected and disposed of by an appropriately licensed contractor under controlled conditions that minimises the release to air, water and soil. Disposal of lead waste must be disposed of as hazardous waste at an approved waste facility.
