Hazardous Building Materials Assessment Tempe Golf Driving Range – Demountable 1 17 Swamp Road Tempe NSW 2044

Inner West Council
April 2018

Job No.: 57722-111

Count ID: CID: 362

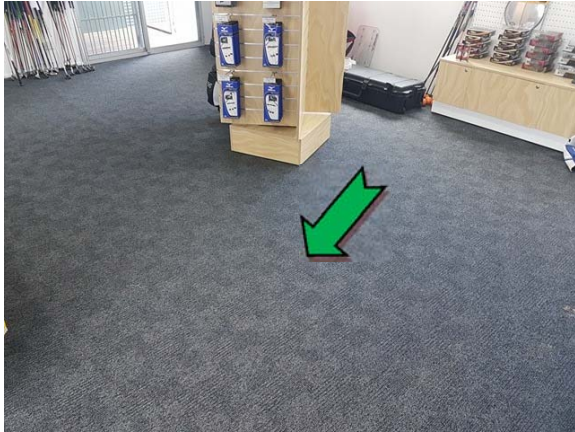
Photo 1. Interior, under carpet, floor coverings (blue) – non asbestos-containing vinyl sheeting.

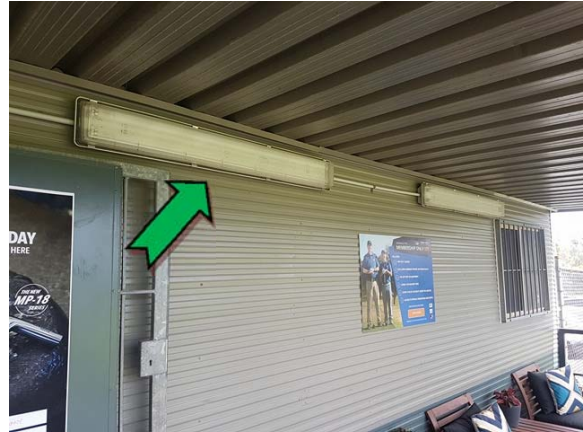
Photo 2. Exterior, throughout, double tube fluorescent light fitting– suspected non PCB-containing capacitor.

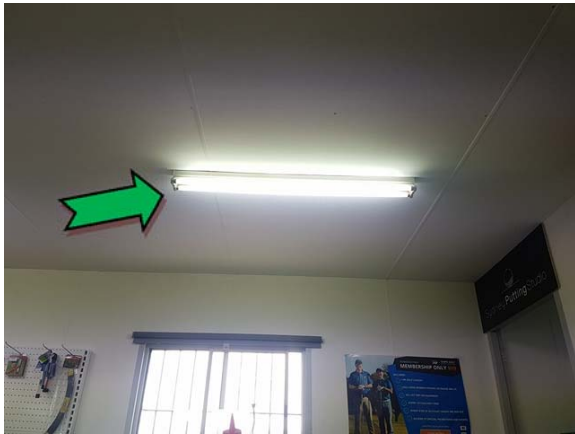
Photo 3. Interior, throughout, double tube fluorescent light fitting – suspected non PCB-containing capacitor.

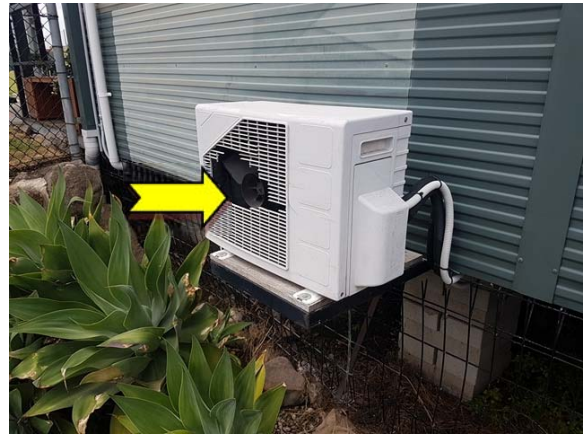
Photo 4. Exterior, west elevation, air conditioning unit – suspected ODS-containing unknown refrigerant gas.

- Two ODS-containing air conditioning units located to the exterior western elevation were suspected to contain ODS refrigerant gas.

- If the ozone depleting substances identified on-site unit require removal they should be appropriately decanted and disposed of by a licensed contractor in accordance with the *Ozone Protection and Synthetic Greenhouse Gas Management Amendment Regulation 2017* as amended from time to time.
- In accordance with the Commonwealth Ozone Protection Legislation, Prensa recommends, in line with Australia's commitment to phase out ODS-containing substances that units which are required to be replaced due to their age, damage or functionality, have their ODS-containing refrigerants replaced with a non-ODS alternative such as R410A.
- It is important to note that, if a system which utilises ODS-refrigerants is in good working order, there is no need to transition to an alternative refrigerant/system (until 2029).

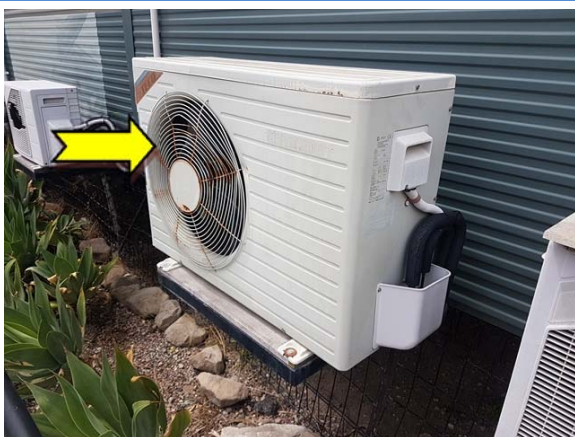
Photo 5. Exterior, west elevation, air conditioning unit – suspected ODS-containing unknown refrigerant gas.

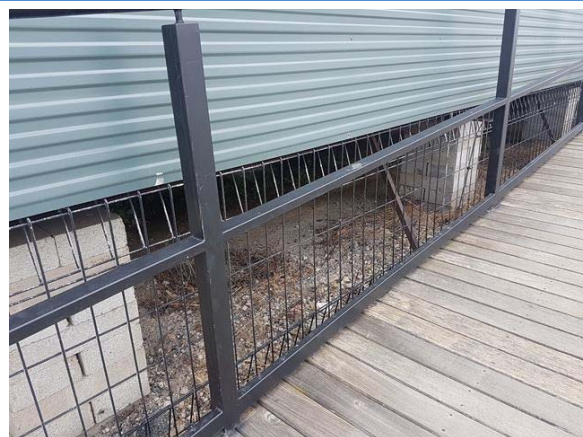
Photo 6. Exterior, subfloor – no access at the time of the assessment.

No access to the subfloor at the time of the Assessment.
