Hazardous Building Materials Assessment Tempe Golf Driving Range – Demountable 2 17 Swamp Road, Tempe NSW 2044

Inner West Council
April 2018

Job No.: 57722-118

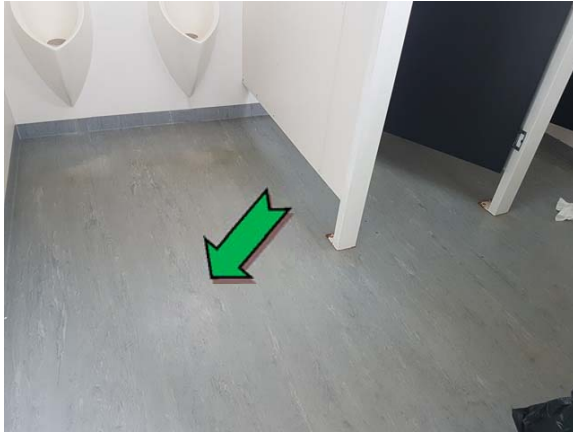
Photo 1. Interior, throughout, floor coverings – non asbestos-containing sheet vinyl.

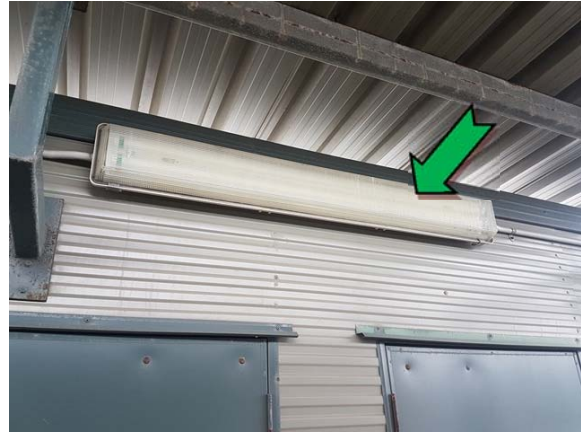
Photo 2. Exterior, throughout, double tube fluorescent light fitting – suspected non PCB-containing capacitors.

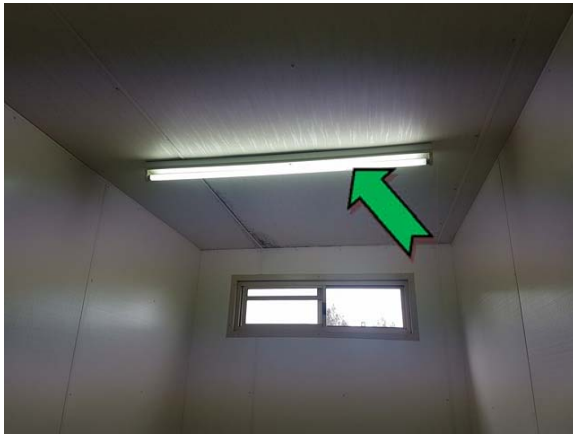
Photo 3. Interior, throughout, double tube fluorescent light fitting – suspected non PCB-containing capacitors.

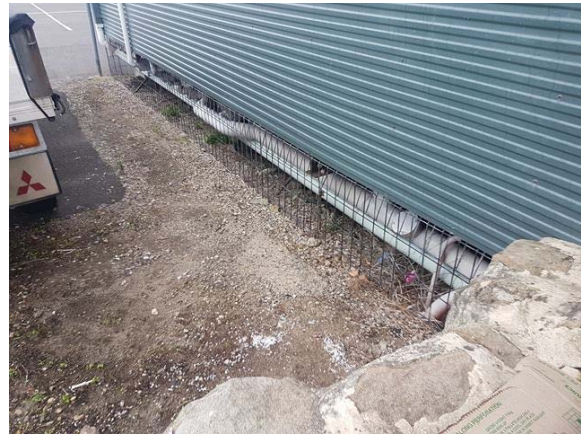
Photo 4. No access to the subfloor at the time of the Assessment.

No access to the subfloor at the time of the Assessment.
