Hazardous Building Materials Assessment Tempe Golf Driving Range - Shelter 17 Swamp Road, Tempe NSW 2044

Inner West Council
April 2018

Job No.: 57722-120

Count ID: CID: 365

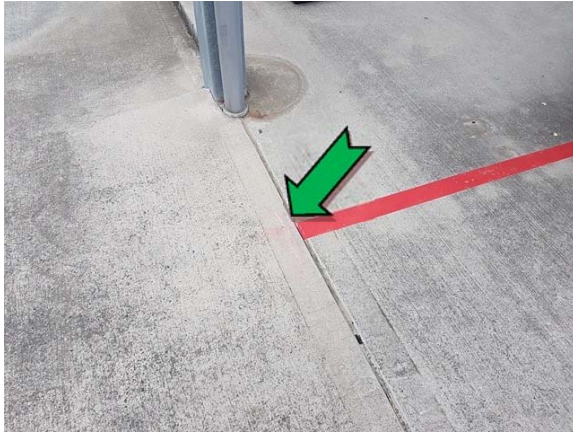
Photo 1. Exterior, floor, expansion joint – non asbestos-containing construction joint mastic.

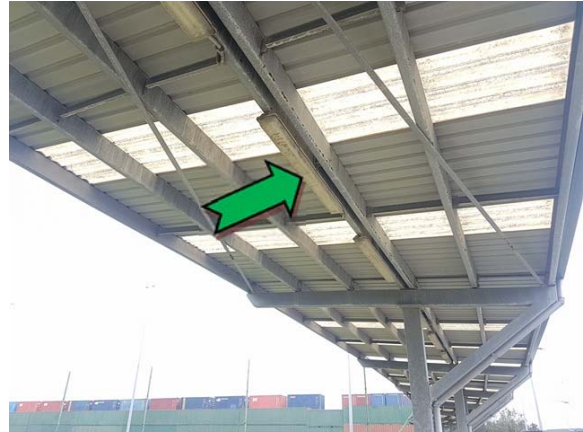
Photo 2. Exterior, throughout, double tubed fluorescent light fitting – suspected non PCB-containing capacitors.
