Hazardous Building Materials Assessment Tillman Park Early Learning Centre 79 Unwins Bridge Road, Tempe NSW 2044

Inner West Council
April 2018

Job No.: 57722-117

Count ID: CID: 376

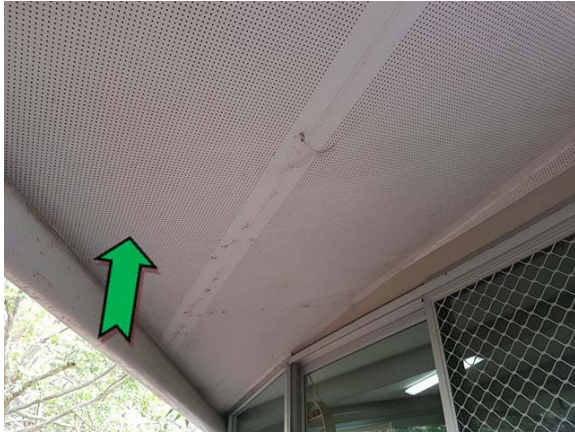
| Area / Level | Room & Location | Feature | Item Description | Hazard Type | Sample No. | Sample Status | Friability | Disturb. Potential | Condition | Risk Status | Approx. Quantity | Recommendations & Comments | Control Priority | Reinspect Date | Photo No. |
|---|---|---|---|---|---|---|---|---|---|---|---|---|---|---|---|
| Exterior | Throughout | Awning | Fibre Cement Sheeting | Asbestos | 57722-117-001 | Negative | - | - | - | - | - | - | - | - | 1 |

Photo 1. Exterior, throughout, awning – non asbestos-containing fibre cement sheeting.

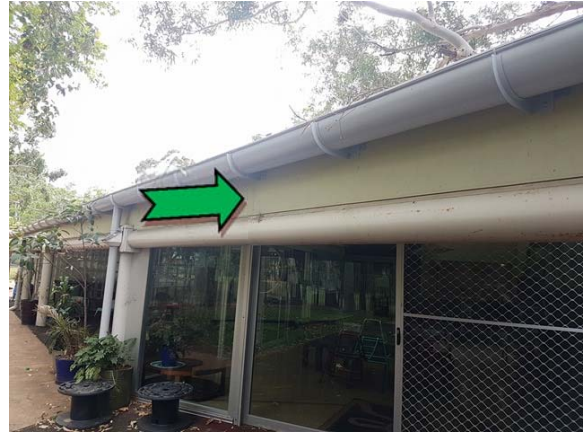
| Area / Level | Room & Location | Feature | Item Description | Hazard Type | Sample No. | Sample Status | Friability | Disturb. Potential | Condition | Risk Status | Approx. Quantity | Recommendations & Comments | Control Priority | Reinspect Date | Photo No. |
|---|---|---|---|---|---|---|---|---|---|---|---|---|---|---|---|
| Exterior | Throughout | Fascia | Fibre Cement Sheeting | Asbestos | 57722-117-002 | Negative | - | - | - | - | - | - | - | - | 2 |

Photo 2. Exterior, throughout, fascia – non asbestos-containing fibre cement sheeting.

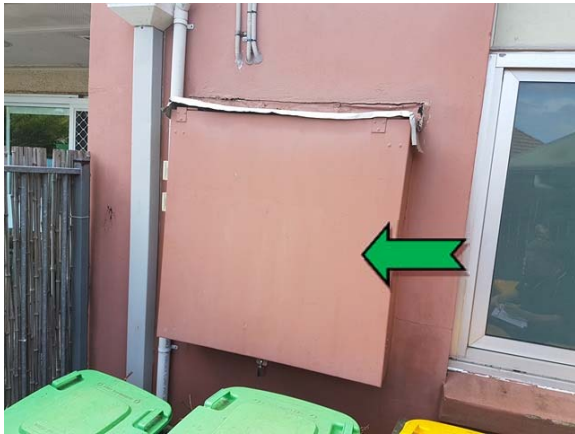
| Area / Level | Room & Location | Feature | Item Description | Hazard Type | Sample No. | Sample Status | Friability | Disturb. Potential | Condition | Risk Status | Approx. Quantity | Recommendations & Comments | Control Priority | Reinspect Date | Photo No. |
|---|---|---|---|---|---|---|---|---|---|---|---|---|---|---|---|
| Exterior | South-east elevation | Electrical backing board | Bituminous backing board | Asbestos | Not sampled: Electrical hazard | Suspected Negative | - | - | - | - | - | Suspected negative due to age and appearance. | - | - | 3 |

Photo 3. Exterior, south-east elevation, electrical backing board – suspected non asbestos-containing bituminous backing board.

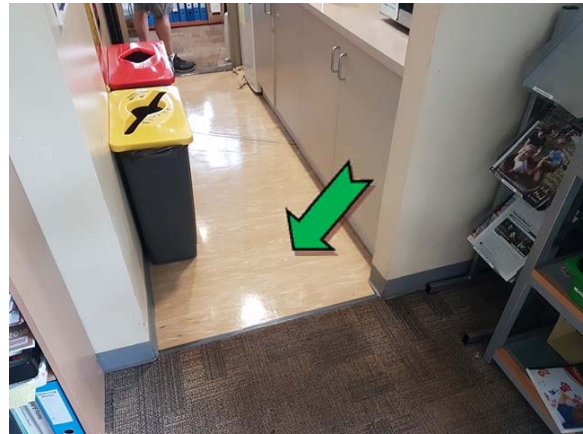
| Area / Level | Room & Location | Feature | Item Description | Hazard Type | Sample No. | Sample Status | Friability | Disturb. Potential | Condition | Risk Status | Approx. Quantity | Recommendations & Comments | Control Priority | Reinspect Date | Photo No. |
|---|---|---|---|---|---|---|---|---|---|---|---|---|---|---|---|
| Interior | Throughout | Floor coverings - cream | Sheet vinyl | Asbestos | Not sampled: Occupied | Suspected Negative | - | - | - | - | - | Suspected negative due to age and appearance. | - | - | 4 |

Photo 4. Interior, throughout, cream floor coverings – suspected non asbestos-containing sheet vinyl.

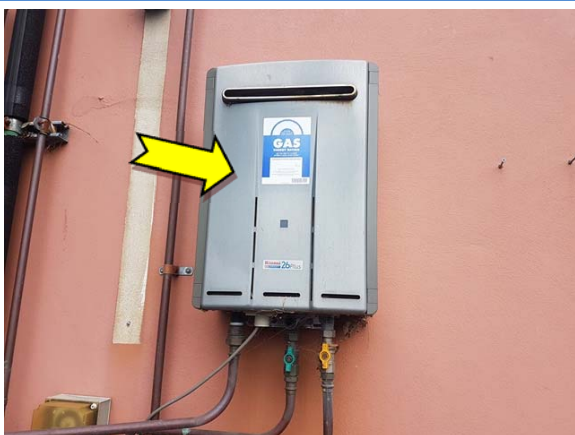
| Area / Level | Room & Location | Feature | Item Description | Hazard Type | Sample No. | Sample Status | Friability | Disturb. Potential | Condition | Risk Status | Approx. Quantity | Recommendations & Comments | Control Priority | Reinspect Date | Photo No. |
|---|---|---|---|---|---|---|---|---|---|---|---|---|---|---|---|
| Exterior | South-west elevation | Hot water heater | Insulation material - internal | SMF | - | Suspected Positive | Bonded | Low | Good | Low | 1 unit | Maintain in current condition if to remain in-situ. Remove under controlled SMF conditions as per the Code of Practice for the Safe Use of Synthetic Mineral Fibres [NOHSC: 2006 (1990)]. | - | - | 5 |

Photo 5. Exterior, south-west elevation, hot water heater – suspected SMF internal insulation material.

- SMF materials that are likely to be disturbed during any proposed demolition/refurbishment works should be handled in accordance with the *Code of Practice for the Safe Use of Synthetic Mineral Fibres* [NOHSC:2006(1990)]. If these materials are impacted upon by accident or by pre-planned works, the Inner West Council must be informed via the contact detailed within Section 7: *Accidental Disturbance of Known or Suspected Hazardous Building Materials*. Following disturbance, inspection by a competent person should be undertaken.

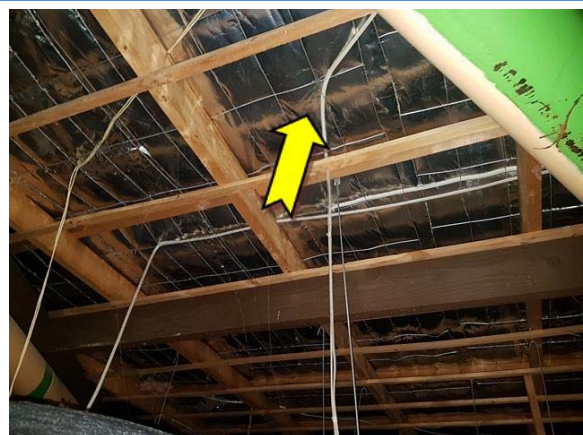
| Area / Level | Room & Location | Feature | Item Description | Hazard Type | Sample No. | Sample Status | Friability | Disturb. Potential | Condition | Risk Status | Approx. Quantity | Recommendations & Comments | Control Priority | Reinspect Date | Photo No. |
|---|---|---|---|---|---|---|---|---|---|---|---|---|---|---|---|
| Interior | Ceiling space, throughout | Insulation | Sarking insulation | SMF | - | Suspected Positive | Bonded | Low | Good | Low | 600m ² | Maintain in current condition if to remain in-situ. Remove under controlled SMF conditions as per the Code of Practice for the Safe Use of Synthetic Mineral Fibres [NOHSC: 2006 (1990)]. | - | - | 6 |

Photo 6. Interior, ceiling space, throughout – suspected SMF sarking insulation material.

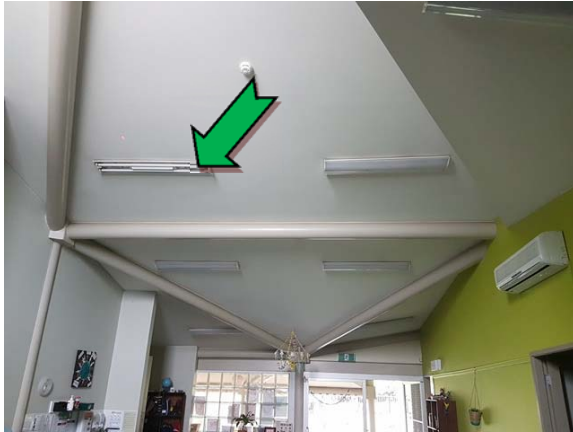
| Area / Level | Room & Location | Feature | Item Description | Hazard Type | Sample No. | Sample Status | Friability | Disturb. Potential | Condition | Risk Status | Approx. Quantity | Recommendations & Comments | Control Priority | Reinspect Date | Photo No. |
|---|---|---|---|---|---|---|---|---|---|---|---|---|---|---|---|
| Interior | Throughout | Fluorescent light fitting - double tube | Capacitor | PCBs | - | Suspected Negative | - | - | - | - | - | PCB-containing capacitors are unlikely to be present due to age and appearance of light fittings. Confirm PCB status prior to refurbishment or demolition works. | - | - | 7 |

Photo 7. Interior, throughout, double tube fluorescent light fitting – suspected non PCB-containing capacitors.

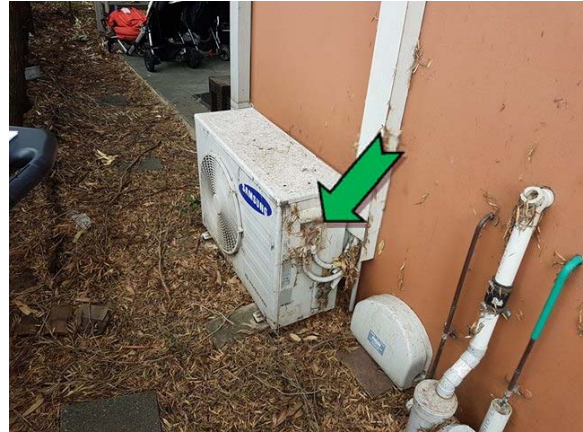
| Area / Level | Room & Location | Feature | Item Description | Hazard Type | Sample No. | Sample Status | Friability | Disturb. Potential | Condition | Risk Status | Approx. Quantity | Recommendations & Comments | Control Priority | Reinspect Date | Photo No. |
|---|---|---|---|---|---|---|---|---|---|---|---|---|---|---|---|
| Exterior | South-west elevation | Air conditioning unit | R410A Hydrofluorocarbon (HFC) | Ozone Depleting Substances | - | Negative | - | - | - | - | 1 unit | Hydrofluorocarbon (HFC) non ozone depleting substances. | - | - | 8 |

Photo 8. Exterior, south-west elevation, air conditioning unit – R410A non ODS-containing refrigerant gas.

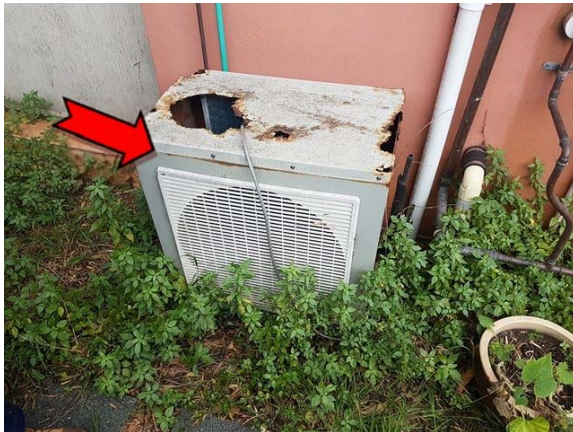
| Area / Level | Room & Location | Feature | Item Description | Hazard Type | Sample No. | Sample Status | Friability | Disturb. Potential | Condition | Risk Status | Approx. Quantity | Recommendations & Comments | Control Priority | Reinspect Date | Photo No. |
|---|---|---|---|---|---|---|---|---|---|---|---|---|---|---|---|
| Exterior | South-west elevation | Air conditioning unit | Unknown refrigerant | Ozone Depleting Substances | - | Suspected Positive | - | Low | Good | Low | 1 unit | No data was visible at the time of the assessment. Confirm status of suspected ozone depleting substances identified in the assessment. | - | - | 9 |

Photo 9. Exterior, south-west elevation, air conditioning unit – suspected ODS-containing unknown refrigerant.

- One air conditioning unit was suspected to containing an unknown ODS refrigerant gas located to the south-west exterior of the building.

- If the ozone depleting substances identified on-site unit require removal they should be appropriately decanted and disposed of by a licensed contractor in accordance with the *Ozone Protection and Synthetic Greenhouse Gas Management Amendment Regulation 2017* as amended from time to time.
- In accordance with the Commonwealth Ozone Protection Legislation, Prensa recommends, in line with Australia's commitment to phase out ODS-containing substances that units which are required to be replaced due to their age, damage or functionality, have their ODS-containing refrigerants replaced with a non-ODS alternative such as R410A.
- It is important to note that, if a system which utilises ODS-refrigerants is in good working order, there is no need to transition to an alternative refrigerant/system (until 2029).
