# Hazardous Building Materials Assessment Tempe Reserve Alexandra Canal Amenities Holbeach Avenue Tempe NSW 2044

Inner West Council  
April 2018

Job No.: 57722-112

Count ID: CID: 369

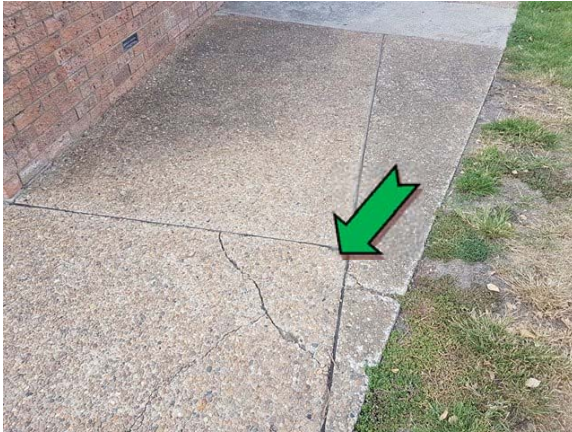
**Photo 1.** Exterior, ground, throughout, expansion joint – non asbestos-containing construction joint mastic.

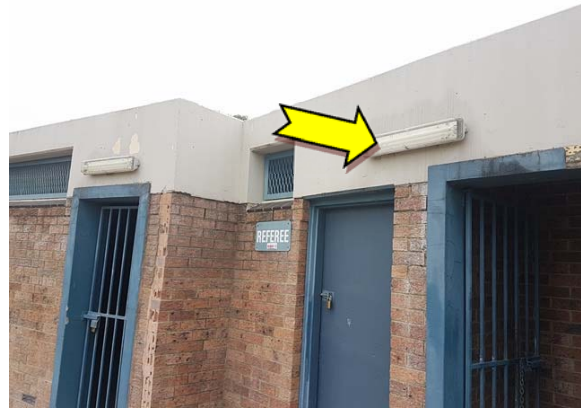
**Photo 2.** Exterior, throughout, single tubed fluorescent light fitting – suspected non PCB-containing capacitors.

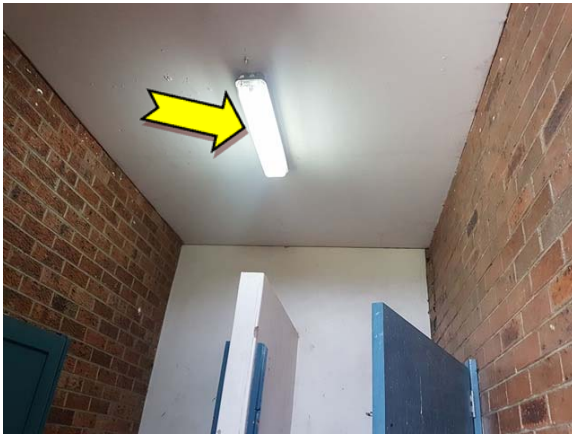
**Photo 3.** Interior, throughout, single tubed fluorescent light fitting – suspected non PCB-containing capacitors.

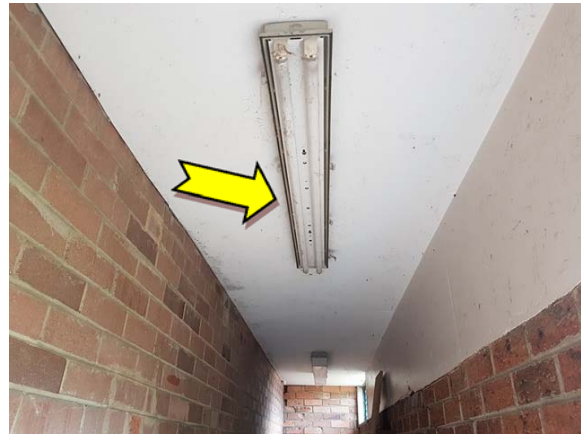
**Photo 4.** Interior, south-east elevation, store room, double tubed fluorescent light fittings – suspected PCB-containing capacitors.

- PCBs were suspected within the capacitors of the double tubed fluorescent light fittings located in the south-east store room.

- Electrical fittings suspected of containing PCB oil capacitors should be treated as containing PCB oils until such time as evidence suggest otherwise e.g. further assessed.
- Electrical fittings that contain or suspected to contain PCB oil-containing capacitors should be removed as hazardous/regulated waste under controlled working conditions prior to the demolition or refurbishment works in accordance with the *Polychlorinated Biphenyls Management Plan, Revised Edition April 2003*.

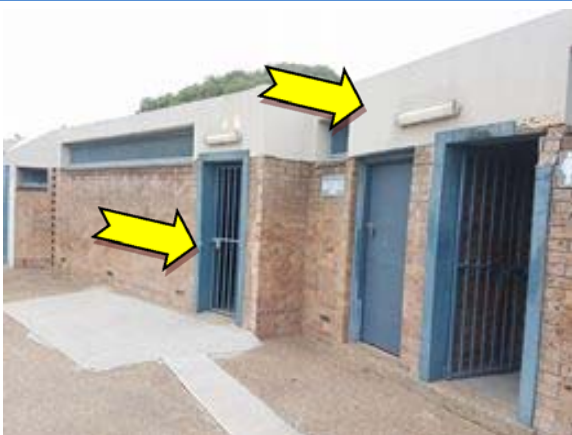
**Photo 5.** Exterior, upper level walls, window and door frames – suspected lead-containing beige and blue upper coloured paint systems.

- LCP was suspected in the form of blue and beige upper coloured paint systems to the exterior of the building.
- LCP was suspected in the form of yellow lower paint system to the exterior of the building.
- LCP was suspected in the form of white upper paint systems to the interior of the building.

- The *LeadCheck* paint swab method can detect lead in paint at concentrations of 0.5% and above, and may indicate lead in some paint films as low as 0.2%. As paint with a lead content greater than 0.1% by dry weight is now considered to be lead-containing, Prensa recommends confirming status of suspected LCP identified during the Assessment by quantitative test method.

- The safest method of dealing with LCP is to replace or remove the items in their entirety that have LCP on them and replace them with new items that do not contain lead. This allows the items to be disposed of as regular building or demolition unsegregated waste in accordance with the NSW Environment Protection Authority (EPA) *Waste Classification Guidelines 2014 Part 1 – Classifying Waste*. The advantage of this method is the reduction in labour requirements to remove the lead paint and also this reduces the risk to workers from exposure to lead dust or fumes. If the removal of the LCP or coatings is the preferred or required option this may generate significant amounts of potential hazardous waste. This waste must be removed, collected and disposed of by an appropriately licensed contractor under controlled conditions that minimises the release to air, water and soil. Disposal of lead waste must be disposed of as hazardous waste at an approved waste facility.

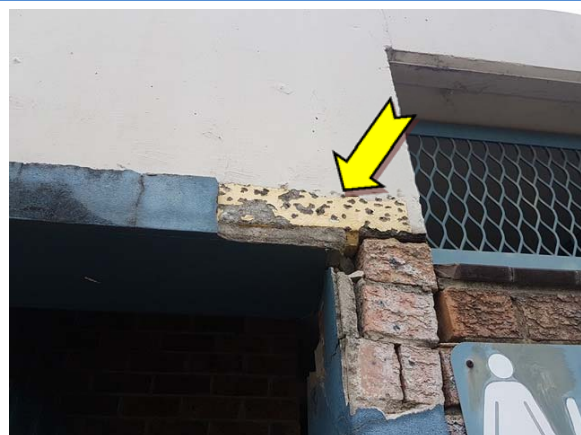
**Photo 6.** Exterior, upper level walls – suspected lead-containing yellow lower paint systems.
