INNER WEST COUNCIL

DEVELOPMENT ASSESSMENT REPORT

Application No.	DA201700224.01
Address	27 Croydon Street, Petersham
Proposal	Section 82A review of Determination No. 201700224, dated 26 June 2017, to remove a Bay tree from the rear of the property
Date of Lodgement	17 August 2017
Applicant	Maria Bergmark
Owners	Maria Bergmark
Number of Submissions	NA
Value of works	\$3,000
Reason for determination at Planning Panel	A request under Section 82A of the Environmental Planning and Assessment Act and there is no substantial change in recommendation on the matters the subject of the review.
Main Issues	Tree does not meet criteria for removal
Recommendation	Refusal

TREE REPORT

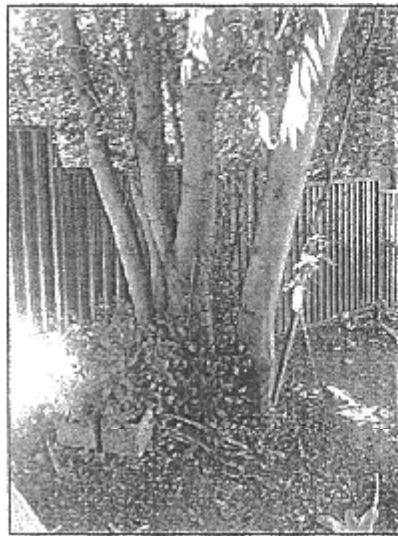
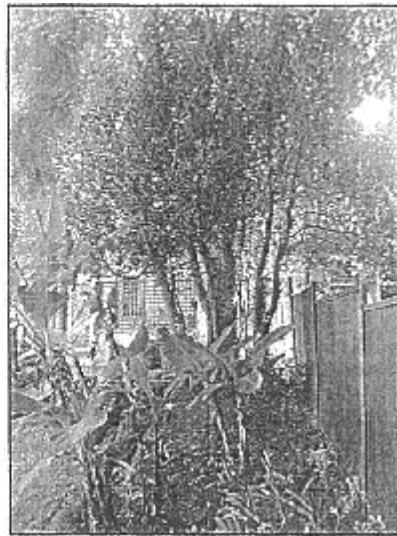
Plates 1 & 2 – showing multi-stemmed nature of subject tree

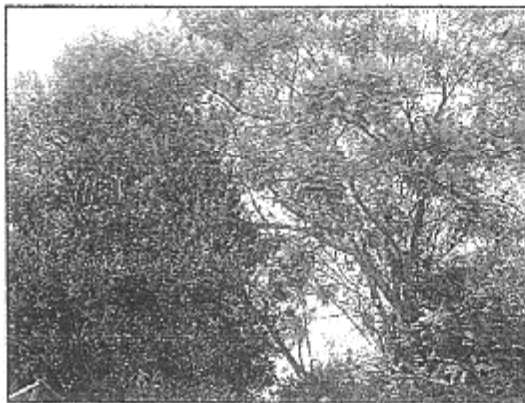
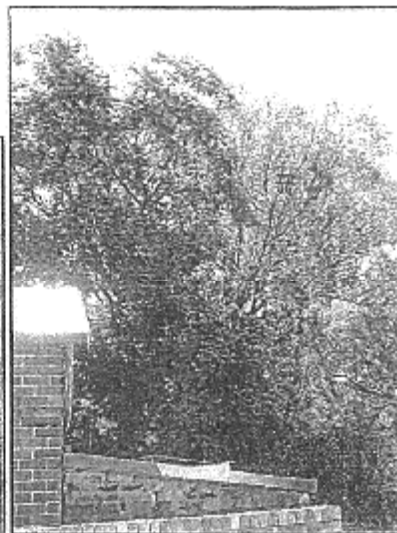
The tree has very little, if any, amenity value within the local area, and due to the presence of the more dominant canopy of the Jacarander tree, there will be no significant loss of tree cover (see Plate 3).

Plates 3 & 4 – showing canopies of subject trees

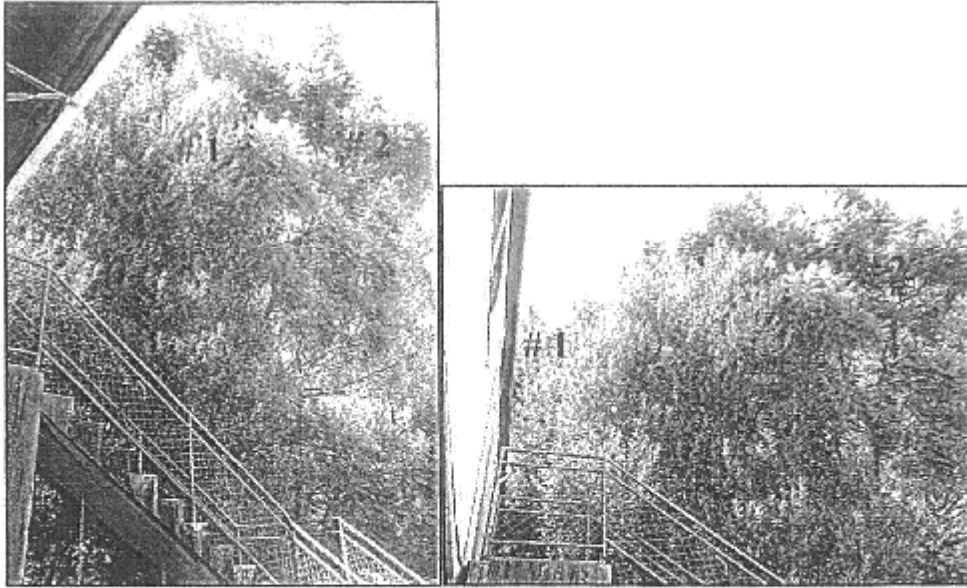
The subject tree has been heavily suppressed by the more dominant form of the much larger Liquidamber tree growing on the adjoining property. This is making its canopy grow predominantly towards the northwest and due to its close proximity to the dwelling, it is conflicting with the southern side of the dwelling and the steps (see Plates 5 & 6).

Plates 5 & 6 -- showing canopies of subject trees

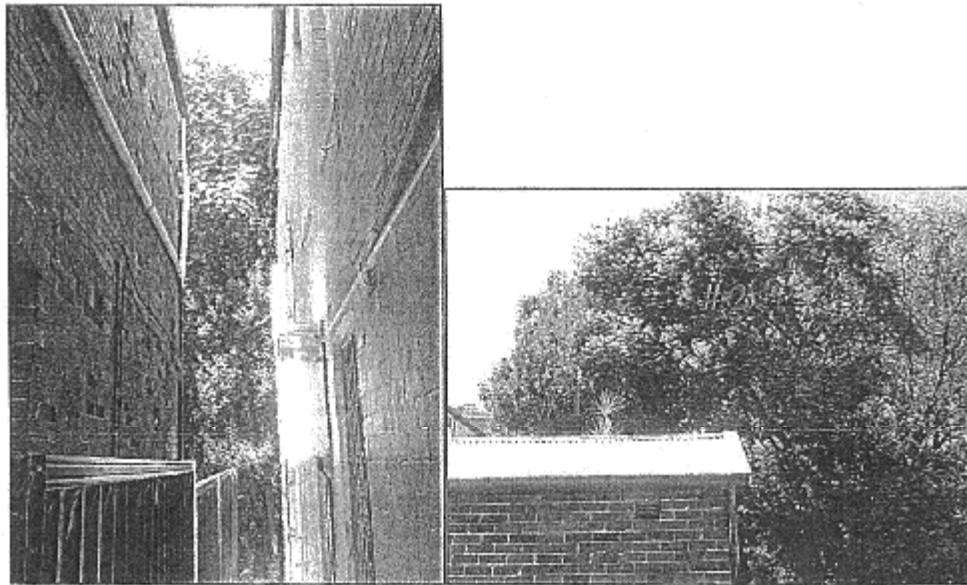
Plate 7 -- showing northern side of tree 1

Plate 8 -- canopies of subject trees, viewed from west
