Hazardous Building Materials Assessment

Tempe Golf Driving Range - Shed

17 Swamp Road,
Tempe NSW 2044

Inner West Council
April 2018

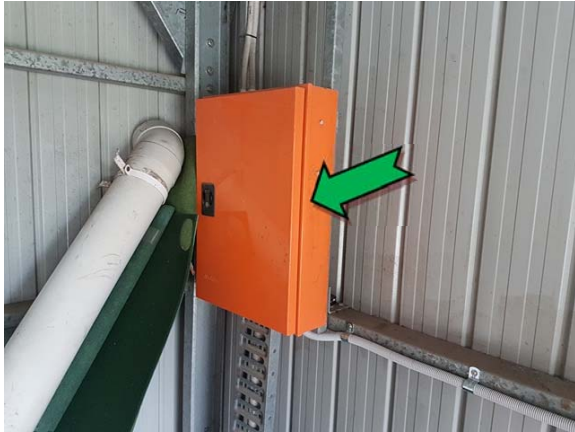
Photo 1. Interior, west elevation, electrical backing board – suspected non asbestos-containing bituminous backing board.

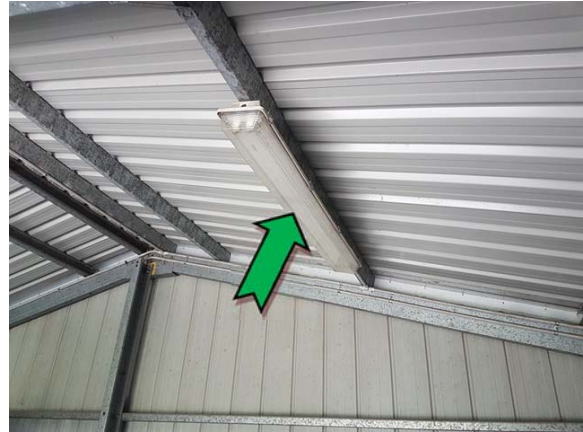
Photo 2. Interior, throughout, double tubed fluorescent light fitting – suspected non PCB-containing capacitor.
