# Cooks to Cove Greenway, In-corridor Works: MMP Exclusion Report

**Gartner Rose**

| <b>Project Number</b> | 23WOL4973 |

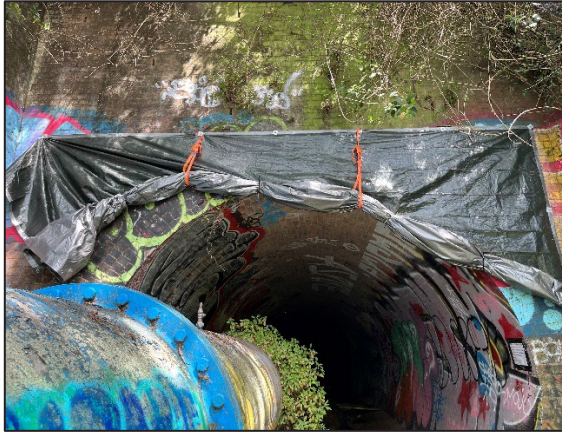
Figure 2: Installed exclusion device prior to lowering

| Activity | Staff | Date | Results |
|--|---|---|---|
| <p><b>Exclusion Device installation:</b><br/>Supervision of Gartner Rose staff installing the tarpaulin utilised for microbat exclusion. Ensuring that the right tension is used, is of reasonable durability and is secured around the edges with no gaps.</p> | Kody Kemp<br>Rodney Armistead | 13 November – Day<br>9:00am – 11:00 am | |

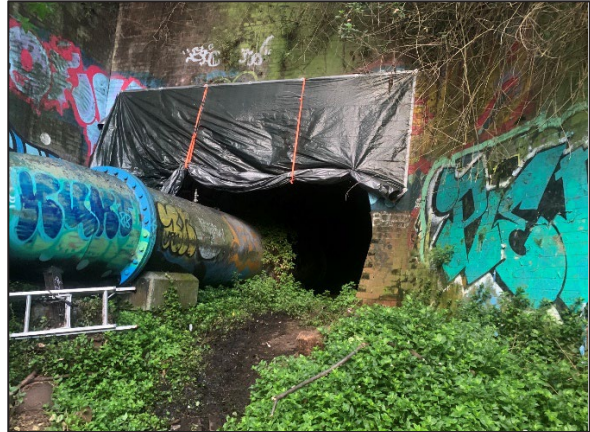
Figure 3: Exclusion Device 40% closed

| Activity | Staff | Date | Results |
|--|---|---|---|
| <p><b>Exclusion monitoring:</b><br/>Thermal imagery camera and two ultrasonic recorders set up facing the roost entrance to record microbat activity.<br/>Dropped exclusion device down to 40% coverage of roost exit.</p> | Tara Dowling<br>Rodney Armistead | 13 November – Night<br>6:50pm – 8:20pm<br>Exclusion device dropped following survey | 29 bats recorded exiting the roost. Long-term dead bat removed from roost |

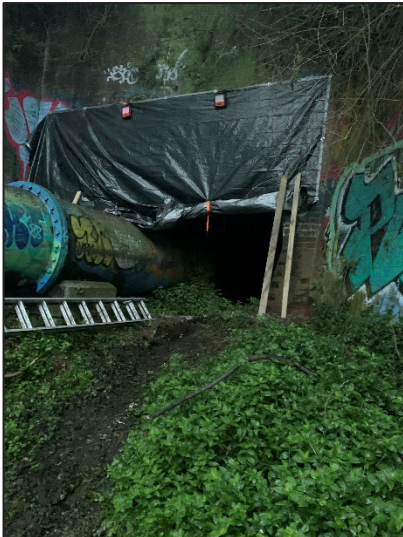
Figure 4: Curtain lifted to allow bats back into roost 50%

| Date | Number of bats recorded | Percentage closed | Survey time | Temperature |
|---|---|--|---|--|
| 15 November – Dawn | Approximately 10 bats recorded to be displaced/disrupted* | 70%, exclusion curtain was lifted to 50% to allow displaced bats to re-enter roost | 5:30am – 7:00am | 20 degrees |

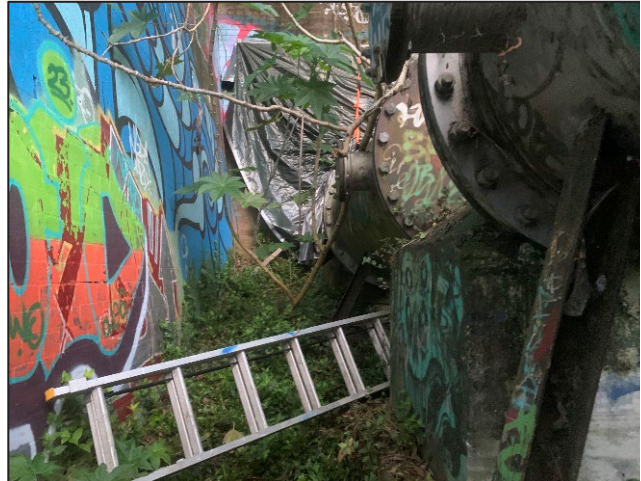
Figure 5: Left hand side of pipe completely closed

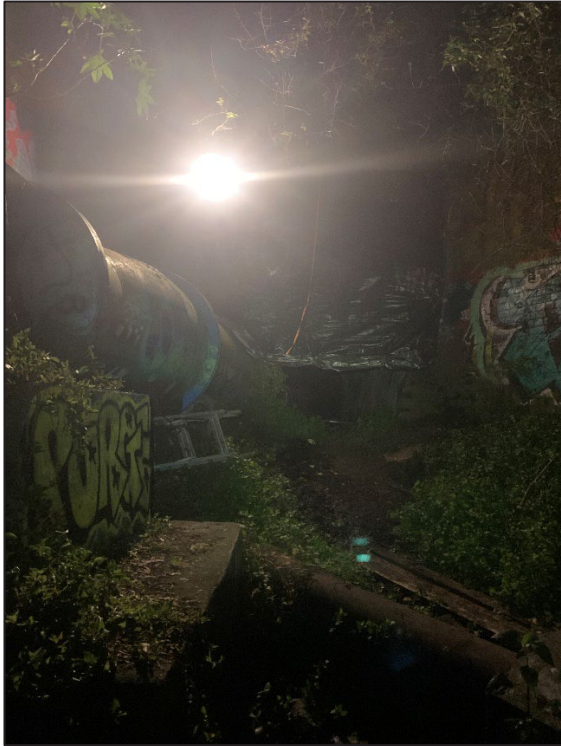
Figure 6: Exclusion device 75% closed

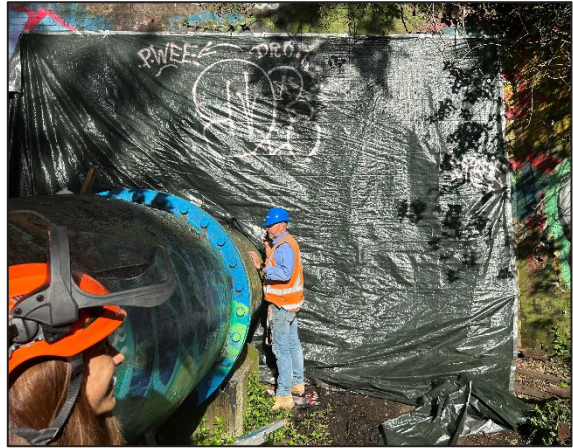
Figure 7: Exclusion device 100%

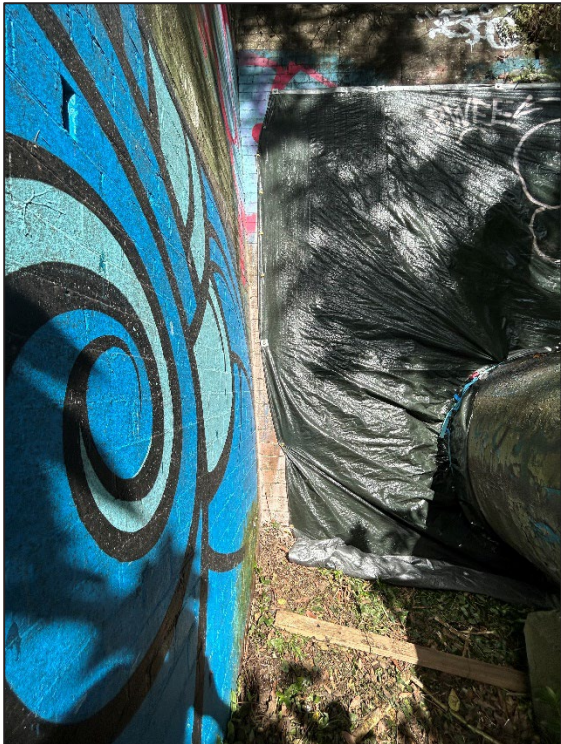
Figure 8: Permanent exclusion LHS of the water pipe

| Activity | Staff | Date | Results |
|---|---|--|--|
| <p><b>Exclusion supervision:</b></p> <p>Placement of ultrasonic recorder within the roost to monitor bat activity for four nights following permanent exclusion.</p> <p>Supervision of construction activities to permanently fix the curtain.</p> | <p>Taylor Benny</p> <p>Crystal Marsland</p> | <p>15 December – Morning<br/>7:00am – 9:30am</p> | <p>Exclusion device permanently fixed with no gaps within the material</p> |

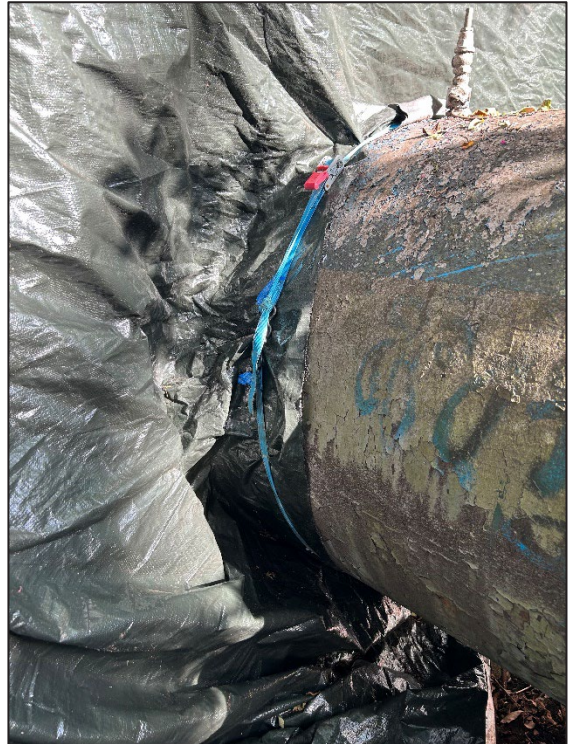
Figure 9: Permanent exclusion around water pipe
