Appendices

Appendix A – General notes and standards sheets

Client: Inner West Council	PROBE: A1-BH01	
Project: The GreenWay Geotechnical and Contamination Services		
Location: UTS Haberfield Club Carpark, Haberfield, NSW	AS 1289.6.3.2-1997 (Cone Tip) 510 mm drop height.	
Position: Refer to investigation log	Chainage: NA	Operator: LM
Elevation: Refer to investigation log	Offset: N/A	Date: 10/10/2019
Adjacent Test Hole / Pit: A1-BH01		Checked: JS
Position Relative to Test Hole / Pit: At investigation location		Date: 01/11/2019

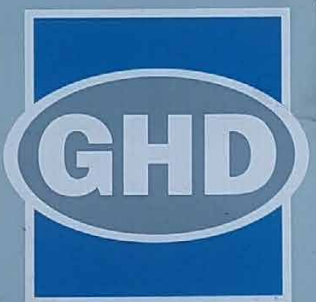
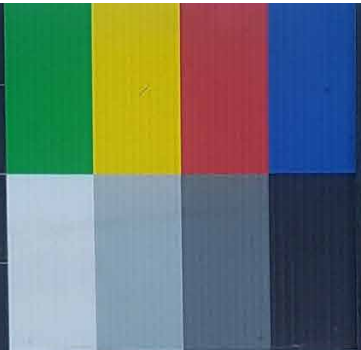
PROJECT: GreenWay SI
 PROJECT No: 12515105
 BOREHOLE No: A1-BH06
 DEPTH: 7.97 - 12.0m DATE: 16/10/2019

7.0 GREENWAY PROJECT - 12515105
 A1 - BH06 16/10/19 START CORING AT 7.97m

8.0 CORE LOSS 8.5m → 8.77 CORE LOSS

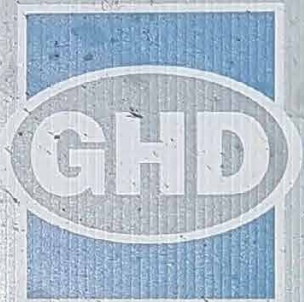
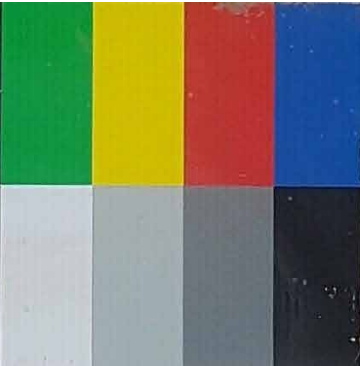
PROJECT: GreenWay SI
 PROJECT No: 12515105
 BOREHOLE No: A2 - BH02
 DEPTH: 4.7 - 8.6m DATE: 18/10/2019

A2-BH02
GreenWay Project - 12515105

COMMENCE CORING → AT 4.7m

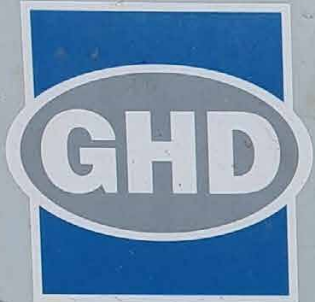
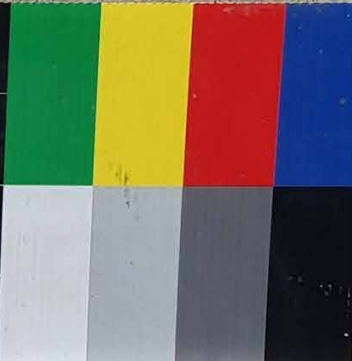
BOREHOLE No: A3-BH11

DEPTH: 9.0 - 10.28m DATE: 24/10/2019
