Review of Environmental Factors
The Cooks to Cove GreenWay (In-Corridor Works)

Appendix C: Soils and Contamination Report (GHD, 2020)

The GreenWay Geotechnical and Contamination Services Preliminary Site Soil and Contamination Investigation Report

May 2020

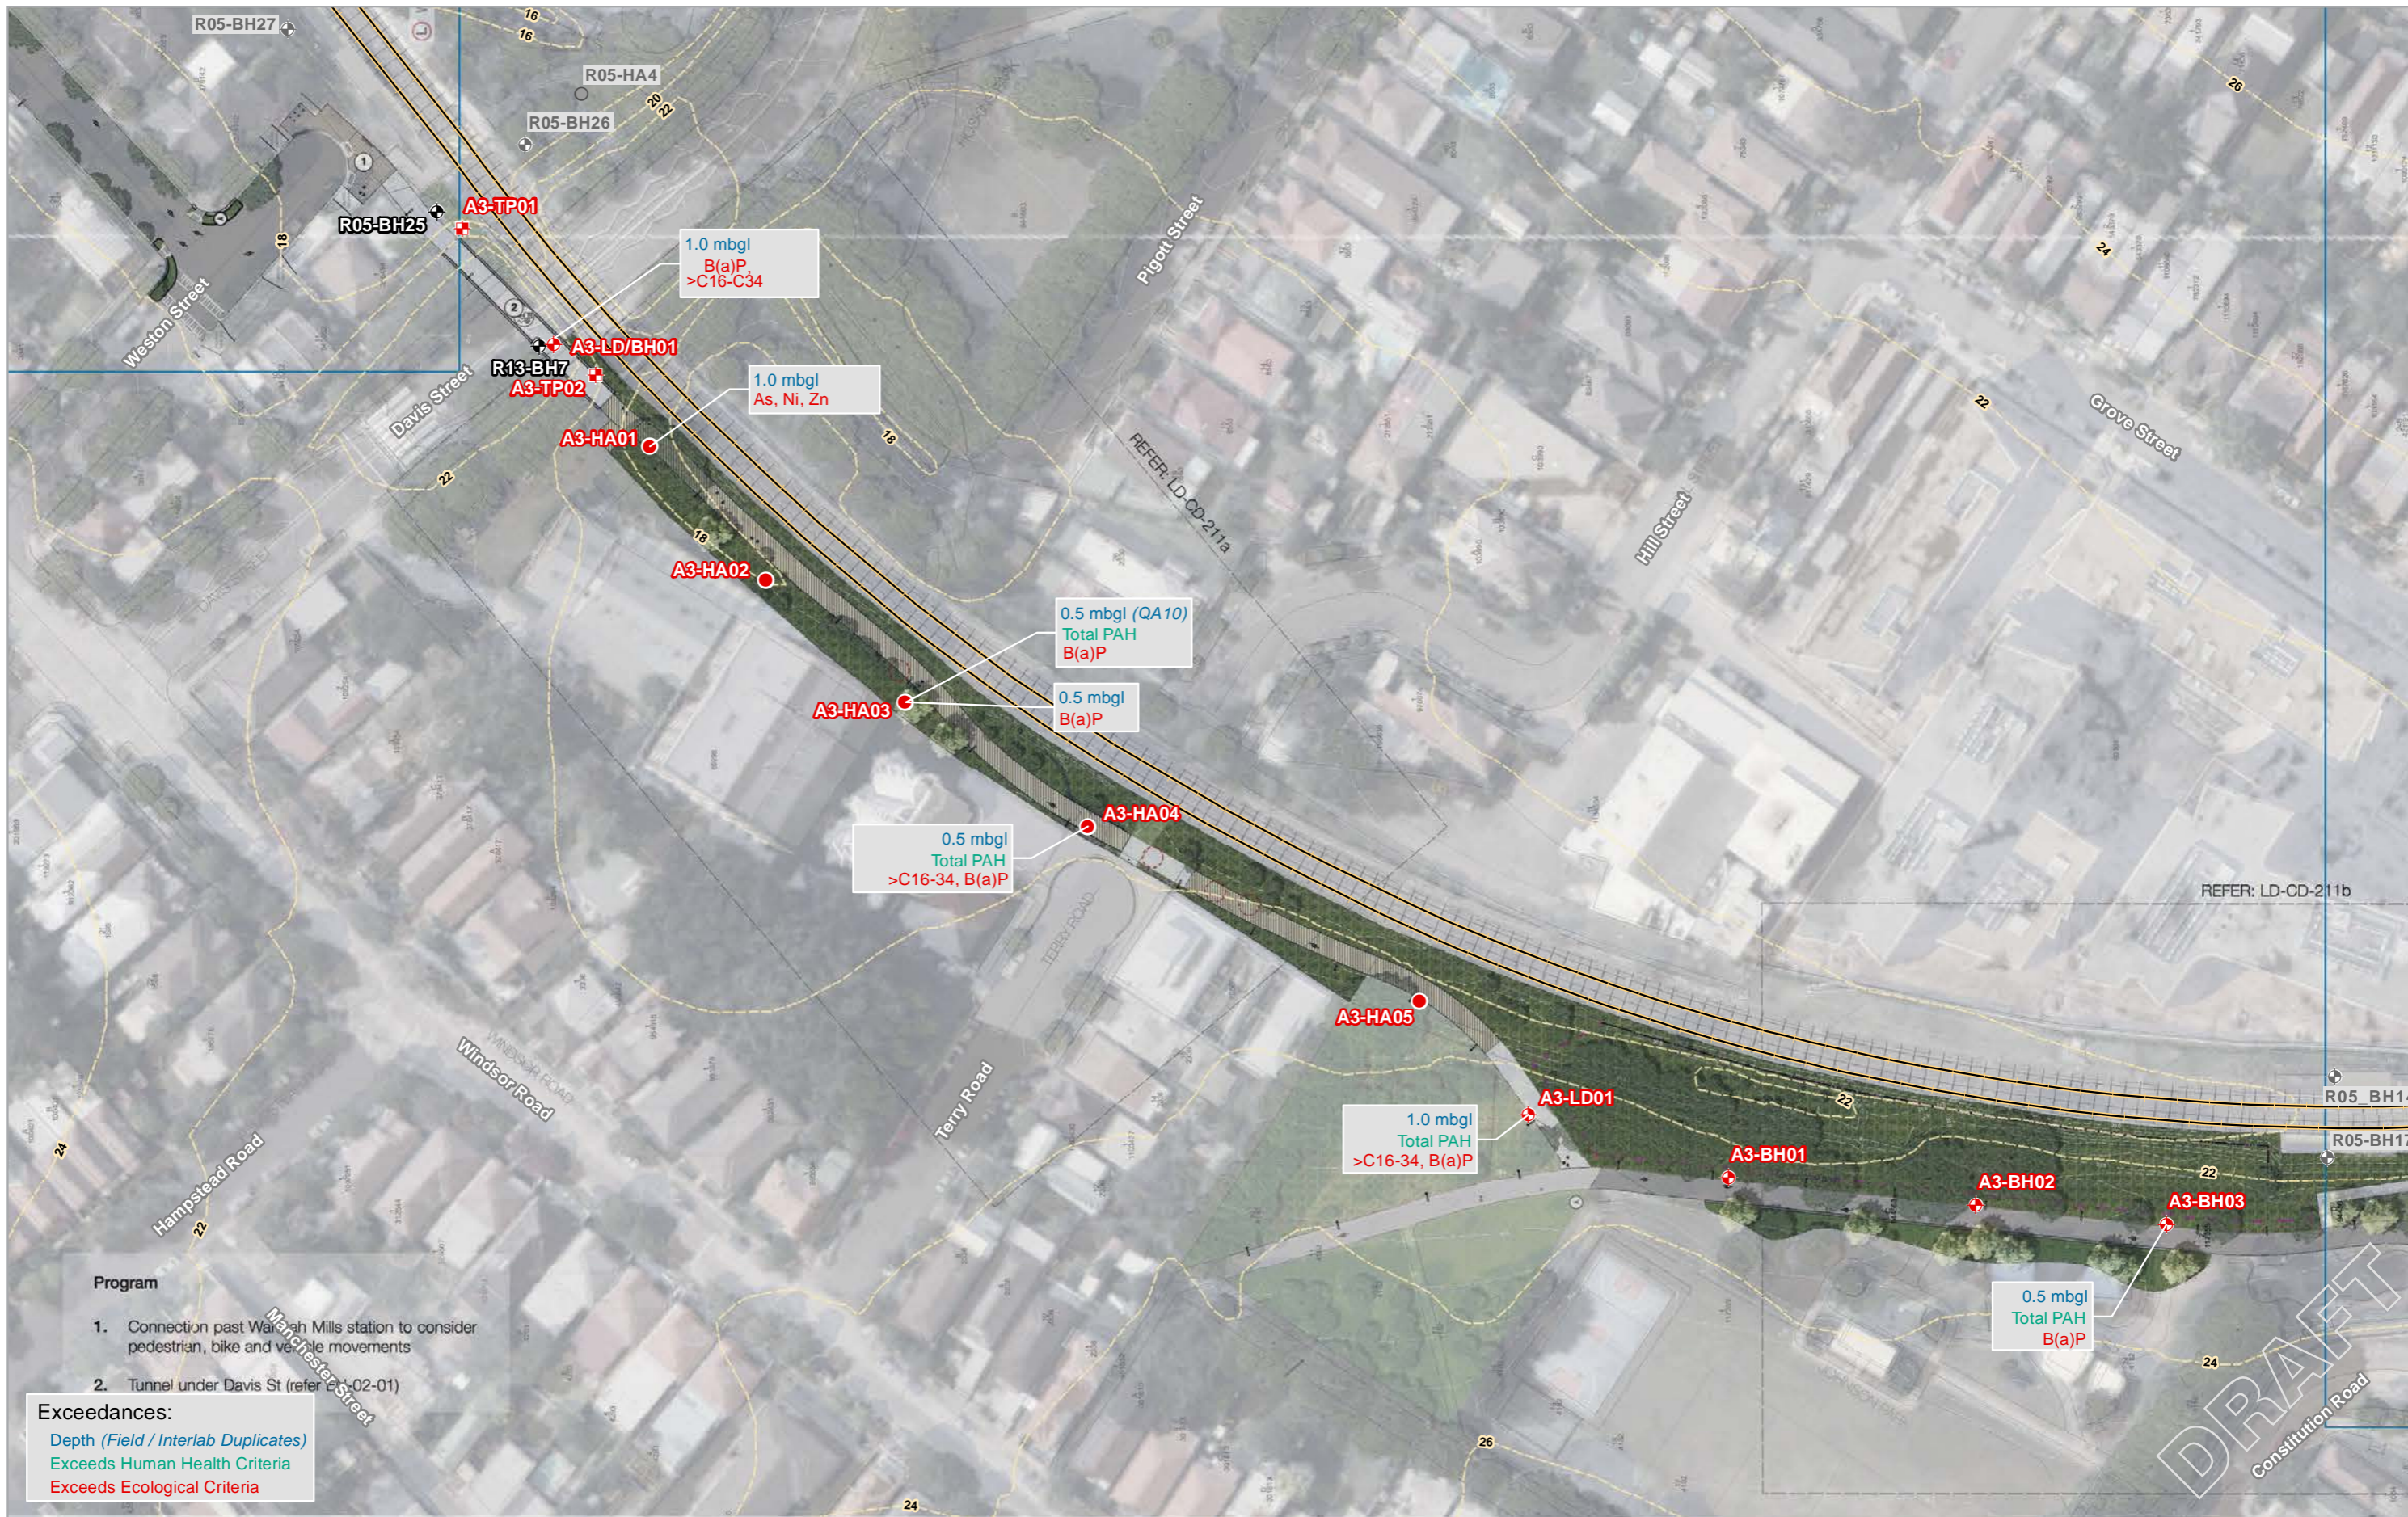
FIGURE 11

Exceedances:
■ Depth (Field / Interlab Duplicates)
■ Exceeds Human Health Criteria
■ Exceeds Ecological Criteria

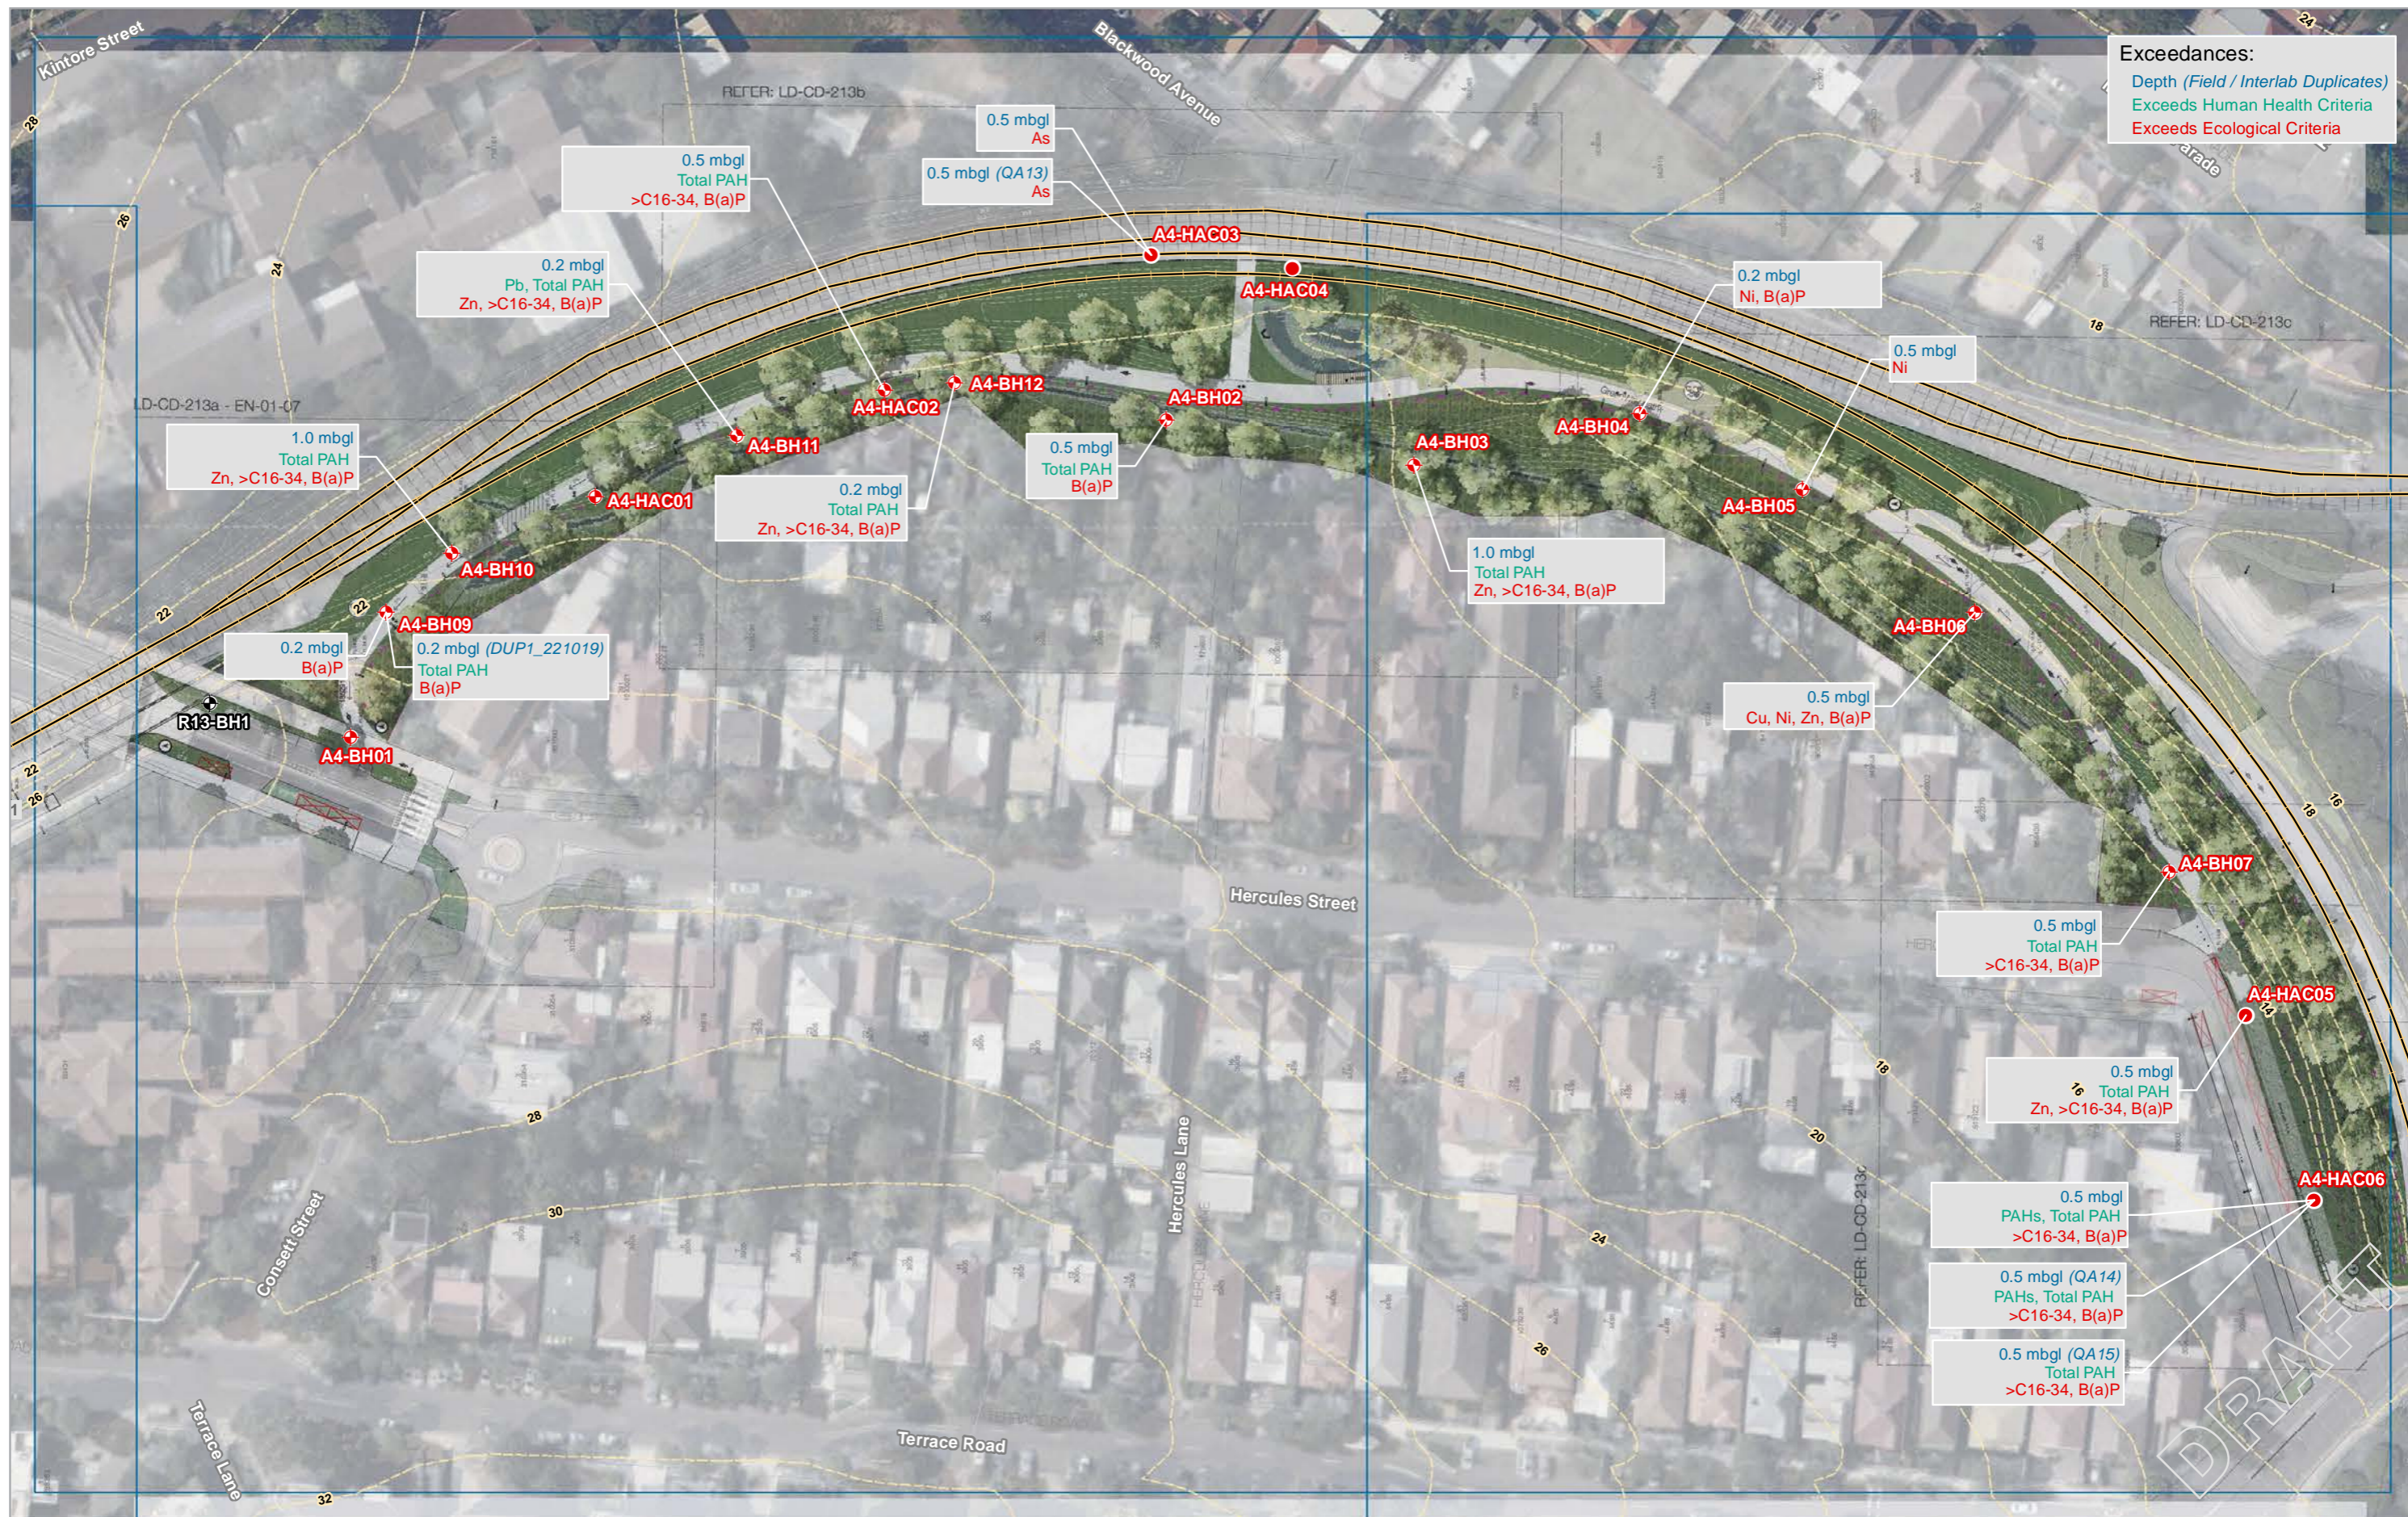
FIGURE 12

Exceedances:
 Depth (Field / Interlab Duplicates)
 Exceeds Human Health Criteria
 Exceeds Ecological Criteria

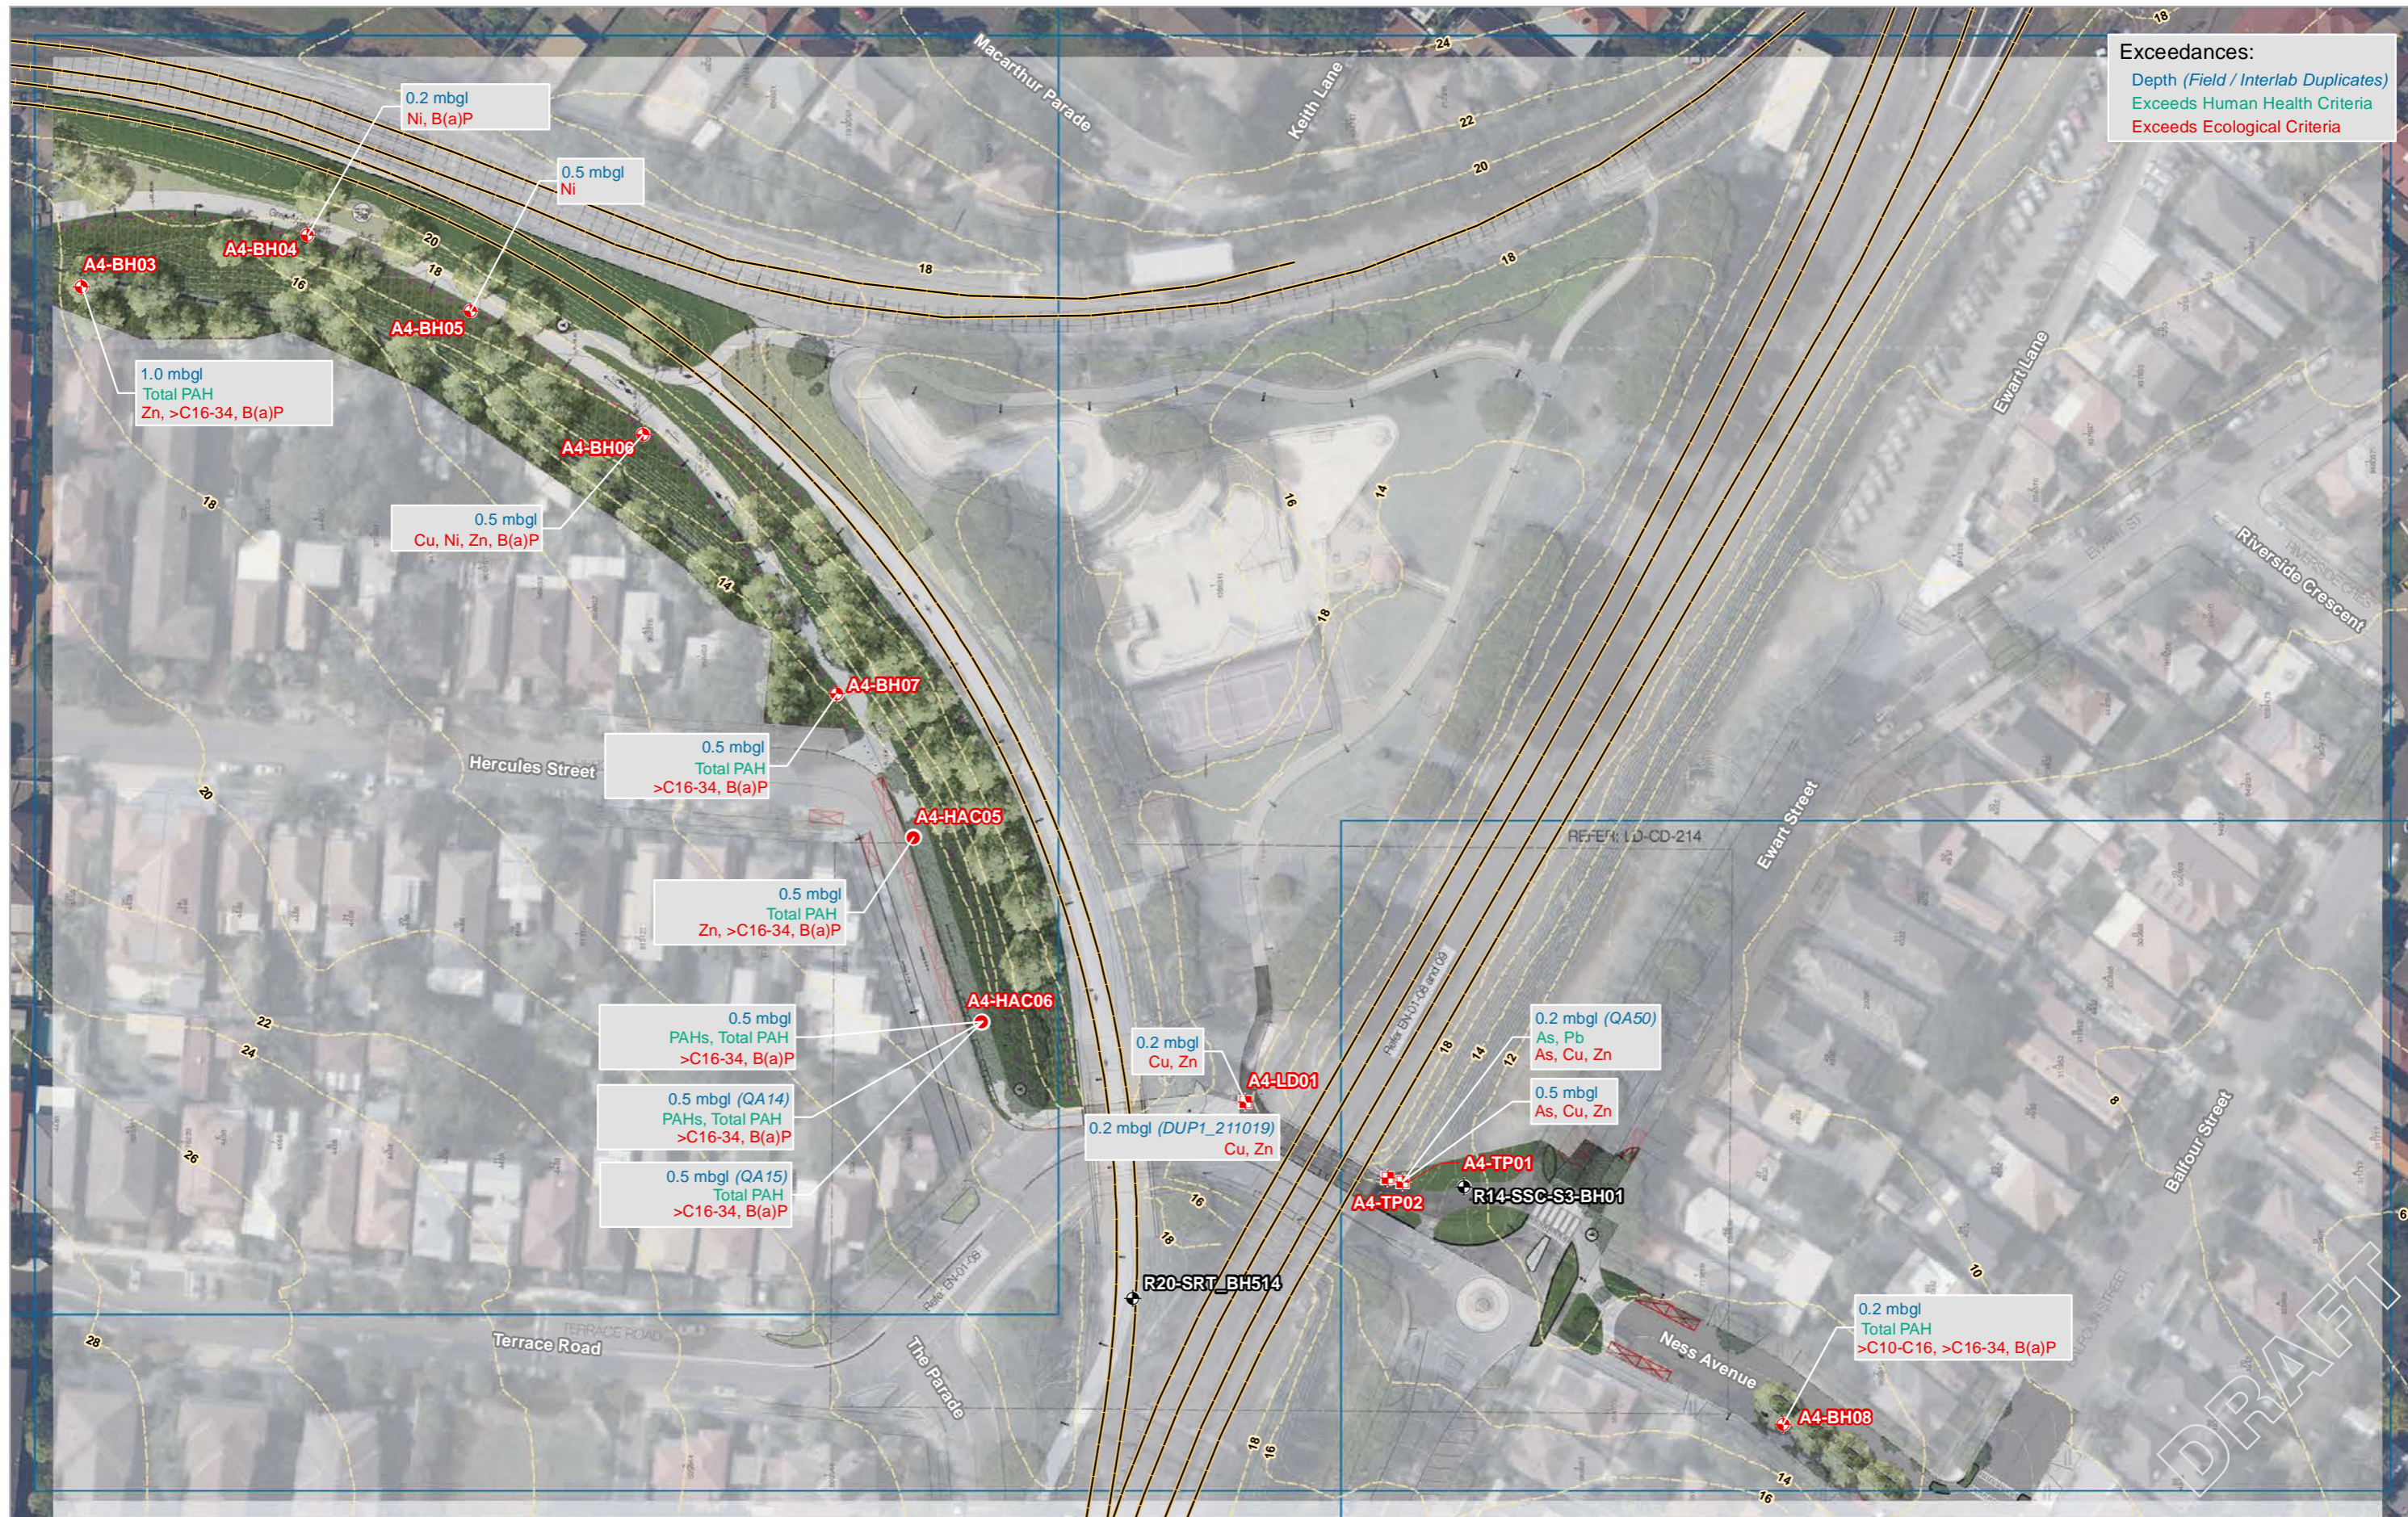
FIGURE 13

Exceedances:
 Depth (Field / Interlab Duplicates)
 Exceeds Human Health Criteria
 Exceeds Ecological Criteria

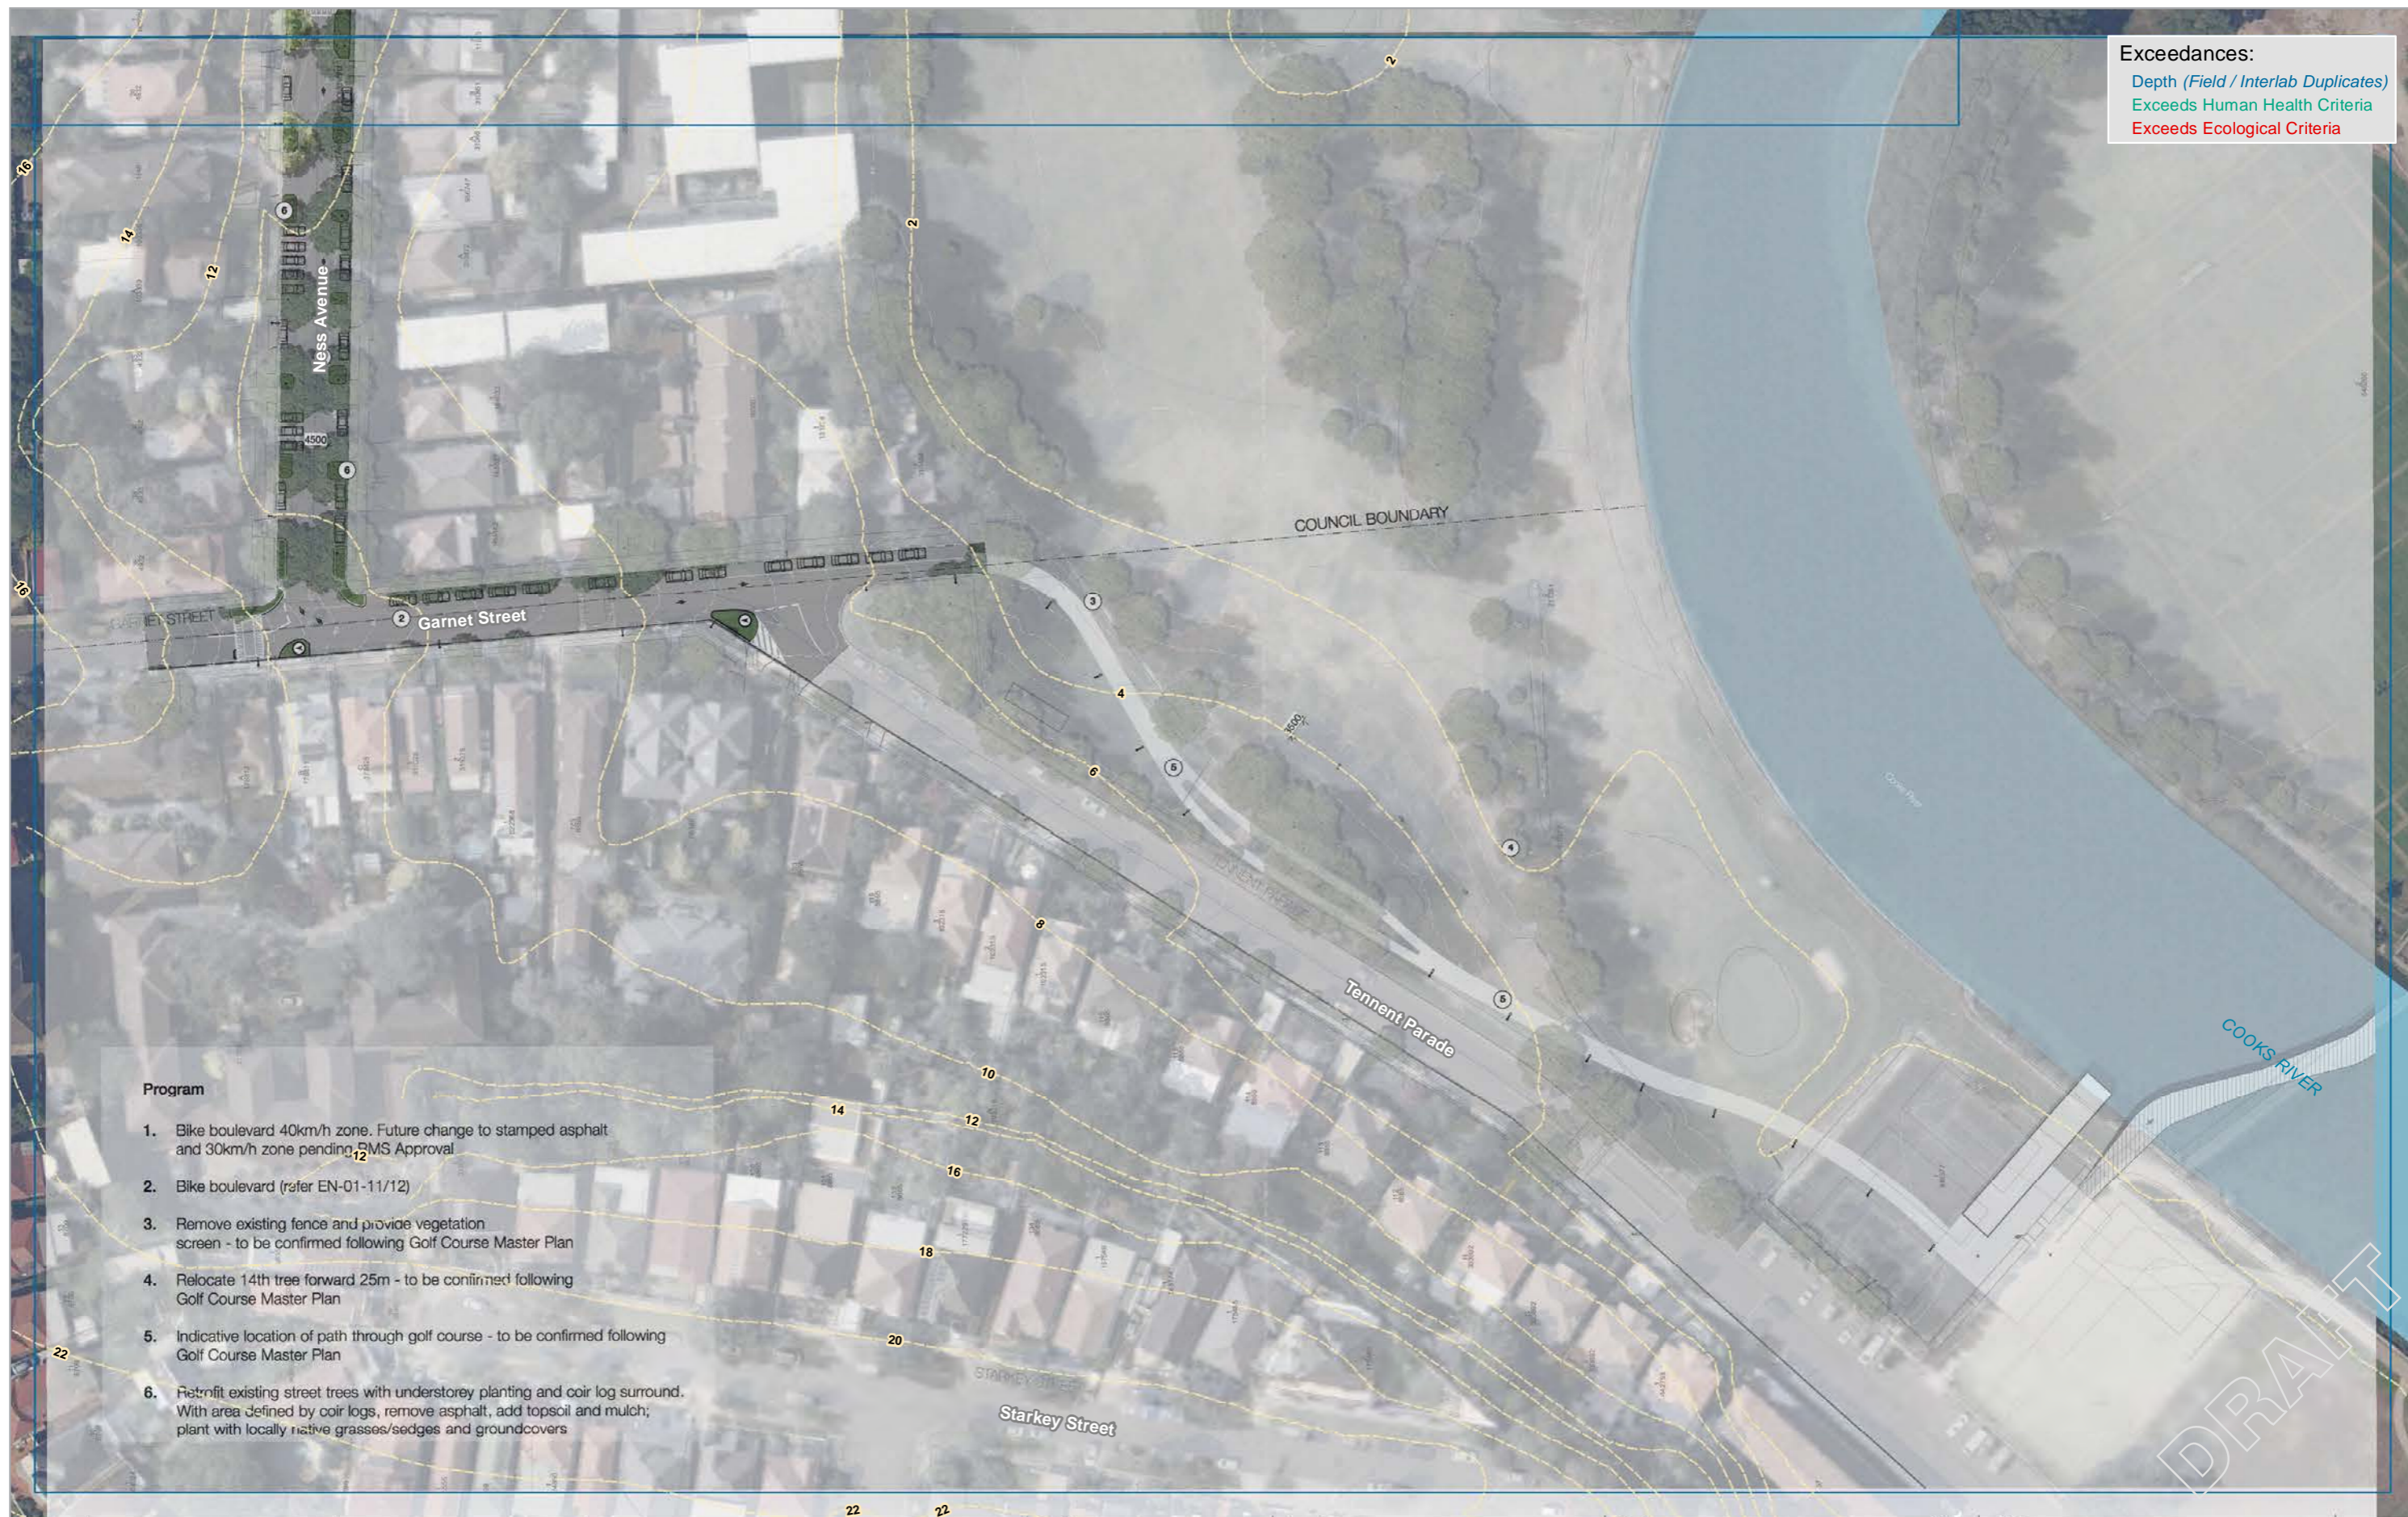
FIGURE 15

Exceedances:
 Depth (Field / Interlab Duplicates)
 Exceeds Human Health Criteria
 Exceeds Ecological Criteria

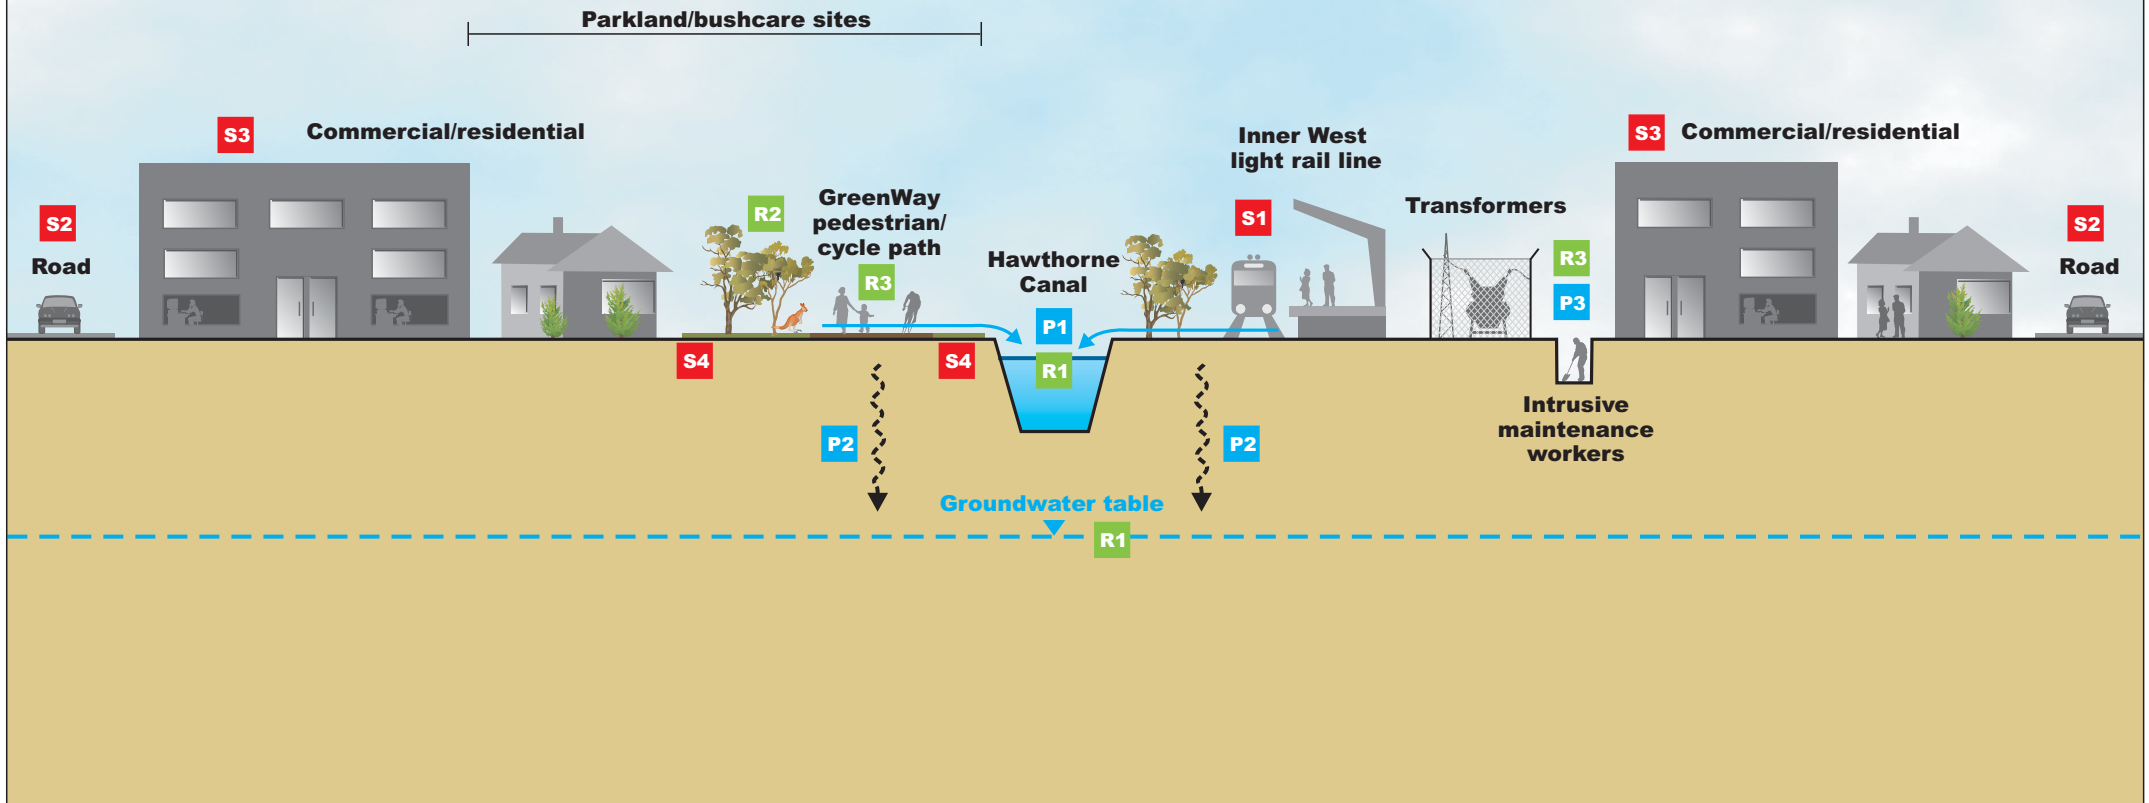
RECEPTORS

- R1** Groundwater, Cooks River, Iron Cove, Hawthorne Canal
- R2** Bushcare sites/onsite vegetation/animal communities
- R3** Recreational users, construction/maintenance workers

Conceptual diagram only - not to scale
