DEVELOPMENT ASSESSMENT REPORT				
Application No.	DA/2022/0791			
Address	14 Hillcrest Avenue ASHFIELD			
Proposal	Proposal for strata subdivision of an existing heritage listed building and tree removal.			
Date of Lodgement	23 September 2022			
Applicant	Paolo Festa			
Owner	Mr Toni El-Haddad Mrs Taminy S El-Haddad			
Number of Submissions	0			
Value of works	\$8,000			
Reason for determination at Planning Panel	Removal of trees on a site containing a Heritage Item			
Main Issues	Unauthorised works			
Recommendation	Approved with Conditions			
Attachment A	Recommended conditions of consent			
Attachment B	Plans of proposed development			
Attachment C	Arboricultural Assessment Report			
Attachment D	Statement of Heritage Significance

This report is an assessment of the application submitted to Council for the strata subdivision of an existing heritage listed building and tree removal at 14 Hillcrest Avenue Ashfield.

Heritage Impact Statement

Strata Title Subdivision of the existing building and removal of two (2) trees
14 Hillcrest Avenue, Ashfield

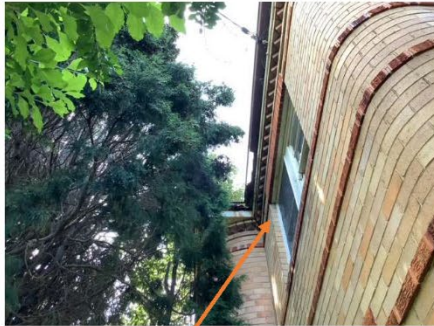
Damage to the roof and gutters.

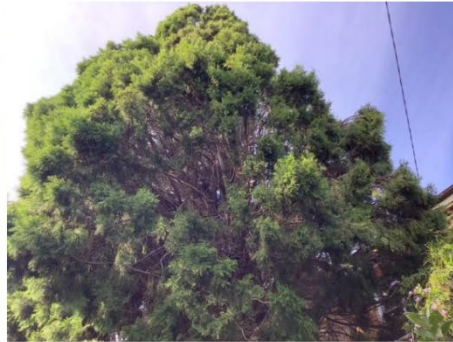
Canopy rubbing on the roof.

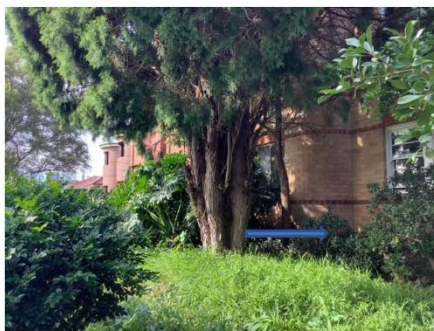
Growing within 3m of the building

The Cypress Pine is located within 3m from the building and there is inadequate above and below ground space for sound, long term development. Council's Tree Officer determined that any property clearance pruning would be detrimental to the trees natural form, that the tree is located on a site identified as a heritage item and the removal of the tree eliminates any possible damage to the building and that replacement planting can better achieve the objectives of the DCP within a reasonable time.

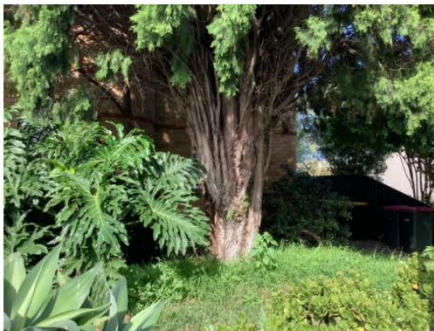
blocking all sun light into the front rooms

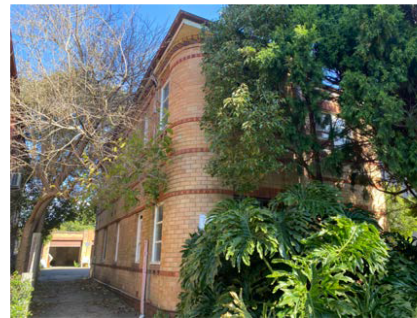
Figure 5: Detailed view of the external brickwork facing south.

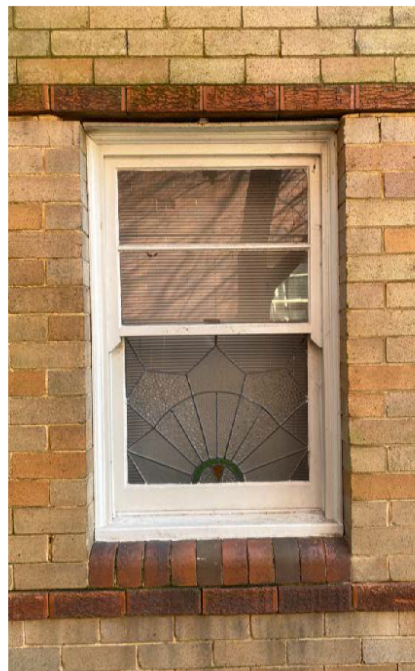
Figure 12: Detailed view of side window.
