ZONE 3 KIRKBRIDE ENTRANCE GARDEN AND EMBANKMENT TO KING GEORGE PARK

INVENTORY OF INDIVIDUAL ELEMENTS

CALLAN PARK
CONSERVATION MANAGEMENT PLAN

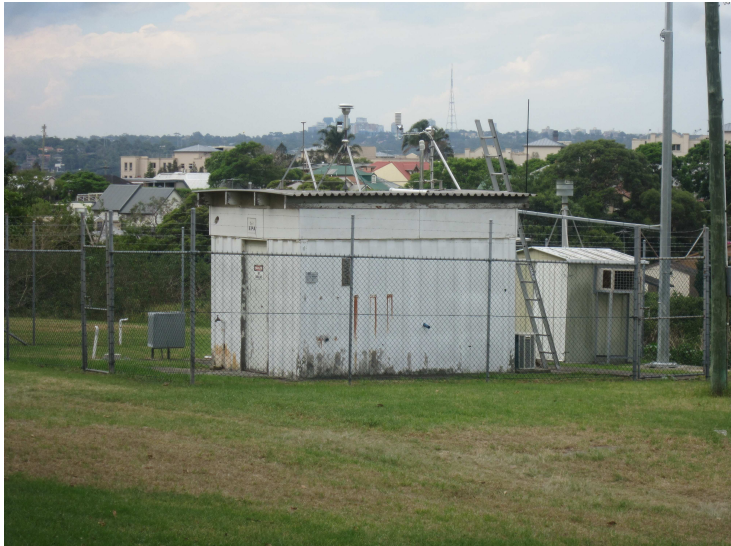
ZONE 3 – KIRKBRIDE ENTRANCE GARDEN and EMBANKMENT TO KING GEORGE PARK		
ITEM No. EPA Station ORIGINAL NAME: Weather Station 85A CURRENT USE: Weather Station	CONSTRUCTION DATE: Recent ARCHITECT / BUILDER: Not relevant	HERITAGE LISTINGS: <input type="checkbox"/> National Estate <input type="checkbox"/> S170 List <input type="checkbox"/> National Trust <input type="checkbox"/> Leichhardt LEP <input type="checkbox"/> State Heritage Register
BUILDING: LOCATION:	EPA WEATHER STATION GRID: K5-6 ZONE: 3	
DESCRIPTION: Equipment surrounded by chain wire fence

SIGNIFICANCE:	None, minor intrusion.	
GUIDELINES:	Retain or consider removal if practicable.

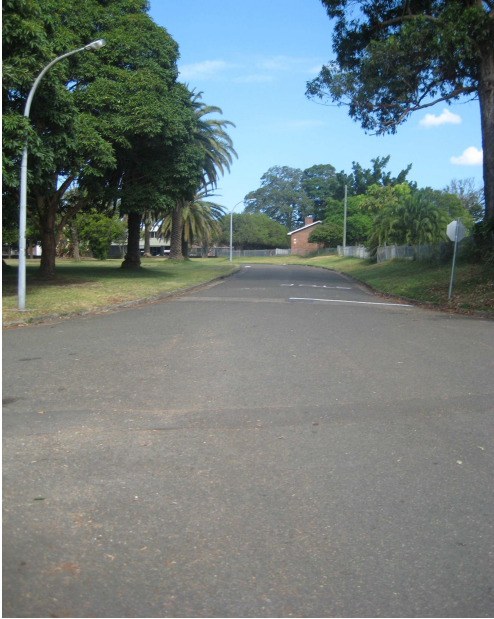
ZONE 3 – KIRKBRIDE ENTRANCE GARDEN and EMBANKMENT TO KING GEORGE PARK	
<p>ITEM No. 1C</p> <p>ORIGINAL NAME:</p> <p>CURRENT USE: Vehicular and pedestrian movement</p>	<p>CONSTRUCTION DATE: 1920s to 1940s</p> <p>ARCHITECT / BUILDER:</p> <p>HERITAGE LISTINGS:</p> <ul style="list-style-type: none"> <input checked="" type="checkbox"/> National Estate <input checked="" type="checkbox"/> S170 List <input checked="" type="checkbox"/> National Trust <input checked="" type="checkbox"/> Leichhardt LEP <input type="checkbox"/> State Heritage Register
<p>ITEM:</p> <p>LOCATION:</p>	<p>1C ROAD AND PATH NETWORK</p> <p>GRID: - ZONE: 3</p>
<p>DESCRIPTION:</p> <p>Kerbed and guttered bitumen roads. Paths concrete or sandstone paving, some with inlaid dates.</p>

<p>CONDITION:</p>	<p>Most intact, some paths in need of repair.</p>
<p>HISTORY:</p>	<p>Park Drive built in the 1920s, replacing original entry carriageway. Other paths and roads added 1930s to 1960s. Some paths laid by patients in 1942.</p>

<p>REFERENCES:</p>	<p>1991 DPWS Heritage Study. 1920s photo panorama, 1930 air photo, 1952 air photo</p>
<p>SIGNIFICANCE:</p>	
<p>GUIDELINES:</p>	<p>Over time add/reconstruct pedestrian path network representative of the 1920s and earlier and remove intrusive paths and roads. New road locations, design materials to be sympathetic to the heritage significance of the gardens as a whole. Where appropriate, retain small representative sections of paths by patients with inlaid dates and incorporate into new paths.</p>

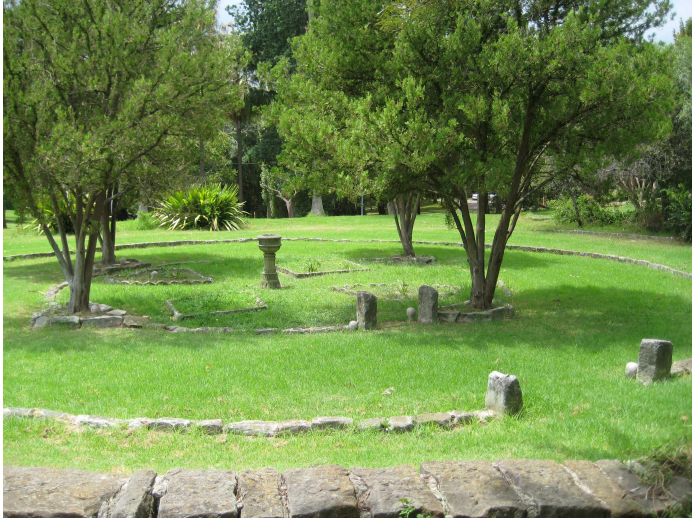
ITEM: LOCATION:	1D SUNKEN GARDEN GRID: K7 ZONE: 3
DESCRIPTION: Circular, sunken garden edge by stone wall and hedge with openings. Circular stone edges and 4 flower beds and 4 cypress and central stone pedestal, all set in lawn.

CONDITION:	Substantially intact as sunken garden.
HISTORY:	Originally an informal pond at the head of the creek, in Charles Moore's design, formalised in 1903 plan (possible Maiden influence) and filled in late 1920s following drawings. Flower beds built by patients
REFERENCES:	1991 DPWS Heritage Study. Site Inspection, c. 192- photo panorama in Powell. 1930 aerial photo.
SIGNIFICANCE:	Sunken Garden is significant in that it represents the visual focus and structural form of the original design and as a complete work by patients reflecting their participation in gardening as therapy.
GUIDELINES:	Restore enclosing retaining walls and hedges and physical relationship to Kirkbride Way as shown in c.1920 photo panorama in Powell. 1930 aerial photo. Restore enclosing retaining walls and hedges and physical relationship to Kirkbride Way as shown in c.1920 photo panorama. Preserve patient garden and restore the formal pond as an important design element in relation to the Kirkbride Block.

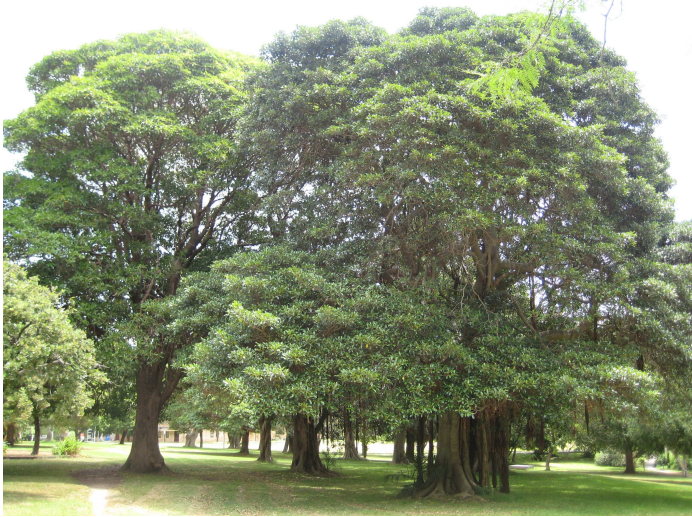
ITEM: LOCATION:	1G AVENUE TO ORIGINAL CARRIAGE DRIVE GRID: J8-L8 ZONE: 3
DESCRIPTION: Port Jackson Figs in curved rows with evidence of road base land flattening in parts.

CONDITION:	Fair to good.
HISTORY:	Charles Moore designed an avenue beside the carriageway of Figs and Pines. Pines were removed probably in the late 1920s.
REFERENCES:	1991 DPWS Heritage Study. c.1920 photo panorama, c. 1903 phot, 1897 site plan.
SIGNIFICANCE:	Trees and archaeological evidence are significant as evidence of original major design element in Victorian picturesque landscape and representative of the work of Charles Moore. The existing trees maintain the integrity of the original alignment.
GUIDELINES:	Search for and document further evidence of original carriage drive. Potential to build new pathway along alignment in materials sympathetic to the original character, and utilise this path as a major pedestrian entrance to the Kirkbride Block, otherwise preserve. Replant missing figs and possibly add some <i>Pinus radiata</i> .

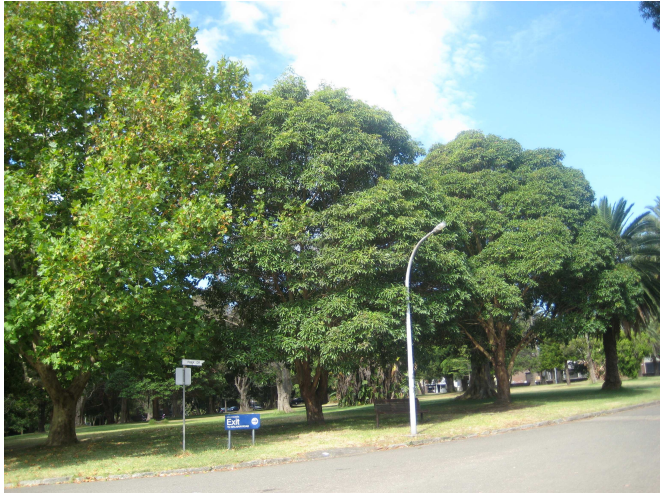
ITEM: LOCATION:	11 INDIVIDUAL TREES AND SHRUBS GRID: K7, K8 ZONE: 3	
DESCRIPTION: Trees of varying ages and mixed species of trees and some shrubs.

CONDITION:	Fair to good.	
HISTORY:	Late 1880s and 1890s tree and shrub planting representative of species selection of Charles Moore also influenced by James Maiden infilled with subsequent individual plantings throughout 1900s and particularly 1960s and 1970s.	
REFERENCES:	1991 DPWS Heritage Study. Plate 56. Powell	
SIGNIFICANCE:	Older trees significant as representative elements in Victorian landscape, however integrity diminished by later plantings which reduce former spatial variations.	
GUIDELINES:	Undertake further research to survey existing trees and establish age. Remove intrusive or recent plantings to restore Victorian picturesque landscape of 1880s to 1900. Maintain significant trees. Restore definition between developed garden areas and broad site landscape.
