<b>ZONE 3 – KIRKBRIDE ENTRANCE GARDEN and EMBANKMENT TO KING GEORGE PARK</b>	
<b>ITEM No.</b> 1K  <b>ORIGINAL NAME:</b>  <b>CURRENT USE:</b>	<b>CONSTRUCTION DATE:</b> Planted in 1920s  <b>ARCHITECT / BUILDER:</b>  <b>HERITAGE LISTINGS:</b> <input checked="" type="checkbox"/> National Estate <input checked="" type="checkbox"/> S170 List <input checked="" type="checkbox"/> National Trust <input checked="" type="checkbox"/> Leichhardt LEP <input type="checkbox"/> State Heritage Register
<b>ITEM:</b>  <b>LOCATION:</b>	<b>1K PALM ROWS</b>  GRID: K6 ZONE: 3
<b>DESCRIPTION:</b>  Uniform row of palms ( <i>Phoenix reclinata</i> ) edging path and row of Cabbage Tree Palms.

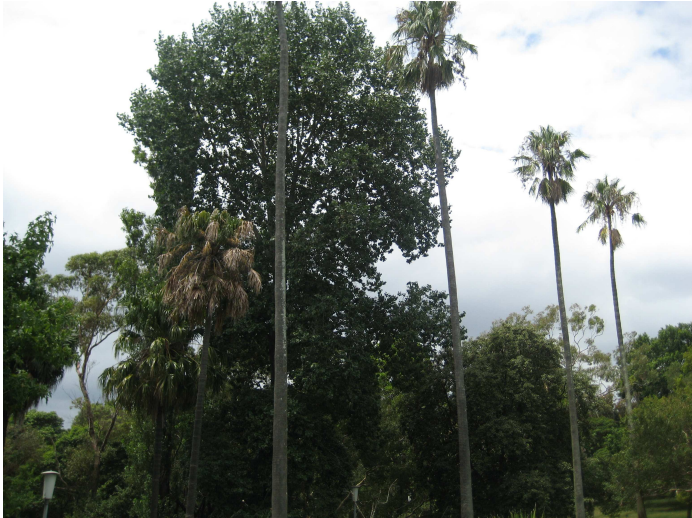
<b>CONDITION:</b>	Fair to good
<b>HISTORY:</b>	Added in 1920s
<b>REFERENCES:</b>	1991 DPWS Heritage Study. c.1920 photo panorama in Powell
<b>SIGNIFICANCE:</b>	Significant as 1920s layer of garden design prerepresentative of growing use of plams with minmal intrusion on the significance of the former gardens.

<b>GUIDELINES:</b>	Maintain and undertake tree surgery on deformed individuals. Replace dying palms.

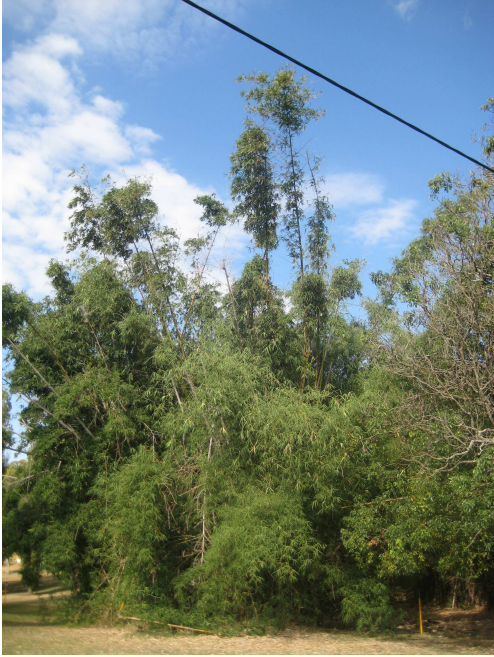
<b>ZONE 3 – KIRKBRIDE ENTRANCE GARDEN and EMBANKMENT TO KING GEORGE PARK</b>		
<b>ITEM No.</b> 1J  <b>ORIGINAL NAME:</b>  <b>CURRENT USE:</b>	<b>CONSTRUCTION DATE:</b>  <b>ARCHITECT / BUILDER:</b>	<b>HERITAGE LISTINGS:</b> <input checked="" type="checkbox"/> National Estate <input checked="" type="checkbox"/> S170 List <input checked="" type="checkbox"/> National Trust <input checked="" type="checkbox"/> Leichhardt LEP <input type="checkbox"/> State Heritage Register
<b>ITEM:</b>  <b>LOCATION:</b>	<b>1J INFORMAL TREE GROUPINGS</b>  GRID: K7 ZONE: 3	
<b>DESCRIPTION:</b>  Timber Bamboo, Willow, Weeping Lily-pilly and other species informally grouped along the formal creek line.

<b>CONDITION:</b>	Good	
<b>HISTORY:</b>	This area remained undeveloped grassland with Willows and Eucalypts along the creek in the early 1900s. Existing mature Willows and Weeping Lily-pilly are typical species used by Charles Moore.

<b>REFERENCES:</b>	1991 DPWS Heritage Study.	
<b>SIGNIFICANCE:</b>	Some significance as reflection of early informal landscape which was a visual contrast to the formal gardens in the original gardens layout. The integrity of this significance is undermined by later tree plantings.	
<b>GUIDELINES:</b>	Retain as practicable.

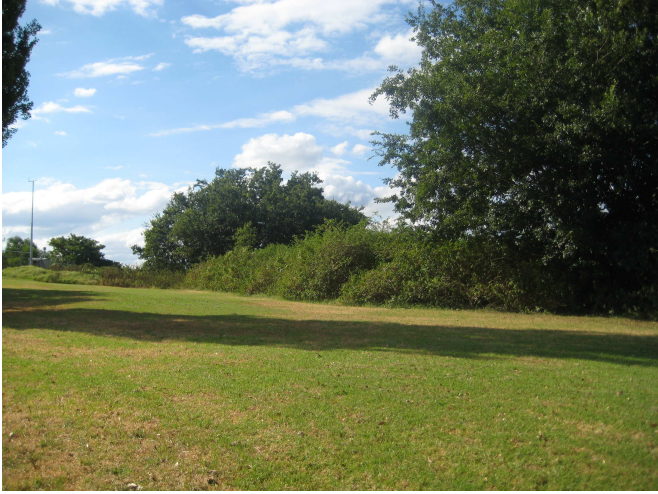
<b>ZONE 3 – KIRKBRIDE ENTRANCE GARDEN and EMBANKMENT TO KING GEORGE PARK</b>		
<b>ITEM No.</b> 4D  <b>ORIGINAL NAME:</b>  <b>CURRENT USE:</b> -	<b>CONSTRUCTION DATE:</b>  <b>ARCHITECT / BUILDER:</b>	<b>HERITAGE LISTINGS:</b> <input checked="" type="checkbox"/> National Estate <input checked="" type="checkbox"/> S170 List <input checked="" type="checkbox"/> National Trust <input checked="" type="checkbox"/> Leichhardt LEP <input type="checkbox"/> State Heritage Register
<b>ITEM:</b>  <b>LOCATION:</b>	<b>4D LANDFILL</b>  GRID: K5 ZONE: 3	
<b>DESCRIPTION:</b>  Extensive rubble and earth landfill covering natural rock outcrop and supporting extensive weed growth.

<b>CONDITION:</b>		
<b>HISTORY:</b>	Dumped in recent years.	
<b>REFERENCES:</b>	1991 DPWS Heritage Study. 1952 aerial photo	
<b>SIGNIFICANCE:</b>	Highly intrusive on natural landform and original rugged setting for the Kirkbride block.

<b>GUIDELINES:</b>	Stop further dumping of fill. Revegetate with indigenous species. Potential to construct pathway linking bottom of stone stair and leading to the point and King Georges Park – reflecting original path network.

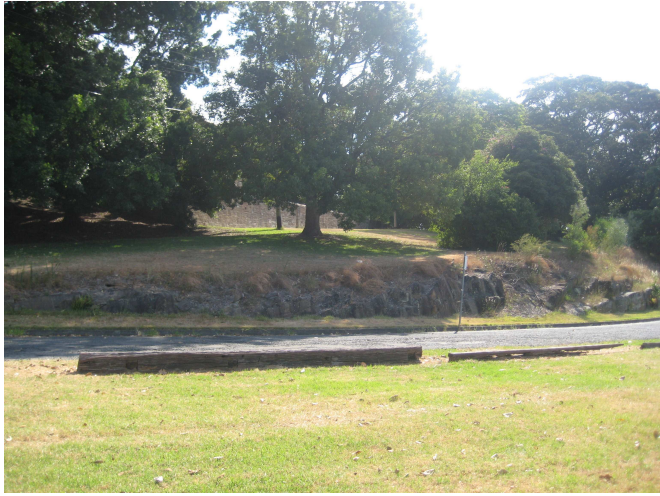
<b>ZONE 3 – KIRKBRIDE ENTRANCE GARDEN and EMBANKMENT TO KING GEORGE PARK</b>		
<b>ITEM No.</b> 4E  <b>ORIGINAL NAME:</b>  <b>CURRENT USE:</b> -	<b>CONSTRUCTION DATE:</b>  <b>ARCHITECT / BUILDER:</b>	<b>HERITAGE LISTINGS:</b> <input checked="" type="checkbox"/> National Estate <input checked="" type="checkbox"/> S170 List <input checked="" type="checkbox"/> National Trust <input checked="" type="checkbox"/> Leichhardt LEP <input type="checkbox"/> State Heritage Register
<b>ITEM:</b>  <b>LOCATION:</b>	<b>4E ROCK OUTCROP</b>  GRID: I3-4 ZONE: 3	
<b>DESCRIPTION:</b>  Natural bedrock outcrop, part covered by fill in some areas.

<b>CONDITION:</b>	Part covered by fill, substantially intact.	
<b>HISTORY:</b>		
<b>REFERENCES:</b>	1991 DPWS Heritage Study.	
<b>SIGNIFICANCE:</b>	Significant as remnant of natural landform and rugged setting for asylum and Garry Owen House.	
<b>GUIDELINES:</b>	Preserve and clear away fill to expose more bedrock and revegetate with indigenous species. During excavation be sensitive to potential for uncovering of aboriginal middens and carvings. Protect any such findings and notify National Parks and Wildlife Service.
