<b>ZONE 4 - RIDGETOP, KIRKBRIDE BLOCK PLATFORM AND CONVALESCENT COTTAGES</b>		
<p><b>ITEM Nos.</b> B702</p> <p><b>ORIGINAL NAME:</b> Stables and Cart Shed: Building 43A, Store</p> <p><b>CURRENT USE:</b> Unoccupied.</p>	<p><b>CONSTRUCTION DATE:</b> c. 1901</p> <p><b>ARCHITECT / BUILDER:</b> Unknown</p>	<p><b>HERITAGE LISTINGS:</b></p> <p><input type="checkbox"/> National Estate</p> <p><input checked="" type="checkbox"/> S170 List</p> <p><input type="checkbox"/> National Trust</p> <p><input type="checkbox"/> Leichhardt LEP</p> <p><input type="checkbox"/> State Heritage Register</p>
<p><b>BUILDING:</b></p>	<p><b>B702</b></p>	
<p><b>LOCATION:</b></p>	<p>GRID: H9 ZONE: 4</p>	
<p><b>DESCRIPTION:</b></p> <p>Single storey square building with hipped corrugated iron roof topped by timber and metal ventilator. Walls pebble dash over brick and (over doors) timber lath. Slit windows to horse stalls. Door on south side crudely altered with poor brick infill. Gutters, downpipes recently replaced.</p>

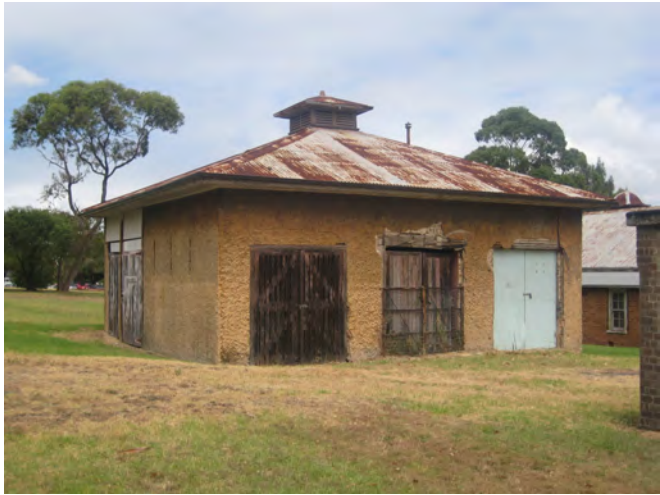
<p><b>CONDITION:</b></p>	<p>Poor. Major cracking to external plaster finish, battens revealed and timber elements deteriorating. Roof is rusting.</p>	
<p><b>HISTORY:</b></p>	<p>Built about 1900? Reputedly stable and cart shed (plan confirms this) and at one time ambulance, then storage.</p>	
<p><b>REFERENCES:</b></p>	<p>Leong (84), a shed in about this location appears on the 1903 site plan; DPWS (1991)</p>	
<p><b>SIGNIFICANCE:</b></p>	<p>Moderate. One of a group of utility/farm buildings demonstrating the early use of the site and contributing to the pastoral character of the area. Example of vernacular style out-buildings.</p>	
<p><b>GUIDELINES:</b></p>	<p>Retain and conserve according to Burra Charter principles. Undertake repairs to deteriorating building fabric as a matter of priority, using appropriate materials, profiles and methodologies. Replace pvc downpipes with galvanised steel downpipes with appropriate profile. Sympathetic adaptive reuse is required.</p>

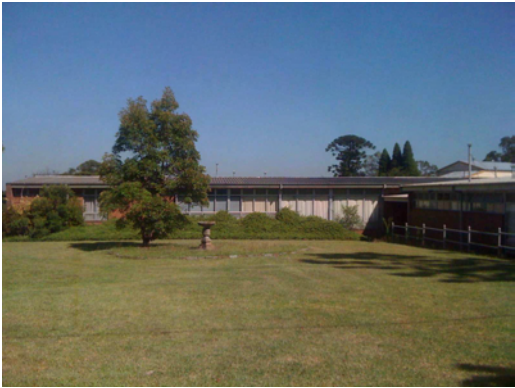
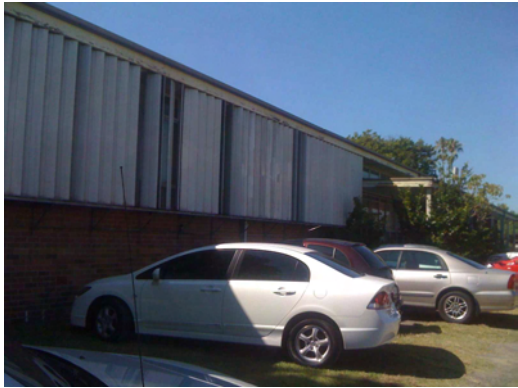
<b>ZONE 4 - RIDGETOP, KIRKBRIDE BLOCK PLATFORM AND CONVALESCENT COTTAGES</b>	
<p><b>ITEM No. B704</b></p> <p><b>ORIGINAL NAME:</b> Staff Amenities Block, Building 53 Storage - ITU</p> <p><b>CURRENT USE:</b></p>	<p><b>CONSTRUCTION DATE:</b> 1963</p> <p><b>ARCHITECT / BUILDER:</b> Unknown</p> <p><b>HERITAGE LISTINGS:</b></p> <p><input type="checkbox"/> National Estate</p> <p><input checked="" type="checkbox"/> S170 List</p> <p><input type="checkbox"/> National Trust</p> <p><input type="checkbox"/> Leichhardt LEP</p> <p><input type="checkbox"/> State Heritage Register</p>
<p><b>BUILDING:</b></p> <p><b>LOCATION:</b></p>	<p><b>B704 ITU CENTRE</b></p> <p>GRID: H8 ZONE: 4</p>
<p><b>DESCRIPTION:</b></p> <p>Single storey brick building with low-pitched gabled metal deck roof and extensive aluminium windows. Building is T shaped in plan. Vertical metal louvres and a verandah provide sun protection on west side.</p>

</div>	
<p><b>CONDITION:</b></p>	<p>Good condition generally, with some verandah railings removed. General maintenance required if retained.</p>
<p><b>HISTORY:</b></p>	<p>Built 1963</p>
<p><b>REFERENCES:</b></p>	<p>Leong (32) JTCW; DPWS (1991)</p>
<p><b>SIGNIFICANCE:</b></p>	<p>Intrusive. Minimal significance, part of development of site, intrusive in style and setting.</p>
<p><b>GUIDELINES:</b></p>	<p>Retain, recycle or preferably replace or remove. Any development should be small scale, or broken up into small units, and compatible in character to Kirkbride, and must conform to the requirements of the Callan Park Act. If removed record prior to demolition.</p>

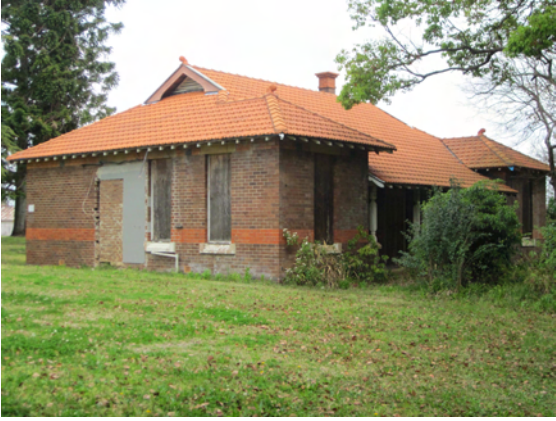
ZONE 4 - RIDGETOP, KIRKBRIDE BLOCK PLATFORM AND CONVALESCENT COTTAGES	
<p><b>ITEM No. B705</b></p> <p><b>ORIGINAL NAME:</b> Male Attendant's Quarters (94) (later Neurophysiological Lab).</p> <p><b>CURRENT USE:</b> Unoccupied</p>	<p><b>CONSTRUCTION DATE:</b> 1895</p> <p><b>ARCHITECT / BUILDER:</b> Government Architect's Office under Walter Liberty Vernon</p> <p><b>HERITAGE LISTINGS:</b></p> <p><input type="checkbox"/> National Estate</p> <p><input checked="" type="checkbox"/> S170 List</p> <p><input type="checkbox"/> National Trust</p> <p><input type="checkbox"/> Leichhardt LEP</p> <p><input type="checkbox"/> State Heritage Register</p>
<p><b>BUILDING:</b></p>	<p><b>B705</b></p>
<p><b>LOCATION:</b></p>	<p>GRID: H-I 9 ZONE: 4</p>
<p><b>DESCRIPTION:</b></p> <p>Single storey brick building with unglazed terracotta tiled roof. Federation Queen Anne in style, with superior brickwork with red brick band just above window sill height and to chimney. Double hung timber windows with upper sash having 9 panes. Rafters with shaped ends exposed in eaves. Verandah with turned columns recessed under main roof. Separate bathroom wing. Minor unsympathetic alterations including internal alterations, removal of shutters, concrete slab on front verandah, unsympathetic enclosure of link to bathroom. Circa 1950 kiosk adjacent to building has been demolished.</p>

</div>	
<p><b>CONDITION:</b></p>	<p>Poor but generally intact, requires extensive maintenance. Roof tiles are relatively recent. Openings boarded over. Interiors not inspected.</p>
<p><b>HISTORY:</b></p>	<p>Built 1895, addition and conversion to Neurophysiological Laboratory c.1963.</p>
<p><b>REFERENCES:</b></p>	<p>Leong (35), MH2/ 377, JTCW, DPWS (1991), (DPWS) 1993</p>
<p><b>SIGNIFICANCE:</b></p>	<p>High. Early addition to Callan Park Hospital. Well designed, detailed and built domestic scale Federation building by Government architect W.L. Vernon. Unobtrusively sited. First named structure constructed outside the Kirkbride Block.</p>
<p><b>GUIDELINES:</b></p>	<p>Conserve according to Burra Charter principles. Now neglected and subject to vandalism. Urgently requires inspection for and treating termites and installation of gutters, downpipes and stormwater drain connections.</p>

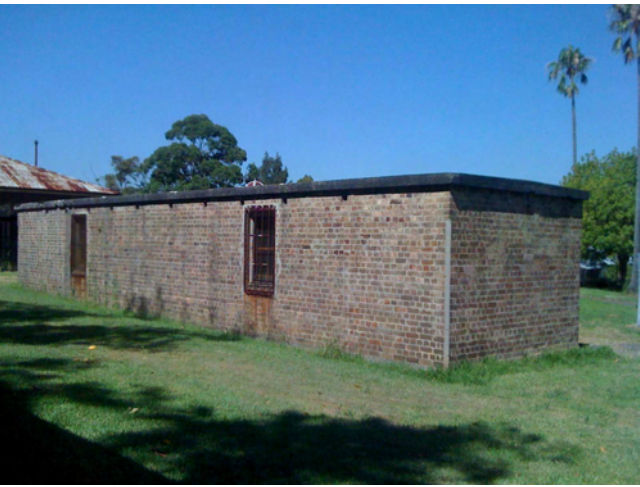
<b>ZONE 4 - RIDGETOP, KIRKBRIDE BLOCK PLATFORM AND CONVALESCENT COTTAGES</b>		
<p><b>ITEM Nos.</b> B706, B707 and B708</p> <p><b>ORIGINAL NAME:</b> Bomb Shelter</p> <p><b>CURRENT USE:</b> Unoccupied</p>	<p><b>CONSTRUCTION DATE:</b> c. 1940</p> <p><b>ARCHITECT / BUILDER:</b> Unknown</p>	<p><b>HERITAGE LISTINGS:</b></p> <p><input type="checkbox"/> National Estate</p> <p><input checked="" type="checkbox"/> S170 List</p> <p><input type="checkbox"/> National Trust</p> <p><input type="checkbox"/> Leichhardt LEP</p> <p><input type="checkbox"/> State Heritage Register</p>
<p><b>BUILDING:</b></p> <p><b>LOCATION:</b></p>	<p><b>B706, B707 and B708</b></p> <p>GRID: H9, H7-8 ZONE: 4</p>	
<p><b>DESCRIPTION:</b></p> <p>Long rectangular flat roofed, brick and concrete structures. Windows in one elevation, doors in another.</p>

<p><b>CONDITION:</b></p>	<p>Average</p>	
<p><b>HISTORY:</b></p>	<p>c. 1940</p>

<p><b>REFERENCES:</b></p>	<p>Site inspection, DPWS (1991).</p>	
<p><b>SIGNIFICANCE:</b></p>	<p>Moderate. Indicative of provisions for war.</p>	
<p><b>GUIDELINES:</b></p>	<p>Retain, remove as practicable. Note other bomb shelters elsewhere on site (B293, B601, BB498, B510). Some are intrusive elements. Retain one as example at minimum. Record any shelters that are to be removed.</p>

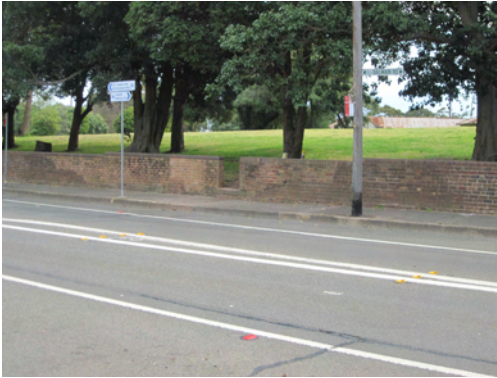
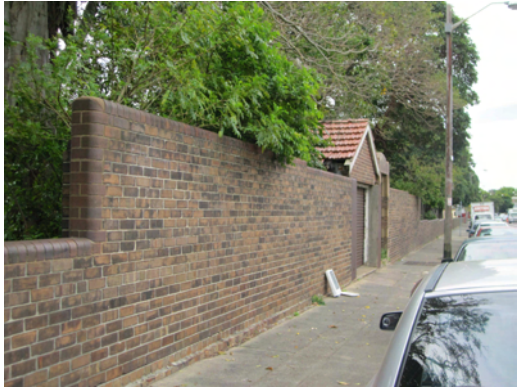
ZONE 4 - RIDGETOP, KIRKBRIDE BLOCK PLATFORM AND CONVALESCENT COTTAGES		
<p><b>ITEM No. 2A</b></p> <p><b>ORIGINAL NAME:</b> Boundary wall</p> <p><b>CURRENT USE:</b> Boundary wall</p>	<p><b>CONSTRUCTION DATE:</b></p> <p><b>ARCHITECT / BUILDER:</b></p>	<p><b>HERITAGE LISTINGS:</b></p> <p><input type="checkbox"/> National Estate</p> <p><input checked="" type="checkbox"/> S170 List</p> <p><input type="checkbox"/> National Trust</p> <p><input type="checkbox"/> Leichhardt LEP</p> <p><input type="checkbox"/> State Heritage Register</p>
<p><b>ITEM:</b></p> <p><b>LOCATION:</b></p>	<p><b>2A BOUNDARY WALL</b></p> <p>GRID: H10, I10, J ZONE: 4</p>	
<p><b>DESCRIPTION:</b></p> <p>Brick wall approximately 0.5 metres high with a section including a Federation era gate portal approximately 2 metres high opposite Alberto Street.</p>		
<div style="display: flex; justify-content: space-around;">

</div>		
<p><b>CONDITION:</b></p>	<p>Intact. Brickwork is cracking in places.</p>

<p><b>HISTORY:</b></p>	<p>Original high timber paling boundary fence was replaced when boundary wall built and gates relocated. Wall height generally reduced in 1950s or 1960s following a Royal Commission.</p>	
<p><b>REFERENCES:</b></p>	<p>1991 DPWS Heritage Study, plans 1912, photos 1903.</p>	
<p><b>SIGNIFICANCE:</b></p>	<p>Existing low wall is significant because it represents the design intent of the original wall/fence, i.e. enclosing the hospital. The high sections of wall are significant as early replacements of the original fence.</p>	
<p><b>GUIDELINES:</b></p>	<p>Preserve high sections at the entrance opposite Alberto Street. Preserve existing wall or construct new wall or fence to maintain the original design intent of a strong boundary definition and physical barrier.</p>

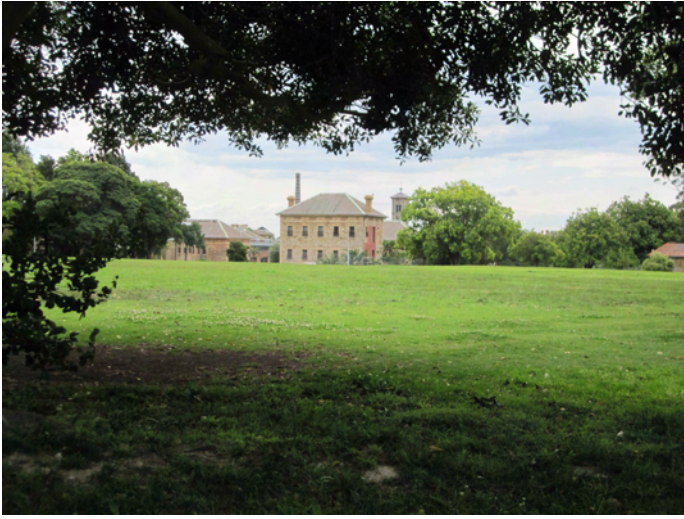
<b>ZONE 4 - RIDGETOP, KIRKBRIDE BLOCK PLATFORM AND CONVALESCENT COTTAGES</b>		
<p><b>ITEM No. 2C</b></p> <p><b>ORIGINAL NAME:</b> Cricket ground</p> <p><b>CURRENT USE:</b> Open space</p>	<p><b>CONSTRUCTION DATE:</b></p> <p><b>ARCHITECT / BUILDER:</b></p>	<p><b>HERITAGE LISTINGS:</b></p> <p><input type="checkbox"/> National Estate</p> <p><input checked="" type="checkbox"/> S170 List</p> <p><input type="checkbox"/> National Trust</p> <p><input type="checkbox"/> Leichhardt LEP</p> <p><input type="checkbox"/> State Heritage Register</p>
<p><b>ITEM:</b></p> <p><b>LOCATION:</b></p>	<p><b>2C CRICKET GROUND</b></p> <p>GRID: I9, J9 ZONE: 4</p>	
<p><b>DESCRIPTION:</b></p> <p>Rectangular grassed field approx 100 metres x 80 metres, part intruded on by 1960s residences and yards. Adjoins Balmain Road. Natural surface deformation (low mound) has rendered it unusable for formal sport.</p>

<p><b>CONDITION:</b></p>	<p>Area largely intact but in poor condition.</p>

<p><b>HISTORY:</b></p>	<p>Former asylum recreation ground with cricket field, bowling green, tennis court and at western end, on low elevated grass, terrace and an ornate pavilion replaced by existing 1960s residences.</p>	
<p><b>REFERENCES:</b></p>	<p>1991 DPWS Heritage Study, Series c.1903 photos and site plan1903, 1893, Leong Thesis.</p>	
<p><b>SIGNIFICANCE:</b></p>	<p>Significant as design element – open space offsetting mass of Kirkbride and framing foreground views. Medical and Architectural significance as design element illustrating Kirkbride Theory – i.e. recreational activity as therapy.</p>	
<p><b>GUIDELINES:</b></p>	<p>Preserve the open space character and shape which reflect former use and maintain views to Kirkbride across this space. Suitable for adaptation to new use compatible with significance and preferably reflecting original use as a recreation ground.</p>

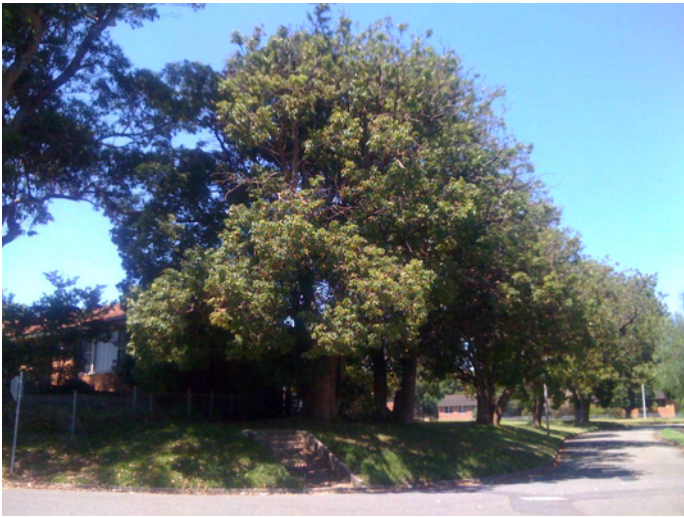
<b>ZONE 4 - RIDGETOP, KIRKBRIDE BLOCK PLATFORM AND CONVALESCENT COTTAGES</b>	
<b>ITEM No. 2D</b>  <b>ORIGINAL NAME:</b>  <b>CURRENT USE:</b>	<b>CONSTRUCTION DATE:</b> circa 1893  <b>ARCHITECT / BUILDER:</b> Possible planting at direction of Charles Moore  <b>HERITAGE LISTINGS:</b> <input type="checkbox"/> National Estate <input checked="" type="checkbox"/> S170 List <input type="checkbox"/> National Trust <input type="checkbox"/> Leichhardt LEP <input type="checkbox"/> State Heritage Register
<b>ITEM:</b>  <b>LOCATION:</b>	<b>2D CAMPHOR LAUREL ROW &amp; EMBANKMENT</b>  GRID: I9, J8 ZONE: 4
<b>DESCRIPTION:</b>  Single Camphor Laurel row along edge of cricket ground. Embankment edge is flat in places ranging to uniform steep grass embankment with the trees at the top.

<b>CONDITION:</b>	Some trees missing and existing trees stunted and in poor condition.
<b>HISTORY:</b>	Originally designed in 1893 during time of Charles Moore as edge to cricket ground.

<b>REFERENCES:</b>	1991 DPWS Heritage Study: Photos c1890, c1903, c1920s. Site plans 1893 + 1903.
<b>SIGNIFICANCE:</b>	Significant as a design element illustrating edge definition of space – major design principle in this original scheme
<b>GUIDELINES:</b>	Investigate reason for poor condition of trees. If rectification is inappropriate or natural conditions are the cause, replan with substitute species at similar spacings. Maintain filtered views to Kirkbride through tree row. Maintain filtered views to Kirkbride through tree row. Maintain simple form and surface of grass embankment sight lines from road to cricket ground. Original plantings adjoining the pavilion were of peppercorns and these may be more vigorous in this locality.

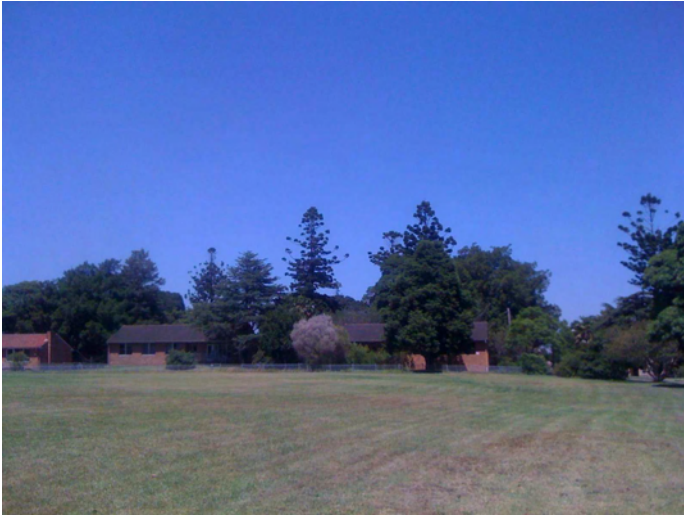
<b>ZONE 4 - RIDGETOP, KIRKBRIDE BLOCK PLATFORM AND CONVALESCENT COTTAGES</b>	
<b>ITEM No. 2E</b>  <b>ORIGINAL NAME:</b>  <b>CURRENT USE:</b>	<b>CONSTRUCTION DATE:</b> 1880s-1900s  <b>ARCHITECT / BUILDER:</b> Plantings by Charles Moore  <b>HERITAGE LISTINGS:</b> <input type="checkbox"/> National Estate <input checked="" type="checkbox"/> S170 List <input type="checkbox"/> National Trust <input type="checkbox"/> Leichhardt LEP <input type="checkbox"/> State Heritage Register
<b>BUILDING:</b>  <b>LOCATION:</b>	<b>2E TREE GROUP ON KNOLL AREA</b>  GRID: H9, H10, I10 ZONE: 4
<b>DESCRIPTION:</b>  Mixed species groups of large trees including but not limited to:- Silky Oak, Bunya Pine, Camphor Laurel, <i>Podocarpus celtis sp</i> , <i>Pinus radiata</i> , Port Jackson Fig, <i>Ficus hillii</i> , and <i>Cedrus sp</i> .

<b>CONDITION:</b>	Many trees require urgent tree surgery
<b>HISTORY:</b>	Original 1880s-1890s planting probably by Charles Moore with later additional planting in early 1900s, located around enclosing western end of cricket ground and tennis court. Originally more extensive.

<b>REFERENCES:</b>	1991 DPWS Heritage Study: Interpretation of c1903 photos and 1930 aerial photo and site investigation.
<b>SIGNIFICANCE:</b>	Significant as expression of prominent visual element. Scientifically and historically significant as collection of species typical of early plantings.
<b>GUIDELINES:</b>	Maintain existing planting carry out tree surgery urgently. Remove dead and dying trees and replace with species sympathetic to original species selection and layout.

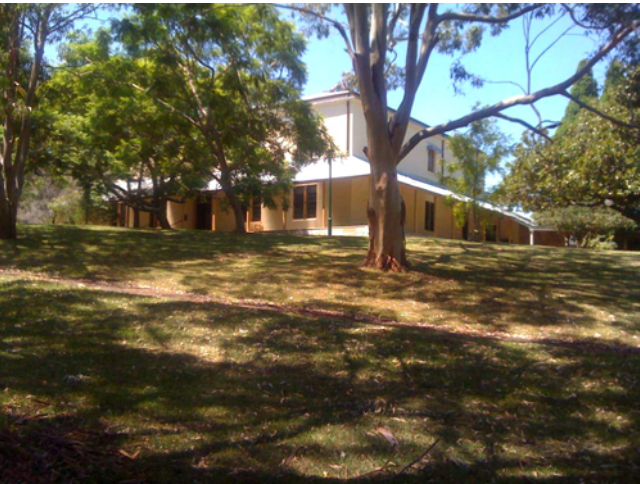
<b>ZONE 4 - RIDGETOP, KIRKBRIDE BLOCK PLATFORM AND CONVALESCENT COTTAGES</b>		
<b>ITEM No. 2J</b>  <b>ORIGINAL NAME:</b>  <b>CURRENT USE:</b> Earth platform to Garry Owen and paths	<b>CONSTRUCTION DATE:</b>  <b>ARCHITECT / BUILDER:</b>	<b>HERITAGE LISTINGS:</b> <input type="checkbox"/> National Estate <input checked="" type="checkbox"/> S170 List <input type="checkbox"/> National Trust <input type="checkbox"/> Leichhardt LEP <input type="checkbox"/> State Heritage Register
<b>ITEM:</b>  <b>LOCATION:</b>	<b>2J GARRY OWEN PATHS &amp; EMBANKMENT</b>  GRID: H8 ZONE: 4	
<b>DESCRIPTION:</b>  Earth fill platform extending in front of house and extended in an arc in front of cottage with sloped grass embankment. Concrete path network in front of Garry Owen and connecting path to cottages.

<b>CONDITION:</b>	Embankment is substantially intact. No visible evidence of original path layout.	
<b>HISTORY:</b>	Original embankment built in c1840s as platform for house and extended in 1880s to accommodate cottage. Existing path layout established 1903c and 1930.

<b>REFERENCES:</b>	1991 DPWS Heritage Study. Interpretation of aerial photo – 1930 and c1903	
<b>SIGNIFICANCE:</b>	Terrace Embankment significant as a design device, reflecting high value of outlook and concept of imposing the house and its immediate surroundings onto the land form as a design and social statement. Existing paths are intrusive to the architectural character of the Estate period.	
<b>GUIDELINES:</b>	Preserve and maintain embankment. Remove existing path network and reconstruct path/carriageway and garden layouts as near as possible to original estate period shown in photo c1903 (p137. LSc thesis). Adapt where necessary to fit modern use but retain sympathy to significance.

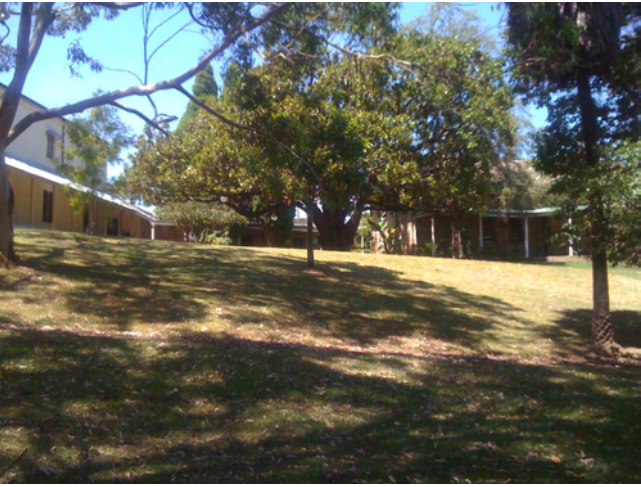
<b>ZONE 4 - RIDGETOP, KIRKBRIDE BLOCK PLATFORM AND CONVALESCENT COTTAGES</b>		
<b>ITEM No.</b> 2Q  <b>ORIGINAL NAME:</b>  <b>CURRENT USE:</b>	<b>CONSTRUCTION DATE:</b> 1840s and 1880s  <b>ARCHITECT / BUILDER:</b> <b>1880s plantings</b> <b>representative of Charles Moore.</b>	<b>HERITAGE LISTINGS:</b> <input type="checkbox"/> National Estate <input checked="" type="checkbox"/> S170 List <input type="checkbox"/> National Trust <input type="checkbox"/> Leichhardt LEP <input type="checkbox"/> State Heritage Register
<b>ITEM:</b>  <b>LOCATION:</b>	<b>2Q INDIVIDUAL TREES AND GARDENS</b>  GRID: H8 ZONE: 4	
<b>DESCRIPTION:</b>  Individual trees in lawn on the embankment in front of Garry Owen.

<b>CONDITION:</b>	Plants of variable condition. Older trees need extremely urgent surgery.	
<b>HISTORY:</b>	Tree Magnolia, Bunya Pine, Coral Tree, Cypress and possibly Privet reflect 1840s species. Selection is typical of C. Moore species selection.

<b>REFERENCES:</b>	1991 DPWS Heritage Study. c. 1903 photos.	
<b>SIGNIFICANCE:</b>	Individual trees from original estate or Asylum plantings are of significance. Newer plantings and gardens are intrusive.	
<b>GUIDELINES:</b>	Carry out urgent tree surgery. Where original trees cannot be restored to health replace with same species. Remove native garden planting in front of cottage and replace with c.1900 species. Carry our further research to identify original planting and restore as far as practical. Over time restore sight lines to Iron Cove.

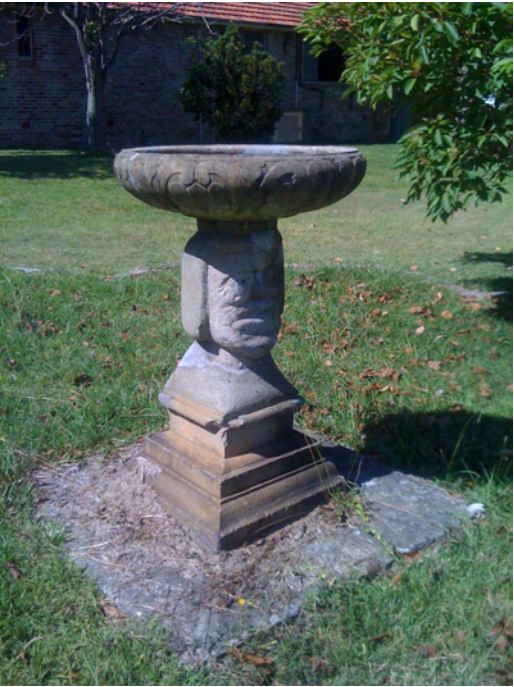
<b>ZONE 4 - RIDGETOP, KIRKBRIDE BLOCK PLATFORM AND CONVALESCENT COTTAGES</b>		
<b>ITEM No.</b> 2S  <b>ORIGINAL NAME:</b>  <b>CURRENT USE:</b> Garden ornament	<b>CONSTRUCTION DATE:</b>  <b>ARCHITECT / BUILDER:</b> Understood to have been carved by a patient.	<b>HERITAGE LISTINGS:</b> <input type="checkbox"/> National Estate <input checked="" type="checkbox"/> S170 List <input type="checkbox"/> National Trust <input type="checkbox"/> Leichhardt LEP <input type="checkbox"/> State Heritage Register
<b>ITEM:</b>  <b>LOCATION:</b>	<b>2S CARVED PEDESTAL</b>  GRID: H9 ZONE: 4	
<b>DESCRIPTION:</b>  Carved head on sandstone pedestal with separate decoratively carved sandstone bird bath dish.

<b>CONDITION:</b>	Intact. Some stone damage.	
<b>HISTORY:</b>	Face probably carved by a patient. Dish from other source	
<b>REFERENCES:</b>	1991 DPWS Heritage Study	
<b>SIGNIFICANCE:</b>	Significant as a substantial work by early asylum patients.

<b>GUIDELINES:</b>	Preserve. If necessary relocate to a place that reflects its significance such as within the Kirkbride Block courtyards. Conserve stonework, reconstruct damaged sections.

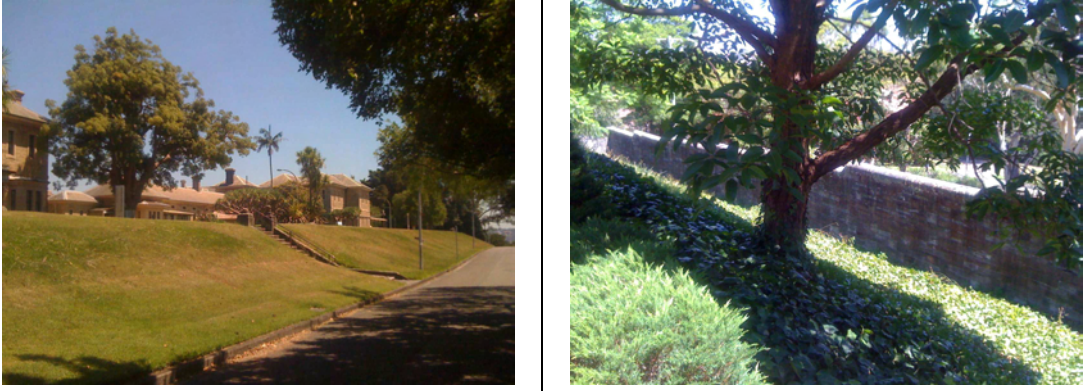
<b>ZONE 4 - RIDGETOP, KIRKBRIDE BLOCK PLATFORM AND CONVALESCENT COTTAGES</b>	
<b>ITEM No. 3A</b>  <b>ORIGINAL NAME:</b>  <b>CURRENT USE:</b>	<b>CONSTRUCTION DATE:</b> 1870s/1880s  <b>ARCHITECT / BUILDER:</b> James Barnet and F N Manning  <b>HERITAGE LISTINGS:</b> <input type="checkbox"/> National Estate <input checked="" type="checkbox"/> S170 List <input type="checkbox"/> National Trust <input type="checkbox"/> Leichhardt LEP <input type="checkbox"/> State Heritage Register
<b>ITEM:</b>  <b>LOCATION:</b>	<b>3A EARTH PLATFORM</b>  GRID: I-J, 5-8 ZONE: 4
<b>DESCRIPTION:</b>  Rectangular terrace formed from cut and fill on natural rocky spur. Grassed surface with steep uniform grassed embankments traversed by sandstone steps, at the west forming Ha Ha walls and treed at north end.

<b>CONDITION:</b>	Intact
<b>HISTORY:</b>	Major element in original asylum design resulting from collaboration of J. Barnet and F.N. Manning following Kirkbride principles.

<b>REFERENCES:</b>	1991 DPWS Heritage Study
<b>SIGNIFICANCE:</b>	Major significance as a designed setting for the Kirkbride Block and as a fine example of site design reflecting the natural land form and as the work of prominent figures. J. Barnet and C. Moore.
<b>GUIDELINES:</b>	Maintain uniform grass surfaces. No future development should break into the embankments on the east or west. Maintain outlook from top of platform.

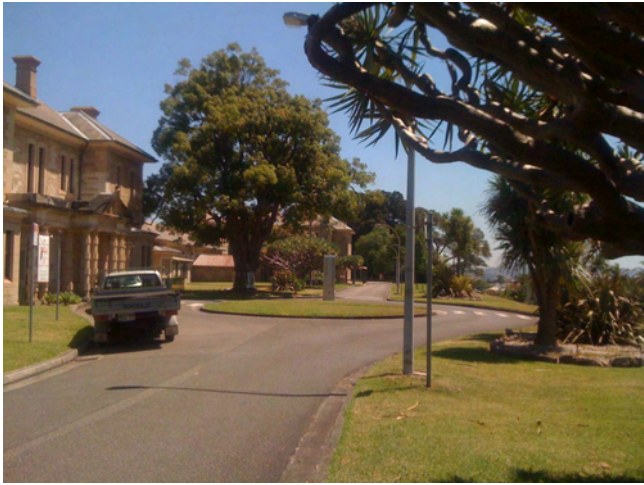
<b>ZONE 4 - RIDGETOP, KIRKBRIDE BLOCK PLATFORM AND CONVALESCENT COTTAGES</b>	
<b>ITEM No. 3B</b>  <b>ORIGINAL NAME:</b>  <b>CURRENT USE:</b> Part of road network	<b>CONSTRUCTION DATE:</b>  <b>ARCHITECT / BUILDER:</b>  <b>HERITAGE LISTINGS:</b> <input type="checkbox"/> National Estate <input checked="" type="checkbox"/> S170 List <input type="checkbox"/> National Trust <input type="checkbox"/> Leichhardt LEP <input type="checkbox"/> State Heritage Register
<b>BUILDING:</b>  <b>LOCATION:</b>	<b>3B KIRKBRIDE WAY &amp; NORTH CIRCUIT</b>  GRID: J7-8, K6 ZONE: 4
<b>DESCRIPTION:</b>  Kerbed and guttered bitumen access road on top of embankment with one central turning circle and parking area offset from the first road along bottom of embankment.

<b>CONDITION:</b>	Intact
<b>HISTORY:</b>	Second turning circle added to original James Barnet design.
<b>REFERENCES:</b>	1991 DPWS Heritage Study. 1893 site plan

<b>SIGNIFICANCE:</b>	Kirkbride way intruded upon by later addition of second turning circle and car parking area. Significant as major original asylum design element still in use.
<b>GUIDELINES:</b>	Remove second turning circle and paved area, restrict/remove car parking in front of the Kirkbride block. Preserve original roads. If appropriate return Kirkbride Way to gravel surface or similar character.

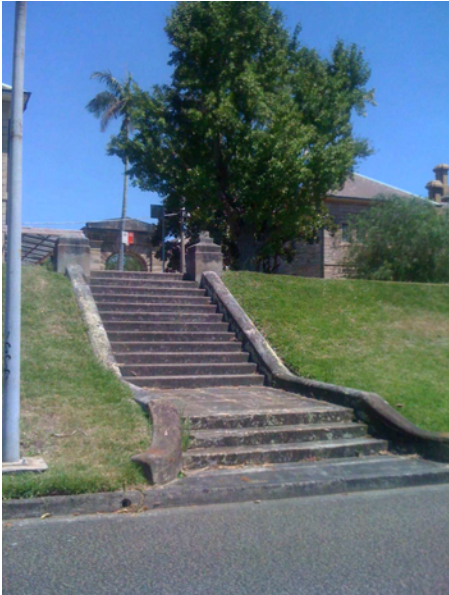
<b>ZONE 4 - RIDGETOP, KIRKBRIDE BLOCK PLATFORM AND CONVALESCENT COTTAGES</b>		
<b>ITEM No. 3C</b>  <b>ORIGINAL NAME:</b>  <b>CURRENT USE:</b> Steps	<b>CONSTRUCTION DATE:</b> 1880-1885  <b>ARCHITECT / BUILDER:</b>	<b>HERITAGE LISTINGS:</b> <input type="checkbox"/> National Estate <input checked="" type="checkbox"/> S170 List <input type="checkbox"/> National Trust <input type="checkbox"/> Leichhardt LEP <input type="checkbox"/> State Heritage Register
<b>ITEM:</b>  <b>LOCATION:</b>	<b>3C STEPS</b>  GRID: I5, K6, J7 ZONE: 4	
<b>DESCRIPTION:</b>  On Kirkbride Way, two flights of sandstone steps with decorative pedestal relating to Kirkbride Block. On Central Avenue stairs of 2 steps each with carved balustrade original treads overlaid with concrete.		
<div style="display: flex; justify-content: space-around;">

</div>		
<b>CONDITION:</b>	Steps on Kirkbride Way intact, steps on Central Avenue substantially intact to part intact.

<b>HISTORY:</b>	Built as part of original asylum design 1880-85	
<b>REFERENCES:</b>	1991 DPWS Heritage Study.	
<b>SIGNIFICANCE:</b>	Significant as original asylum design elements. Integrity of steps on Central Avenue undermined by deterioration / lack of associated pathways.	
<b>GUIDELINES:</b>	Preserve steps on Kirkbride Way. Restore steps on Central Avenue.

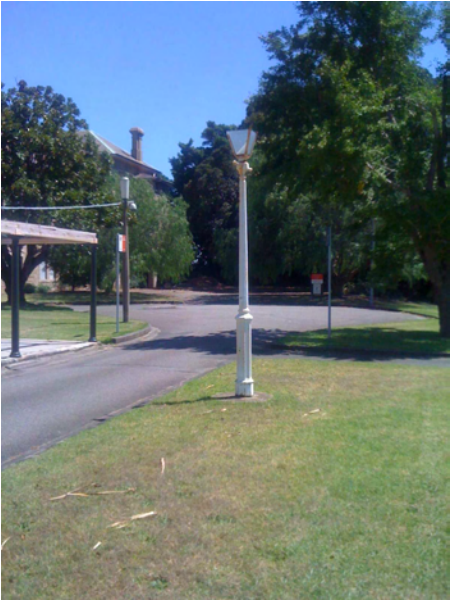
<b>ZONE 4 - RIDGETOP, KIRKBRIDE BLOCK PLATFORM AND CONVALESCENT COTTAGES</b>	
<b>ITEM No.</b> 3E  <b>ORIGINAL NAME:</b>  <b>CURRENT USE:</b> Lamp standard.	<b>CONSTRUCTION DATE:</b> Circa 1885  <b>ARCHITECT / BUILDER:</b>  <b>HERITAGE LISTINGS:</b> <input type="checkbox"/> National Estate <input checked="" type="checkbox"/> S170 List <input type="checkbox"/> National Trust <input type="checkbox"/> Leichhardt LEP <input type="checkbox"/> State Heritage Register
<b>ITEM:</b>  <b>LOCATION:</b>	<b>3E STANDARD LIGHT</b>  GRID: K6 ZONE: 4
<b>DESCRIPTION:</b>  Decorative cast iron post and light fitting.

<b>CONDITION:</b>	Glazed lantern at top of standard has been damaged and top removed.
<b>HISTORY:</b>	Installed in the time of construction of the Kirkbride Block
<b>REFERENCES:</b>	1991 DPWS Heritage Study, Site inspection 1880s photo held at Public Works and State Records
<b>SIGNIFICANCE:</b>	Significant as only remaining gas light on Kirkbride Platform

<b>GUIDELINES:</b>	Reconstruct missing elements. Install reconstructed light standards on eastern side of Kirkbride Block as shown in early photographs.

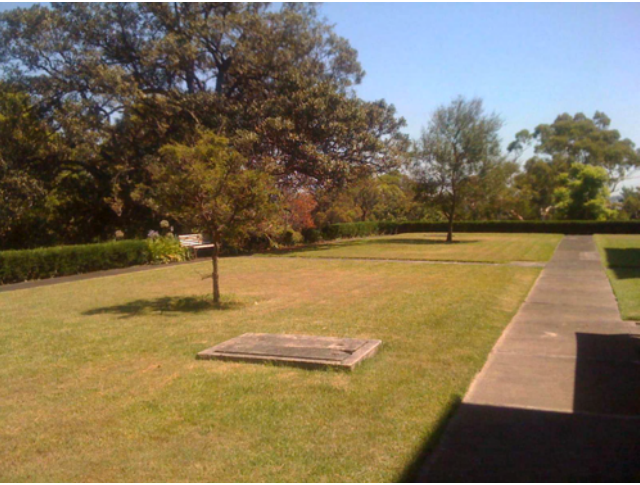
<b>ZONE 4 - RIDGETOP, KIRKBRIDE BLOCK PLATFORM AND CONVALESCENT COTTAGES</b>		
<b>ITEM No.</b> 3F  <b>ORIGINAL NAME:</b>  <b>CURRENT USE:</b>	<b>CONSTRUCTION DATE:</b> 1880s-1890s  <b>ARCHITECT / BUILDER:</b>	<b>HERITAGE LISTINGS:</b> <input type="checkbox"/> National Estate <input checked="" type="checkbox"/> S170 List <input type="checkbox"/> National Trust <input type="checkbox"/> Leichhardt LEP <input type="checkbox"/> State Heritage Register
<b>ITEM:</b>  <b>LOCATION:</b>	<b>3F WARD COURTYARDS</b>  GRID: 16-7-8 ZONE: 4	
<b>DESCRIPTION:</b>  Courtyards for male and female wards with verandahs, enclosing walls, path networks and lawn. Some with original trees, Camphor Laurel and palms remaining.

<b>CONDITION:</b>	Some substantially intact, others in poor condition.	
<b>HISTORY:</b>	Originally laid out following completion of Kirkbride Block in 1885. Probably laid out in 1890s wave of landscape works.

<b>REFERENCES:</b>	1991 DPWS Heritage Study	
<b>SIGNIFICANCE:</b>	Significant as original asylum design demonstrating character of ward courtyards and the use of gardens as therapy.	
<b>GUIDELINES:</b>	Preserve representative samples of courtyard path networks and over time reconstruct garden areas to early 1900s character.

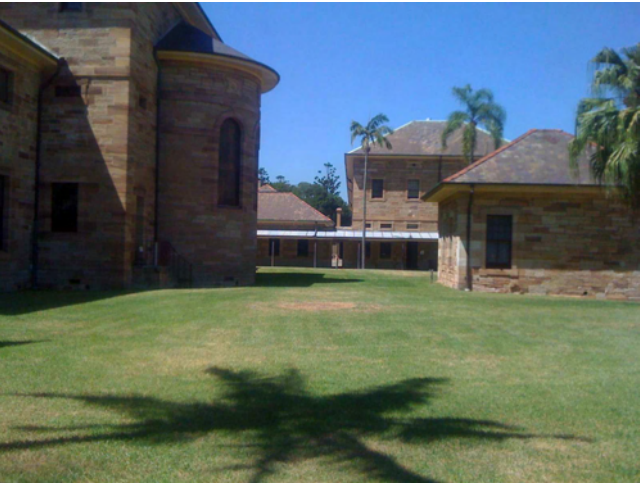
<b>ZONE 4 - RIDGETOP, KIRKBRIDE BLOCK PLATFORM AND CONVALESCENT COTTAGES</b>	
<b>ITEM No.</b> 3G  <b>ORIGINAL NAME:</b>  <b>CURRENT USE:</b>	<b>CONSTRUCTION DATE:</b> 1890s  <b>ARCHITECT / BUILDER:</b>  <b>HERITAGE LISTINGS:</b> <input type="checkbox"/> National Estate <input checked="" type="checkbox"/> S170 List <input type="checkbox"/> National Trust <input type="checkbox"/> Leichhardt LEP <input type="checkbox"/> State Heritage Register
<b>ITEM:</b>  <b>LOCATION:</b>	<b>3G CHAPEL COURTYARD</b>  GRID: I7 - J7 ZONE: 4
<b>DESCRIPTION:</b>  Grassed courtyard enclosed by verandahs with central chapel. Individual plants located at wide intervals along edges. Plants include palms, <i>cordyline</i> , <i>cotoneaster</i> and Dragon's blood. Shade structure and paving northern side.

<b>CONDITION:</b>	
<b>HISTORY:</b>	Established in late 1890s.
<b>REFERENCES:</b>	1991 DPWS Heritage Study. c. 1903 photo

<b>SIGNIFICANCE:</b>	Significant as representative of original design concept however individual plants not significant.
<b>GUIDELINES:</b>	Document existing fabric prior to any redevelopment. New development should be sympathetic to this original design concept.

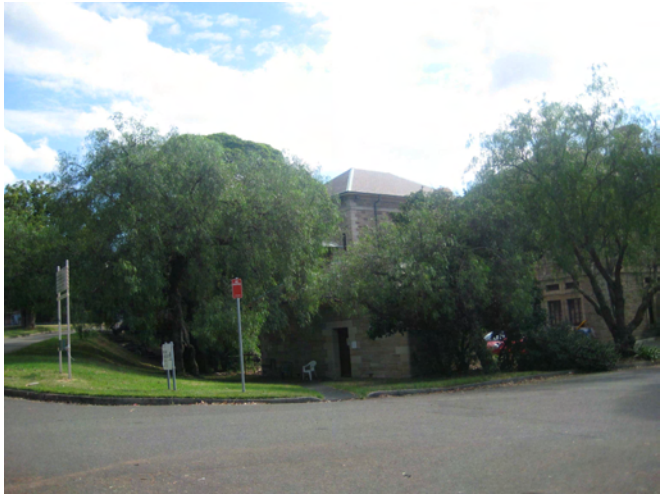
<b>ZONE 4 - RIDGETOP, KIRKBRIDE BLOCK PLATFORM AND CONVALESCENT COTTAGES</b>		
<b>ITEM No.</b> 3H  <b>ORIGINAL NAME:</b>  <b>CURRENT USE:</b>	<b>CONSTRUCTION DATE:</b> Planted circa 1890s  <b>ARCHITECT / BUILDER:</b>	<b>HERITAGE LISTINGS:</b> <input type="checkbox"/> National Estate <input checked="" type="checkbox"/> S170 List <input type="checkbox"/> National Trust <input type="checkbox"/> Leichhardt LEP <input type="checkbox"/> State Heritage Register
<b>ITEM:</b>  <b>LOCATION:</b>	<b>3H TREE GROUPS AT SOUTH GATE</b>  GRID: J8 ZONE: 4	
<b>DESCRIPTION:</b>  Peppercorn and brush box planted around original morgue.

<b>CONDITION:</b>	Good to fair	
<b>HISTORY:</b>	Planted about 1890s	
<b>REFERENCES:</b>	1991 DPWS Heritage Study. c. 1903 photo	
<b>SIGNIFICANCE:</b>	Significant as original plantings and new plantings maintaining character of original concept. Loss of associated garden beds has reduced integrity of original planting. Reflects species selection of Charles Moore.

<b>GUIDELINES:</b>	Maintain existing trees. Remove dead tree and replace with same species.

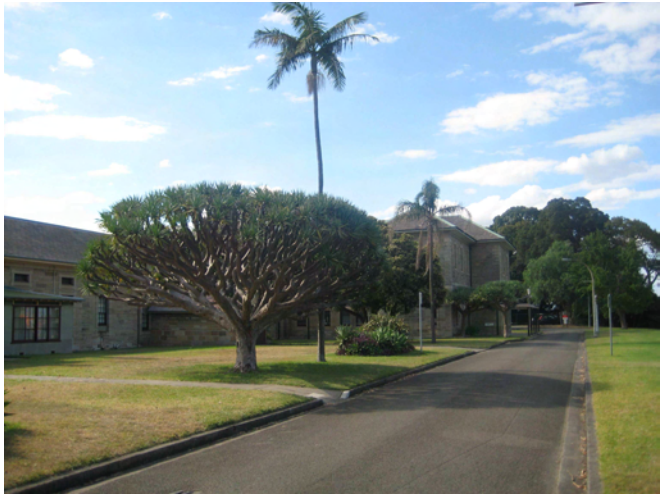
<b>ZONE 4 - RIDGETOP, KIRKBRIDE BLOCK PLATFORM AND CONVALESCENT COTTAGES</b>		
<b>ITEM No. 3J</b>  <b>ORIGINAL NAME:</b>  <b>CURRENT USE:</b>	<b>CONSTRUCTION DATE:</b> 1890-1920s  <b>ARCHITECT / BUILDER:</b>	<b>HERITAGE LISTINGS:</b> <input type="checkbox"/> National Estate <input checked="" type="checkbox"/> S170 List <input type="checkbox"/> National Trust <input type="checkbox"/> Leichhardt LEP <input type="checkbox"/> State Heritage Register
<b>ITEM:</b>  <b>LOCATION:</b>	<b>3J INDIVIDUAL TREES</b>  GRID: J-K 6-8 ZONE: 4	
<b>DESCRIPTION:</b>  Individual trees of mixed species along front of Kirkbride Platform. Species include tree Magnolia, Ginko, Dragon's Blood, Camphor Laurel, Lilly Pilly, Camellia and Cypress.

<b>CONDITION:</b>	Good to fair	
<b>HISTORY:</b>	Moore's original scheme appeared to have only 4 pines along top of embankment. Assume other trees added in 1890-1920s.	
<b>REFERENCES:</b>	1991 DPWS Heritage Study, c. 1903 photos, c. 1920 photo, photopanorama.

<b>SIGNIFICANCE:</b>	Representative of early tree plantings but lacking design integrity due to loss of associated gardens.	
<b>GUIDELINES:</b>	Undertake tree surgery.

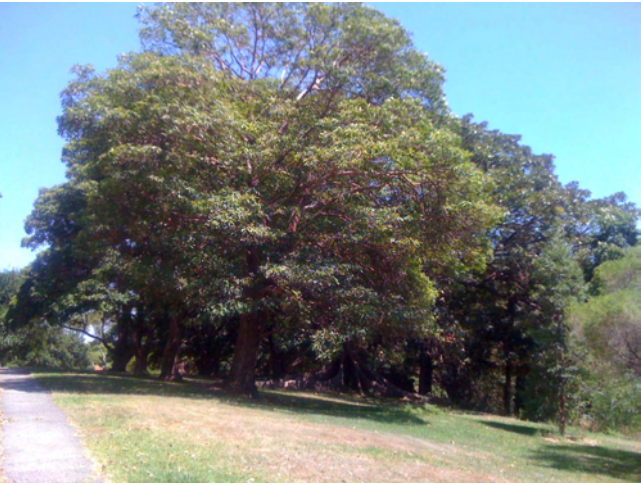
<b>ZONE 4 - RIDGETOP, KIRKBRIDE BLOCK PLATFORM AND CONVALESCENT COTTAGES</b>		
<b>ITEM No.</b> 3L	<b>CONSTRUCTION DATE:</b> Understood planted 1890s-1900s.	<b>HERITAGE LISTINGS:</b> <input type="checkbox"/> National Estate <input checked="" type="checkbox"/> S170 List <input type="checkbox"/> National Trust <input type="checkbox"/> Leichhardt LEP <input type="checkbox"/> State Heritage Register
<b>ORIGINAL NAME:</b>		
<b>CURRENT USE:</b>	<b>ARCHITECT / BUILDER:</b>	
<b>ITEM:</b>	<b>3L CAMPHOR LAUREL ROW</b>	
<b>LOCATION:</b>	GRID: J5 ZONE: 4	
<b>DESCRIPTION:</b> Row of Camphor Laurels beside footpath. Many have been severely lopped in the past.

<b>CONDITION:</b>	Good to poor	
<b>HISTORY:</b>	Likely planted in 1890s or early 1900s. Original row extended full length of Kirkbride North Wall.	
<b>REFERENCES:</b>	1991 DPWS Heritage Study	
<b>SIGNIFICANCE:</b>	Significant early design element related to access path. Integrity of significance reduced by heavy tree lopping.

<b>GUIDELINES:</b>	Replace missing trees from row as opportunity arises.

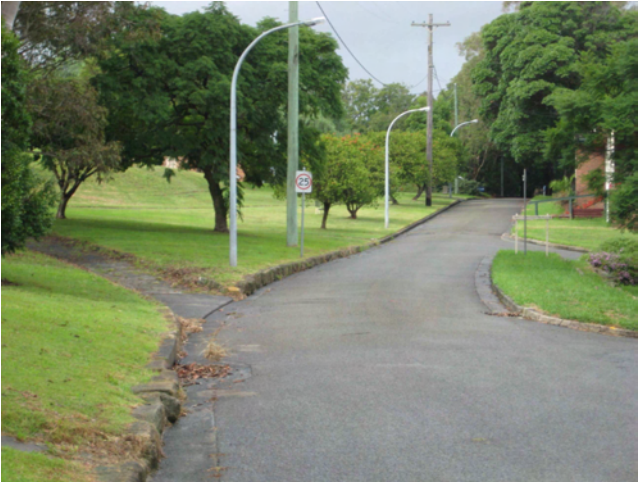
<b>ZONE 4 - RIDGETOP, KIRKBRIDE BLOCK PLATFORM AND CONVALESCENT COTTAGES</b>		
<b>ITEM No. 30</b>	<b>CONSTRUCTION DATE:</b>	<b>HERITAGE LISTINGS:</b> <input type="checkbox"/> National Estate <input checked="" type="checkbox"/> S170 List <input type="checkbox"/> National Trust <input type="checkbox"/> Leichhardt LEP <input type="checkbox"/> State Heritage Register
<b>ORIGINAL NAME:</b>	<b>ARCHITECT / BUILDER:</b>	
<b>CURRENT USE:</b>		
<b>ITEM:</b>	<b>30 CENTRAL DRIVE</b>	
<b>LOCATION:</b>	GRID: H6-7, I5 ZONE: 4	
<b>DESCRIPTION:</b>	<p>Kerbed and guttered bitumen road enclosing western edge of Kirkbride Block.</p>

<b>CONDITION:</b>	Intact	
<b>HISTORY:</b>	Present alignment formalised by 1930 – possibly before.	
<b>REFERENCES:</b>	1991 DPWS Heritage Study. 1930 aerial photo.	
<b>SIGNIFICANCE:</b>	Intrusive on the original J. Barnet design concept of serpentine alignment.	
<b>GUIDELINES:</b>	Over time reduce visual emphasis on existing road alignment and develop it as a visually recessive element in the landscape.

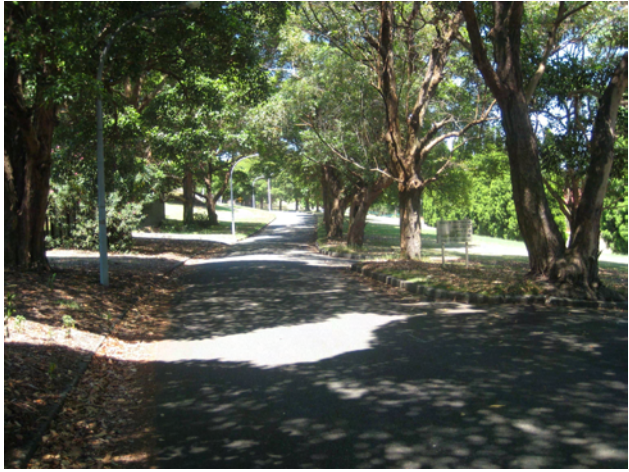
<b>ZONE 4 - RIDGETOP, KIRKBRIDE BLOCK PLATFORM AND CONVALESCENT COTTAGES</b>	
<b>ITEM No. 3P</b>  <b>ORIGINAL NAME:</b>  <b>CURRENT USE:</b>	<b>CONSTRUCTION DATE:</b> Planted during 1930s-1940s  <b>ARCHITECT / BUILDER:</b>  <b>HERITAGE LISTINGS:</b> <input type="checkbox"/> National Estate <input checked="" type="checkbox"/> S170 List <input type="checkbox"/> National Trust <input type="checkbox"/> Leichhardt LEP <input type="checkbox"/> State Heritage Register
<b>ITEM:</b>  <b>LOCATION:</b>	<b>3P BRUSH BOX AVENUE</b>  GRID: I6, H7 ZONE: 4
<b>DESCRIPTION:</b> Brush box avenue

<b>CONDITION:</b>	Good
<b>HISTORY:</b>	Planted in 1930s to 1940s in two separate plantings.
<b>REFERENCES:</b>	1991 DPWS Heritage Study. Fig 36 and 34 Powell.
<b>SIGNIFICANCE:</b>	Intrusive on the original J. Barnet design concept which included clear views from the Kirkbride Platform to the treed lower slopes
<b>GUIDELINES:</b>	Remove as opportunity arises to restore views to Iron Cove.

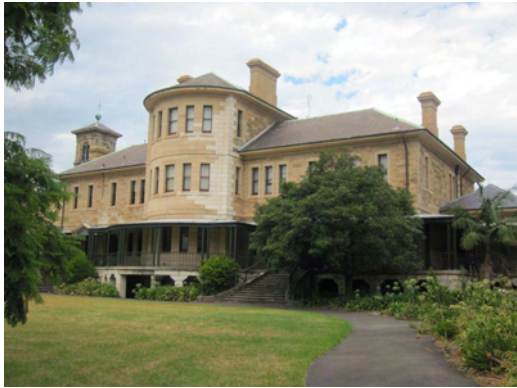
<b>ZONE 4 - RIDGETOP, KIRKBRIDE BLOCK PLATFORM AND CONVALESCENT COTTAGES</b>		
<b>ITEM No.</b> 3Q	<b>CONSTRUCTION DATE:</b>	<b>HERITAGE LISTINGS:</b>
<b>ORIGINAL NAME:</b>	<b>ARCHITECT / BUILDER:</b>	<input type="checkbox"/> National Estate
<b>CURRENT USE:</b>		<input checked="" type="checkbox"/> S170 List
		<input type="checkbox"/> National Trust
		<input type="checkbox"/> Leichhardt LEP
		<input type="checkbox"/> State Heritage Register
<b>ITEM:</b>	<b>3Q LIBRARY PLATFORM &amp; PLANTING</b>	
<b>LOCATION:</b>	GRID: I6 ZONE: 4	
<b>DESCRIPTION:</b>	<p>High earth terrace with curved embankment centred on library building. Trees flank staircase and edge side entry paths.</p>

<b>CONDITION:</b>	Landform intact. Planting good to fair. Some Peppercorns have been removed due to termite infestation.	
<b>HISTORY:</b>	In 1903 a circular gravel path enclosing a formal pond and edged by luxuriant growth, with picket fence at bottom of embankment. Original trees include Peppercorns. Poplars added 1930s or later.

<b>REFERENCES:</b>	1991 DPWS Heritage Study. Photo c. 1903 and c. 1930s	
<b>SIGNIFICANCE:</b>	Landform, stairs and paths and Peppercorns are of significance as original design elements reflecting the work of Charles Moore and James Barnet as a major element in original asylum design.	
<b>GUIDELINES:</b>	Maintain original trees. Preserve steps, paths and landform. Any future development in this area should reflect the original design concept. Further research recommended.
