ZONE 5 CENTRAL SLOPE

INVENTORY OF INDIVIDUAL ITEMS

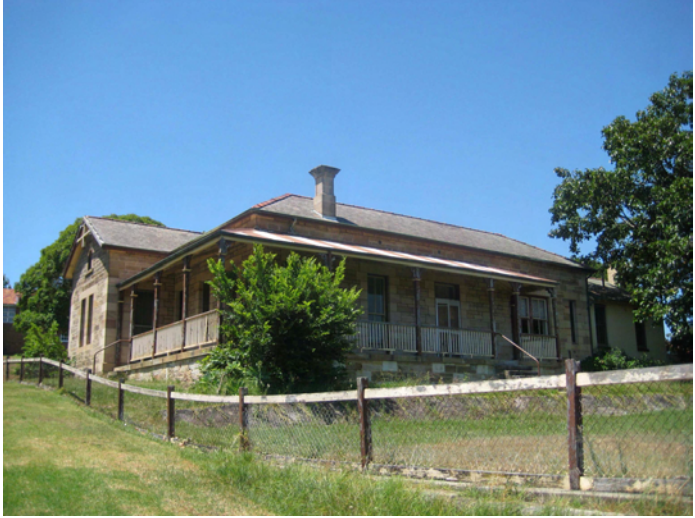
ZONE 5 – CENTRAL SLOPE		
<p>ITEM No. B205</p> <p>FORMER NAMES: Gardener's Cottage / Assistant Medical Superintendent's Residence / Chaplain's Offices</p> <p>CURRENT USE: Unoccupied</p>	<p>CONSTRUCTION DATE: c. 1879</p> <p>ARCHITECT / BUILDER: James Barnet</p>	<p>HERITAGE LISTINGS:</p> <p><input checked="" type="checkbox"/> National Estate</p> <p><input checked="" type="checkbox"/> S170 List</p> <p><input checked="" type="checkbox"/> National Trust</p> <p><input type="checkbox"/> Leichhardt LEP</p> <p><input type="checkbox"/> State Heritage Register</p>
<p>ITEM:</p> <p>LOCATION:</p>	<p>B205 BONNYVIEW COTTAGE</p> <p>GRID: G6 ZONE: 5</p>	
<p>DESCRIPTION:</p> <p>Single storey sandstone detached cottage similar in style and detailing to Kirkbride Block. Traditional house plan with verandah on two sides. Slate roof, verandah with timber posts, brackets and plain balustrade. Fenced yard built up with stone wall from surrounding sloping ground.</p> <p>Single storey brick addition to the south of the original building.</p> <p>Garage (B206) to west.</p>

<p>CONDITION:</p>	<p>Good, largely intact</p>	
<p>HISTORY:</p>	<p>Built 1879, preceding Kirkbride Block, as Gardener's Cottage and also accommodating patients. Various additions, including conversion to Medical Superintendent's Residence c.1910.</p>	
<p>REFERENCES:</p>	<p>Leong (44), MH2/382, 555, JTCW</p>	
<p>SIGNIFICANCE:</p>	<p>Exceptional. Part of Barnet's original design. Excellent design and workmanship. Part of picturesque setting in views from north west.</p>	
<p>GUIDELINES:</p>	<p>Retain and conserve according to the principles of the Burra Charter. Initiate appropriate use for the building and regular maintenance program. Retain, reuse or remove garage; if removed record prior to demolition.</p>

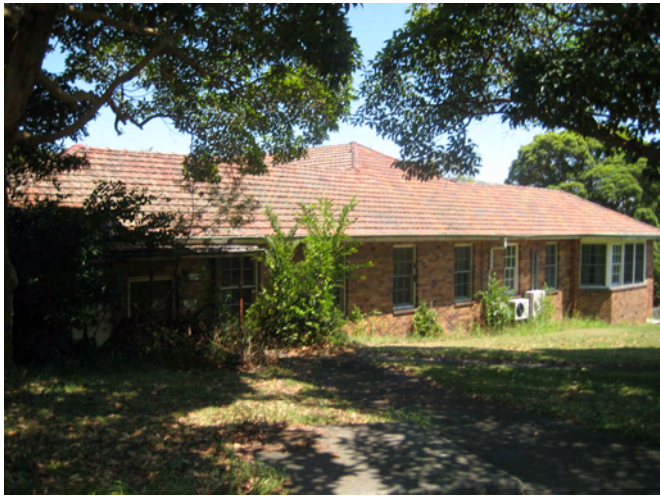
ZONE 5 – CENTRAL SLOPE		
<p>ITEM No. B208</p> <p>ORIGINAL NAME: Male Admission Ward 16 (later Male Ward 9, Laundry), Building 39</p> <p>CURRENT USE: Unoccupied</p>	<p>CONSTRUCTION DATE: c.1948</p> <p>ARCHITECT / BUILDER: Unknown</p>	<p>HERITAGE LISTINGS:</p> <p><input type="checkbox"/> National Estate</p> <p><input type="checkbox"/> S170 List</p> <p><input type="checkbox"/> National Trust</p> <p><input type="checkbox"/> Leichhardt LEP</p> <p><input type="checkbox"/> State Heritage Register</p>
<p>BUILDING:</p>	<p>B 208</p>	
<p>LOCATION:</p>	<p>GRID: H6-7 ZONE: 5</p>	
<p>DESCRIPTION:</p> <p>Long and rambling single storey brick and hipped terracotta tiled roof building. Two wings with central entry. Timber and aluminium doors and windows.</p>

<p>CONDITION:</p>	<p>Good</p>	
<p>HISTORY:</p>	<p>Built c.1948 (working drawing signed 11 November 1948).</p>	
<p>REFERENCES:</p>	<p>Leong (28) MH2/6-18, JTCW, DPWS 1991 & Public Works 1993, Aerial photo 1951.</p>

<p>SIGNIFICANCE:</p>	<p>Intrusive, sited high and directly in front of the central axis of the Kirkbride Unit.</p>	
<p>GUIDELINES:</p>	<p>Retain, recycle, or preferably remove as practicable. Intrusiveness could be reduced by screen planting to give the effect of bush in views to and from Kirkbride. This area should be left open in any redevelopment but if development occurs it must conform to the requirements of the Callan Park Act. If removed record prior to demolition.</p>

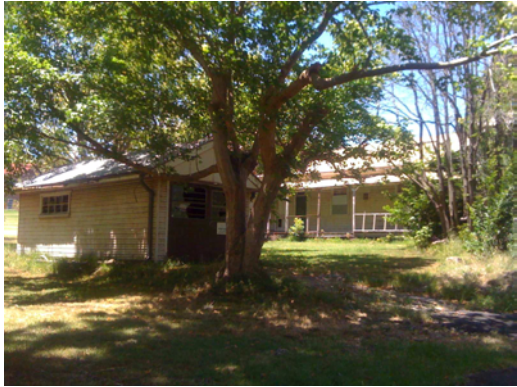
ZONE 5 – CENTRAL SLOPE		
<p>ITEM No. B298</p> <p>ORIGINAL NAME: Farm Attendant's Cottage (later Engineers Cottage), Building 103; ITU Stores.</p> <p>CURRENT USE: Vacant</p>	<p>CONSTRUCTION DATE: pre 1903</p> <p>ARCHITECT / BUILDER: Unknown</p>	<p>HERITAGE LISTINGS:</p> <p><input type="checkbox"/> National Estate</p> <p><input checked="" type="checkbox"/> S170 List</p> <p><input type="checkbox"/> National Trust</p> <p><input type="checkbox"/> Leichhardt LEP</p> <p><input type="checkbox"/> State Heritage Register</p>
<p>BUILDING:</p> <p>LOCATION:</p>	<p>B298 WEATHERBOARD COTTAGE</p> <p>GRID: E7 ZONE: 5</p>	
<p>DESCRIPTION:</p> <p>Single storey weatherboard cottage with corrugated steel roof, verandahs. Various sympathetic additions. Garage to north (B298A) constructed circa 1960 with corrugated steel roof and timber weatherboard wall linings.</p>		
<div style="display: flex; justify-content: space-around;">

<p>CONDITION:</p>	<p>Fair, but rainwater goods need replacement and structural condition requires investigation – the verandah on the western side of the building is sagging. The garage is in fair condition but rainwater goods are deteriorating and glass in doors has been broken.</p>	
<p>HISTORY:</p>	<p>Built before 1903 as shown on contour survey produced by W. L. Vernon in 1903 with associated poultry yard.</p>	
<p>REFERENCES:</p>	<p>1903 plan Public Works 1993, DPWS 1991.</p>	
<p>SIGNIFICANCE:</p>	<p>High. Significant as part of early or original development of the hospital and as one of the few remaining items demonstrating the farm use of the site and one of the only early vernacular buildings on the site. Garage has Neutral significance.</p>	
<p>GUIDELINES:</p>	<p>Retain and conserve cottage according to Burra Charter principles. Adaptive reuse should be sympathetic to the building's heritage significance. Investigate condition of footings. Undertake repairs as required and initiate regular maintenance program. Retain, reuse or remove garage; if removed record prior to demolition. Any new structure in this location must conform to the requirements of the Callan Park Act</p>

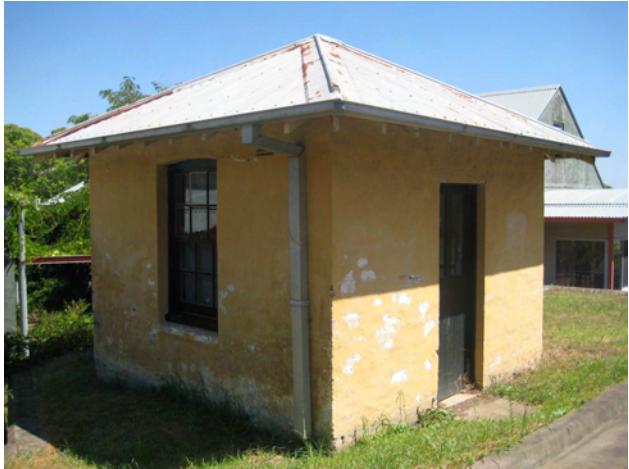
ZONE 5 – CENTRAL SLOPE		
<p>ITEM Nos. B401</p> <p>ORIGINAL NAME: Ward 15; Building 50C</p> <p>CURRENT USE: Unoccupied</p>	<p>CONSTRUCTION DATE: Unknown</p> <p>ARCHITECT / BUILDER: Unknown</p>	<p>HERITAGE LISTINGS:</p> <p><input type="checkbox"/> National Estate</p> <p><input checked="" type="checkbox"/> S170 List</p> <p><input type="checkbox"/> National Trust</p> <p><input type="checkbox"/> Leichhardt LEP</p> <p><input type="checkbox"/> State Heritage Register</p>
<p>BUILDING:</p>	<p>B401</p>	
<p>LOCATION:</p>	<p>GRID: G9 ZONE: 5</p>	
<p>DESCRIPTION:</p> <p>Tiny square building. Rendered brick with rendered finish, hipped corrugated iron roof with exposed rafters in eaves. Two timber doors on opposite sides, 2 timber windows on other sides.</p> <p>Awkwardly placed beside early 1990s development. Close to road side and elevated by lowered landscaping of new buildings.</p>

<p>CONDITION:</p>	<p>Fair. Window sill joinery badly deteriorated, cracks in wall surfaces and rust in roof linings and cappings. Painted wall surfaces are also deteriorating.</p>

<p>HISTORY:</p>	<p>Unknown - appears to be early farm building. Doors and window indicate intended for use by people (rather than store) possibly for supervision and controlling entry into orchard or farm.</p>	
<p>REFERENCES:</p>	<p>DPWS (1991), site inspection.</p>	
<p>SIGNIFICANCE:</p>	<p>Moderate significance as part of a group of utility/farm buildings demonstrating the early use of the site and contributing to the pastoral character of the area. Design gives indication of former use.</p>	
<p>GUIDELINES:</p>	<p>Retain and conserve according to Burra Charter principles. Carefully repair deteriorating fabric using appropriate materials and profiles.</p>

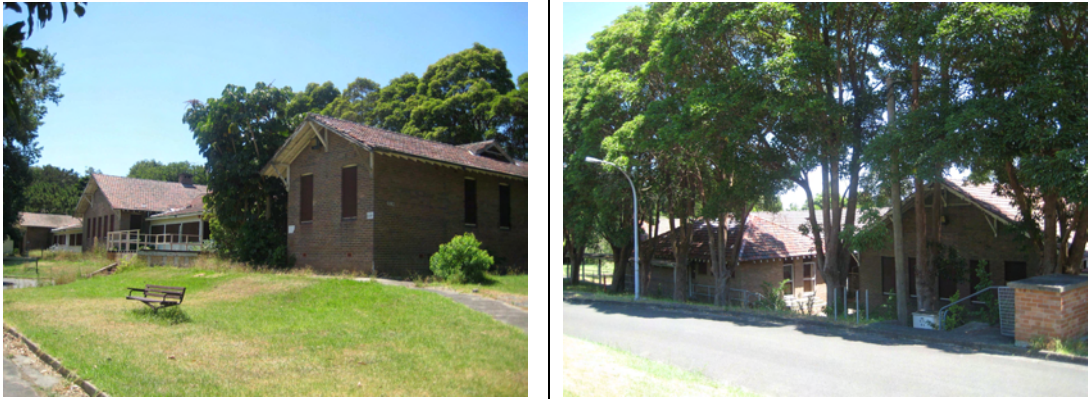
ZONE 5 – CENTRAL SLOPE		
ITEM No. B497 ORIGINAL NAME: Ward B, Building 90 CURRENT USE: Disused	CONSTRUCTION DATE: early 1920s? (plans dated 1918) ARCHITECT / BUILDER: Unknown	HERITAGE LISTINGS: <input type="checkbox"/> National Estate <input checked="" type="checkbox"/> S170 List <input type="checkbox"/> National Trust <input type="checkbox"/> Leichhardt LEP <input type="checkbox"/> State Heritage Register
BUILDING: LOCATION:	B497 GRID: G5 ZONE: 5	
DESCRIPTION: Long single storey brick (commons) building with glazed terracotta tiled roof. Timber windows with each sash divided into 9 panes (windows boarded over). Rafter ends exposed, eaves lined with timber boards. Service courts at rear of building. Verandahs enclosed and toilet blocks altered. Originally similar to B502 in Zone 7. Well screened by trees. Harbour Bridge War Memorial constructed by patients to north of building and is carefully related to it.

CONDITION:	Fair. Damp problems, some deteriorating roof and rainwater fabric.	
HISTORY:	Built early 1920s? Plans are dated 1918, appears on 1931 aerial photo.	
REFERENCES:	Leong (49), MH2/370, JTCW	
SIGNIFICANCE:	Low. Significance as first building of repatriation hospital though not of great architectural value.	
GUIDELINES:	Retain and conserve according to Burra Charter principles. Adaptive reuse should be sympathetic to the building. Maintain and enhance the relationship between the building and the Harbour Bridge War Memorial and the building and its setting within the site. Requires maintenance, especially gutters, downpipes and stormwater drains. Verandahs should be reinstated and intrusive accretions removed.

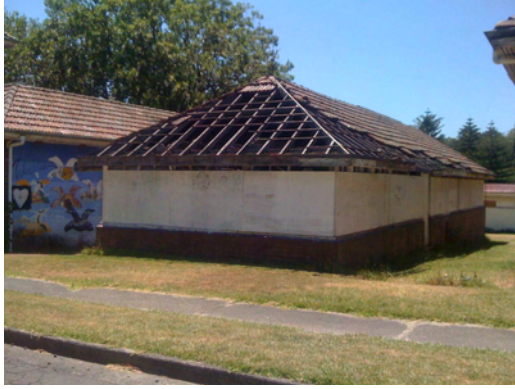
ZONE 5 – CENTRAL SLOPE		
<p>ITEM Nos. B506, B507, B508</p> <p>ORIGINAL NAME: Wards D & E; Former Bootmaker's Workshop (B508); Wawina High School</p> <p>CURRENT USE: Vacant</p>	<p>CONSTRUCTION DATE: c. 1933-5</p> <p>ARCHITECT / BUILDER: Unknown (Possibly Government Architect G.A. Edwin Smith)</p>	<p>HERITAGE LISTINGS:</p> <p><input type="checkbox"/> National Estate</p> <p><input checked="" type="checkbox"/> S170 List</p> <p><input type="checkbox"/> National Trust</p> <p><input type="checkbox"/> Leichhardt LEP</p> <p><input type="checkbox"/> State Heritage Register</p>
<p>BUILDING:</p>	<p>B506, B507, B508.</p>	
<p>LOCATION:</p>	<p>GRID: E5-6 ZONE: 5</p>	
<p>DESCRIPTION:</p> <p>Two U shaped buildings (B506 and B507), two storey brick construction with hipped tiled roof. Timber framed multi-paned double hung windows Vented timber eaves linings, enclosed verandahs east sides with Fibrolite roofs. Formally composed around rectangular courts. B508 is a single storey brick building with hipped and partially tiled roof situated between Buildings B506 and B507. Continuous bands of windows on three sides, which have been boarded up. Weatherboard lined bay at eastern end.</p>

</div>		
<p>CONDITION:</p>	<p>Poor - unoccupied and vandalised. Extensively damaged with numerous broken windows and deteriorating roofs. B508 burnt out and roof tiles missing.</p>	
<p>HISTORY:</p>	<p>Built c. 1933 (date on drawing)</p>	
<p>REFERENCES:</p>	<p>Leong (55) MH2/391-5</p>	
<p>SIGNIFICANCE:</p>	<p>Low. Minor significance, well detailed and built example of ward building of inter war period.</p>	
<p>GUIDELINES:</p>	<p>Retain and conserve according to Burra Charter principles. The buildings should be immediately boarded up and made weatherproof to protect them from vandalism, vermin and rainwater. All damaged fabric should be repaired and reconstructed to match existing original detailing.</p>

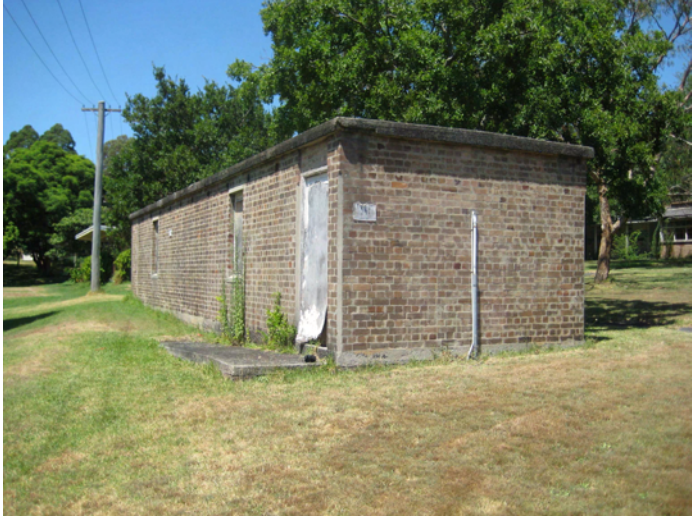
ZONE 5 – CENTRAL SLOPE		
<p>ITEM No. B510</p> <p>ORIGINAL NAME: Bomb Shelter; Gardener's Shed.</p> <p>CURRENT USE: Unoccupied</p>	<p>CONSTRUCTION DATE: c. 1940</p> <p>ARCHITECT / BUILDER: Unknown</p>	<p>HERITAGE LISTINGS:</p> <p><input type="checkbox"/> National Estate</p> <p><input checked="" type="checkbox"/> S170 List</p> <p><input type="checkbox"/> National Trust</p> <p><input type="checkbox"/> Leichhardt LEP</p> <p><input type="checkbox"/> State Heritage Register</p>
<p>BUILDING:</p> <p>LOCATION:</p>	<p>B510 BOMB SHELTER</p> <p>GRID: E-F 5 ZONE: 5</p> <p>(See also: B498 Zone 1; B293, B601, B706, B707 and B708 Zone 4; B295 Zone 5)</p>	
<p>DESCRIPTION:</p> <p>Long rectangular flat roofed, brick and concrete structures.</p>

CONDITION:	Average	
HISTORY:	c. 1940	
REFERENCES:	Site inspection; DPWS (1991)	
SIGNIFICANCE:	Moderate. Indicative of provisions for war.	
GUIDELINES:	Retain, remove as practicable. Some are intrusive elements. Retain one as example at minimum. If removed record prior to demolition.

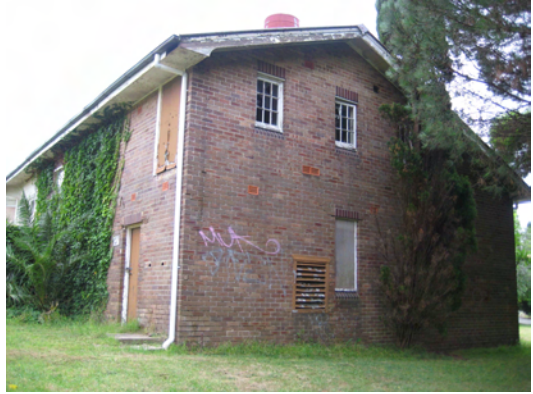
ZONE 5 – CENTRAL SLOPE		
<p>ITEM No. B511</p> <p>ORIGINAL NAME: Former Sports and Social Club / Repatriation Film Hall Building 31</p> <p>CURRENT USE: Vacant</p>	<p>CONSTRUCTION DATE: 1930 & 1935</p> <p>ARCHITECT / BUILDER: Unknown (Possibly Government Architect. Edwin Smith)</p>	<p>HERITAGE LISTINGS:</p> <ul style="list-style-type: none"> <input type="checkbox"/> National Estate <input type="checkbox"/> S170 List <input type="checkbox"/> National Trust <input type="checkbox"/> Leichhardt LEP <input type="checkbox"/> State Heritage Register
<p>BUILDING:</p>	<p>B511</p>	
<p>LOCATION:</p>	<p>GRID: F5 ZONE: 5</p>	
<p>DESCRIPTION:</p> <p>Simple rectangular building, with weatherboard addition, pitched corrugated iron roof. Fibre cement eaves linings. Two story brick section at east end with multi-paned timber framed casement windows.</p>		
<div style="display: flex; justify-content: space-around;">

<p>CONDITION:</p>	<p>Fair. Timber section requires repair and repainting, brickwork deteriorating, windows broken.</p>	
<p>HISTORY:</p>	<p>Built 1930, extension 1935</p>	
<p>REFERENCES:</p>	<p>Leong (48) JTCW Aerial photo 1931</p>	
<p>SIGNIFICANCE:</p>	<p>Low</p>	
<p>GUIDELINES:</p>	<p>Retain and conserve according to Burra Charter principles. Adaptive reuse should be sympathetic to the building. Undertake repairs to timber section and repaint. Repair broken windows and ensure building is vermin and weather proof. Repoint brickwork.</p>

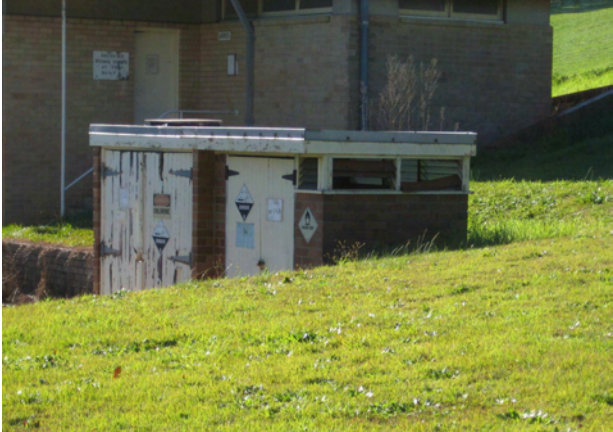
ZONE 5 – CENTRAL SLOPE	
ITEM No. B515A ORIGINAL NAME: CURRENT USE: Pool pump house	CONSTRUCTION DATE: ARCHITECT / BUILDER Unknown HERITAGE LISTINGS: <input type="checkbox"/> National Estate <input type="checkbox"/> S170 List <input type="checkbox"/> National Trust <input type="checkbox"/> Leichhardt LEP <input type="checkbox"/> State Heritage Register
BUILDING: LOCATION:	B515A SWIMMING POOL PUMP HOUSE GRID: F7 ZONE: 5
DESCRIPTION: Small brick building with flat roof covered by steel decking. Pairs of timber doors on one side, high openings beneath roof with louvres.

CONDITION:	Fair.
HISTORY:	Probably built at the same time as the swimming pool.
REFERENCES:	
SIGNIFICANCE:	None, intrusive in style.
GUIDELINES:	Retain, recycle or preferably remove. If removed record prior to demolition.

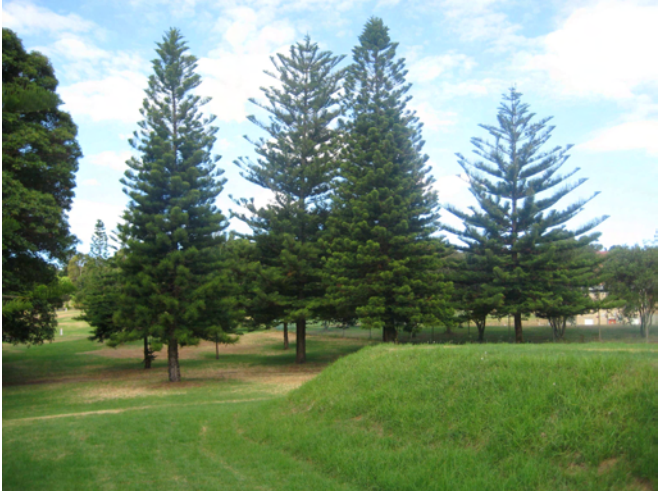
ZONE 5 – CENTRAL SLOPE		
ITEM No. ORIGINAL NAME: CURRENT USE:	CONSTRUCTION DATE: Possibly planted 1920s ARCHITECT / BUILDER: Unknown	HERITAGE LISTINGS: <input type="checkbox"/> National Estate <input type="checkbox"/> S170 List <input type="checkbox"/> National Trust <input type="checkbox"/> Leichhardt LEP <input type="checkbox"/> State Heritage Register
ITEM: LOCATION:	7L CYPRESS ROW GRID: F4-F5 ZONE: 1	
DESCRIPTION: Row of <i>Cypressus sempervirens</i> edging bowling green.

CONDITION:	Good	
HISTORY:	Planted probably in 1920s in association with bowling green construction.	
REFERENCES:	1991 DPWS Heritage Study. 1930 aerial photo, Site plan 1931-51	
SIGNIFICANCE:	No identified heritage significance	
GUIDELINES:

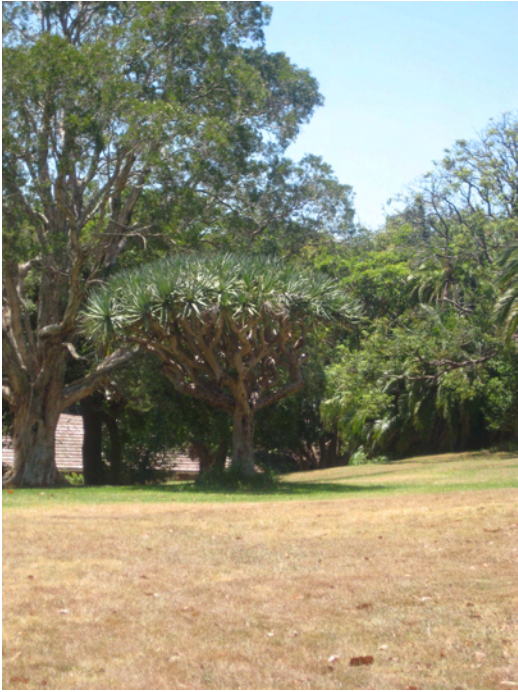
ITEM: LOCATION:	ORIGINAL TREES GRID: G6 ZONE: 5
DESCRIPTION: Individual trees in grass including Dragon’s Blood and large Fig tree. Remains of early path to gardener’s cottage (B205) evident near Dragon’s Blood Tree.

CONDITION:	Good
HISTORY:	Evident on 1930 aerial photo. Species representative of 1880s to 1890s plantings.
REFERENCES:	1991 DPWS Heritage Study: Aerial photo 1930, Site inspection
SIGNIFICANCE:	Significant as planting of original asylum period. Evidence of early pathway significant to original design.
GUIDELINES:	Retain and conserve original trees. Document evidence of path.
ZONE 5 – CENTRAL SLOPE

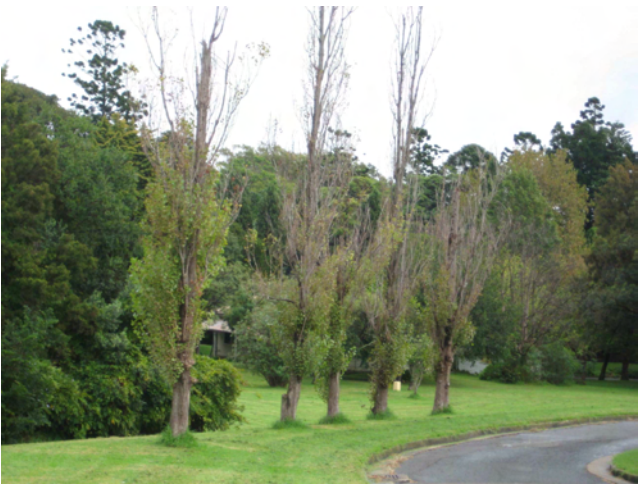
ZONE 5 – CENTRAL SLOPE	
ITEM No. 8H ORIGINAL NAME: CURRENT USE:	DATE: Circa 1960 DESIGNER / BUILDER: HERITAGE LISTINGS: <input type="checkbox"/> National Estate <input checked="" type="checkbox"/> S170 List <input type="checkbox"/> National Trust <input type="checkbox"/> Leichhardt LEP <input type="checkbox"/> State Heritage Register
ITEM: LOCATION:	POPLAR ROWS GRID: F9 ZONE: 5
DESCRIPTION: Row of Lombardy Poplar.

CONDITION:	Fair to poor
HISTORY:	Planted about 1960.
REFERENCES:	1991 DPWS Heritage Study: Powell
SIGNIFICANCE:	Intrudes on significant fabric and on original asylum design concept.
GUIDELINES:	Remove as practicable.

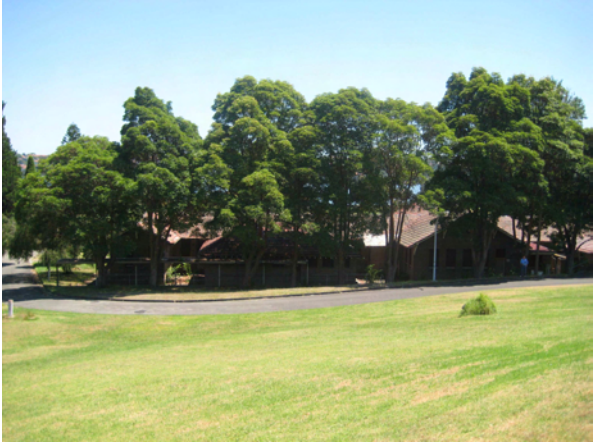
ITEM: LOCATION:	BRUSH BOX ROWS GRID: G5 ZONE: 5
DESCRIPTION: Row of Brush Box along section of Military Drive.

CONDITION:	Good.
HISTORY:	Originally planted in late 1930s or 1940s behind Building B497 and extending to end of the canal section of row removed for road construction.
REFERENCES:	1991 DPWS Heritage Study; Interpretation of site plans 1931-51 and 1965.
SIGNIFICANCE:	No evidence of heritage significance.
GUIDELINES:	Over time break down lineal formation and incorporate into future informal tree plantings as appropriate. Remove section of brush box row adjoining significant tree group at end of canal.

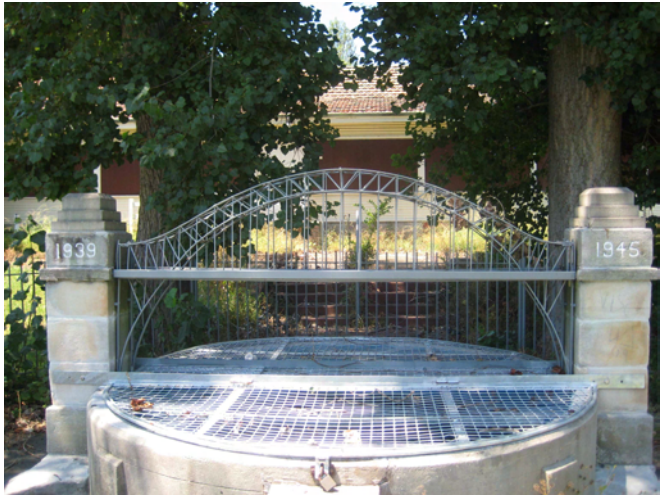
ZONE 5 – CENTRAL SLOPE		
<p>ITEM No. 70</p> <p>ORIGINAL NAME: War memorial</p> <p>CURRENT USE: War memorial</p>	<p>CONSTRUCTION DATE: unveiled 4 August 1931</p> <p>DESIGNER / BUILDER: Design attributed to Douglas Grant; construction attributed to World War I veteran patients.</p>	<p>HERITAGE LISTINGS:</p> <p><input type="checkbox"/> National Estate</p> <p><input checked="" type="checkbox"/> S170 List</p> <p><input type="checkbox"/> National Trust</p> <p><input type="checkbox"/> Leichhardt LEP</p> <p><input type="checkbox"/> State Heritage Register</p>
<p>ITEM:</p> <p>LOCATION:</p>	<p>WAR MEMORIAL</p> <p>GRID: G5 ZONE: 5</p>	
<p>DESCRIPTION:</p> <p>Scale model of Sydney Harbour Bridge with stone pylons, beneath which is a circular concrete basin. Years 1914 and 1918 inscribed on south side (facing former B ward, B497) and years 1939 and 1945 inscribed on north side. Bronze plaques on south sides of pylons commemorate unveiling by Governor Game and erection of memorial by patients of B Ward. Memorial is aligned with steps leading up to the western section of B497. The basin has been enclosed by a metal security grille.</p>

<p>CONDITION:</p>	<p>Good. Security grille over basin detracts from the memorial.</p>	
<p>HISTORY:</p>	<p>Erected by returned servicemen housed in Convalescent Ward B (B497), but has also been attributed to Aboriginal ex-serviceman Douglas Grant. It was unveiled by the Governor of NSW, Sir Phillip Game, on 4 August 1931. "1939" and "1945" inscriptions on north side are later modifications.</p>	
<p>REFERENCES:</p>	<p>1991 DPWS Heritage Study; "Military Cottages", <i>Sydney Morning Herald</i> 4 August 1931, p.6; C D Coulthard-Clark, "Grant, Douglas (1885?-1951)" in <i>Australian Dictionary of Biography</i>, Volume 9.</p>	
<p>SIGNIFICANCE:</p>	<p>Significant as war memorial associated with significant Aboriginal ex-serviceman Douglas Grant and erected by patients. An unusual 'folly' landscape element that reinforces the associations between building B 497 and the repatriation phase of Callan Park.</p>

<p>GUIDELINES:</p>	<p>Retain and conserve in existing location. Investigate less intrusive methods of making the basin secure. Integrate with B497 through careful landscaping.</p>

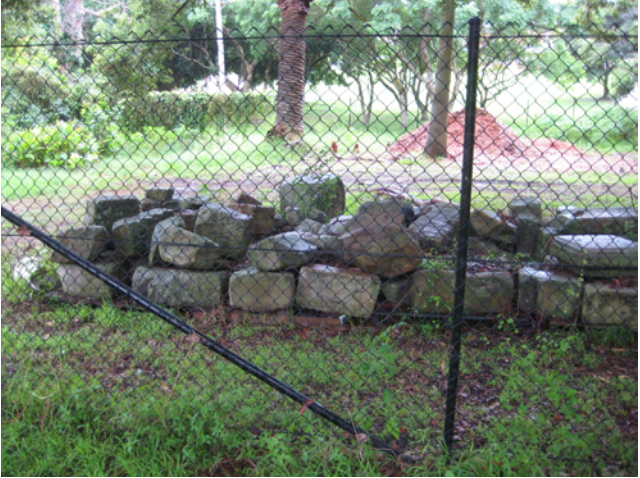
ITEM: LOCATION:	11D GATE POST CAPITAL GRID: E6 ZONE: 5	
DESCRIPTION: One carved stone and many uncarved sandstone blocks in various conditions. Blocks are located in a secure compound to the south of B506

CONDITION:	Intact stones, apparently in good condition.	
HISTORY:	Constructed as part of Kirkbride Block. Demolished when gateway widened in internal court. In 2002 located in vicinity of B196 (Grid D7, Zone 7).	
REFERENCES:	Historic Buildings Group Report on Kirkbride Block (Item B2.01)	
SIGNIFICANCE:	Significant as original fabric from the Kirkbride Block.	
GUIDELINES:	Retain all stone and relocate to Kirkbride Block for eventual reconstruction of gateway.
