HCA 8 Cardigan Street Heritage Conservation Area

Figure 8.1 HCA 8 Cardigan Street Heritage Conservation Area

8.1 LOCATION

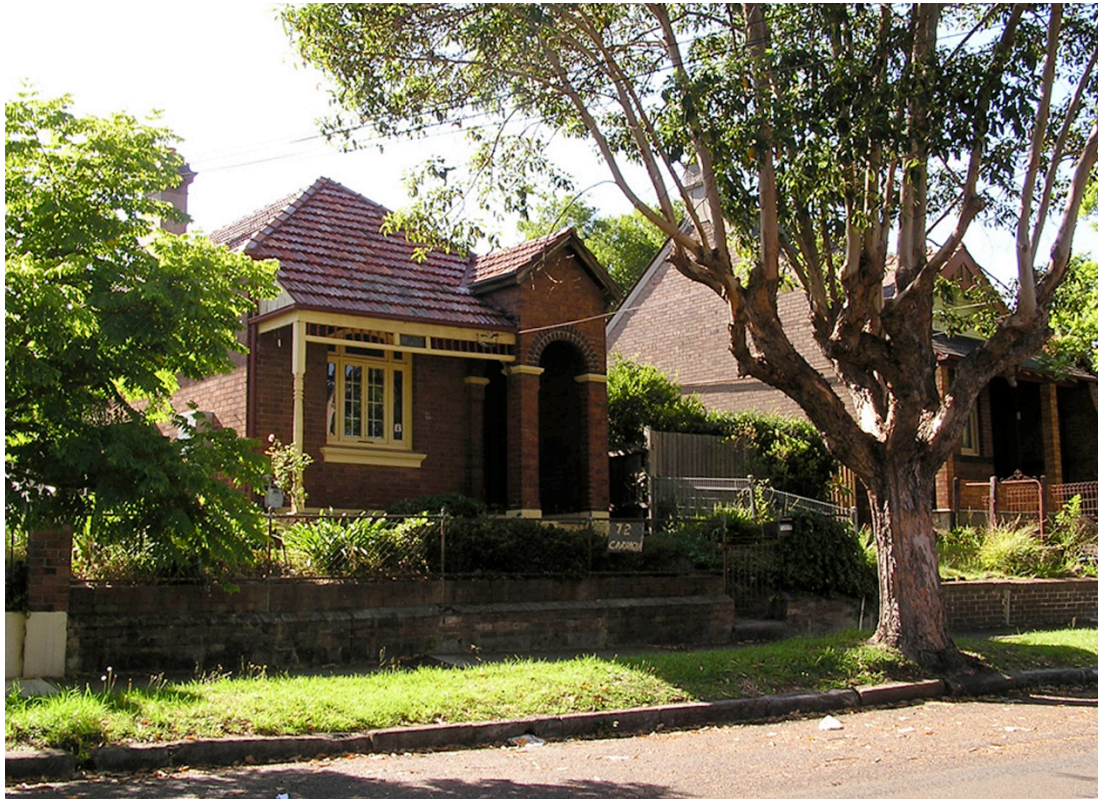
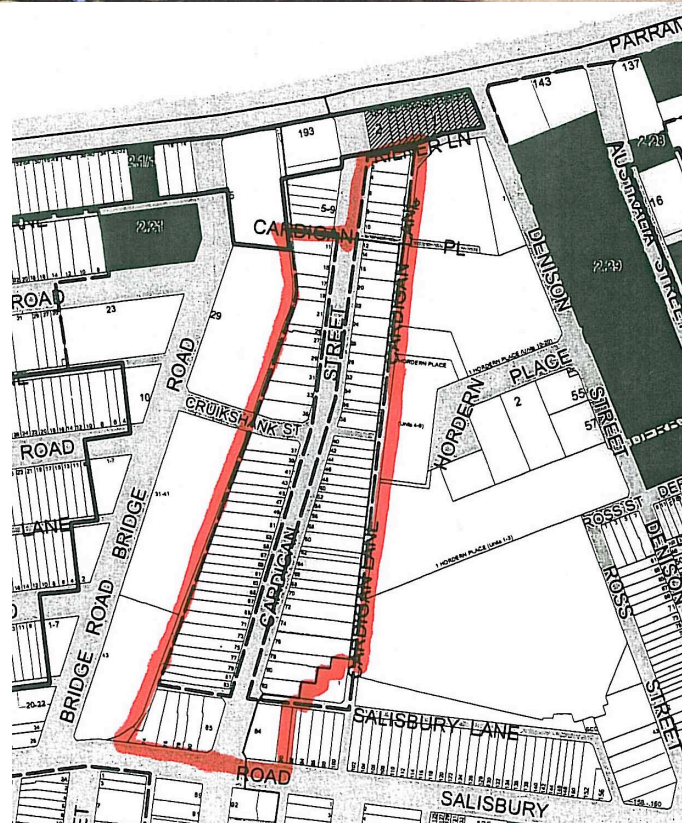
The Cardigan Street Heritage Conservation Area is located in Stanmore at the northern end of Cardigan Street between Salisbury and Parramatta Roads.

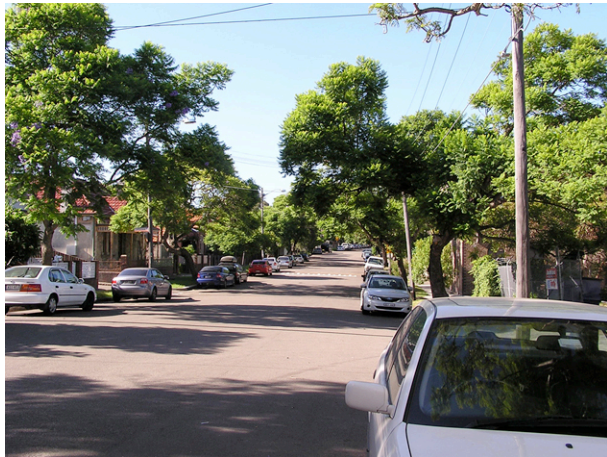
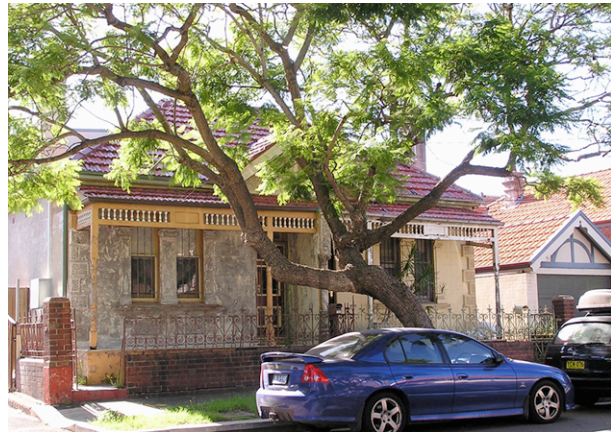
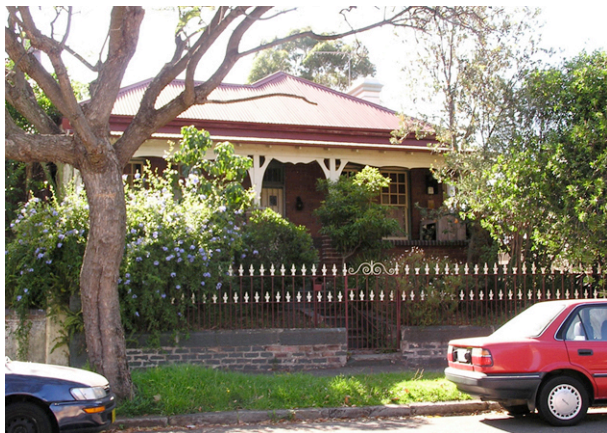
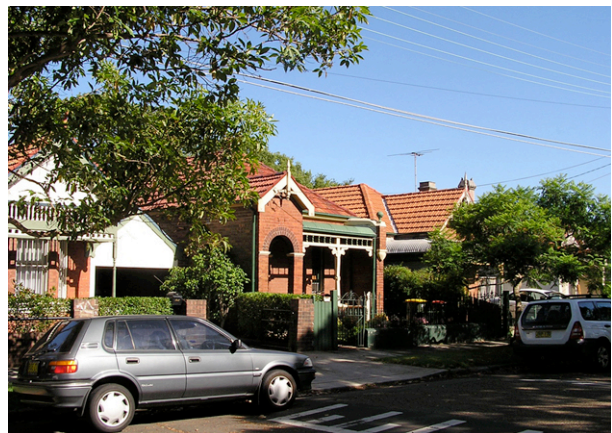
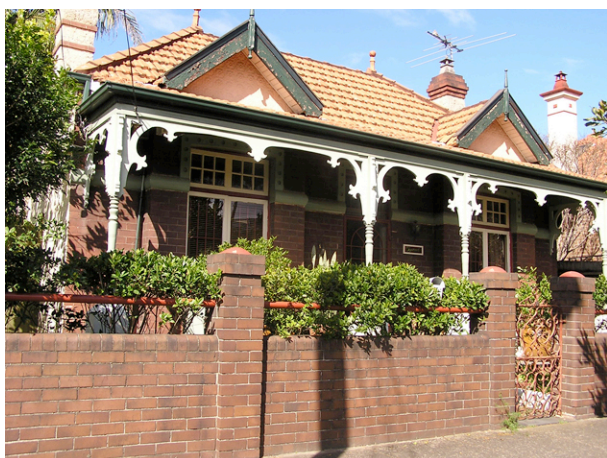
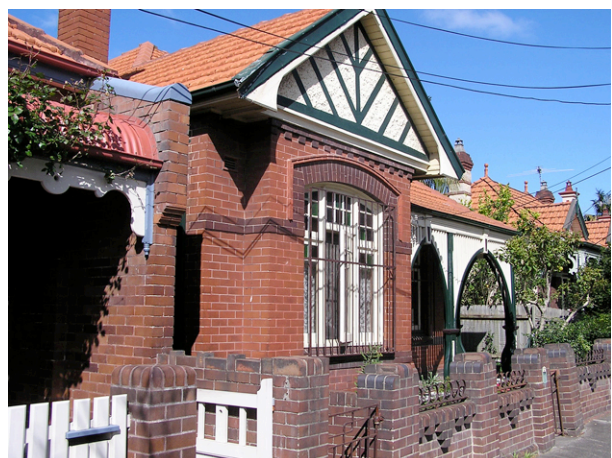
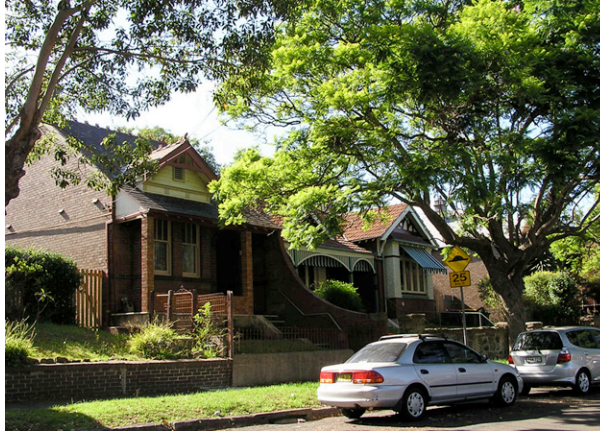
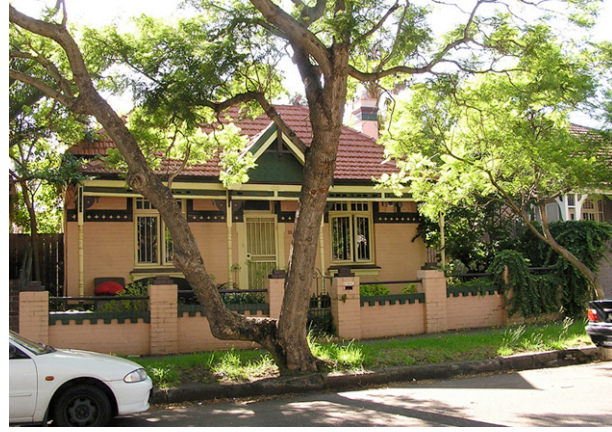
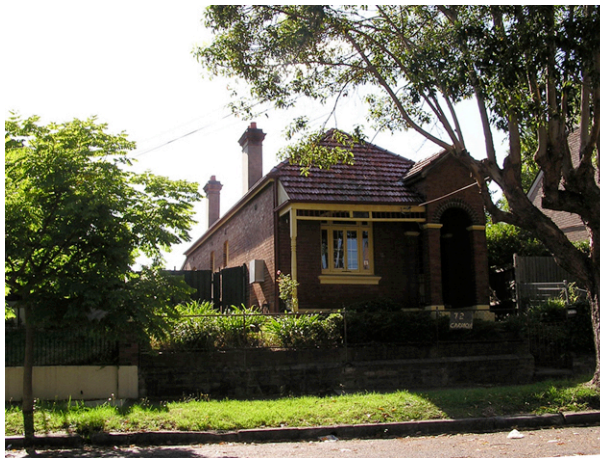
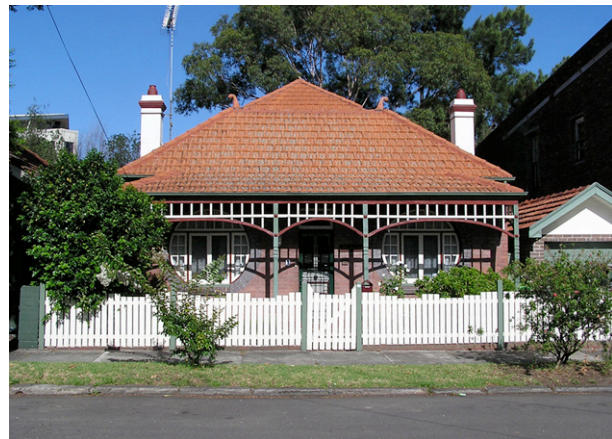
The following figures illustrate the main elements and characteristics of the Cardigan Street Heritage Conservation Area. All are taken from Cardigan Street unless stated otherwise.

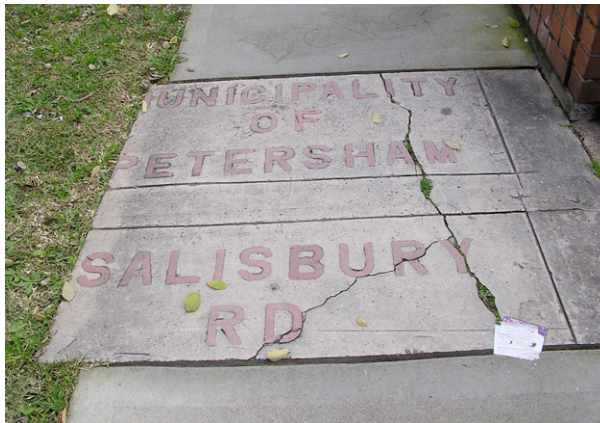
The inlaid footpath includes 'Municipality of Petersham' at the boundary to the former local government area at Salisbury Road. The lettering has been truncated at some stage in the past.

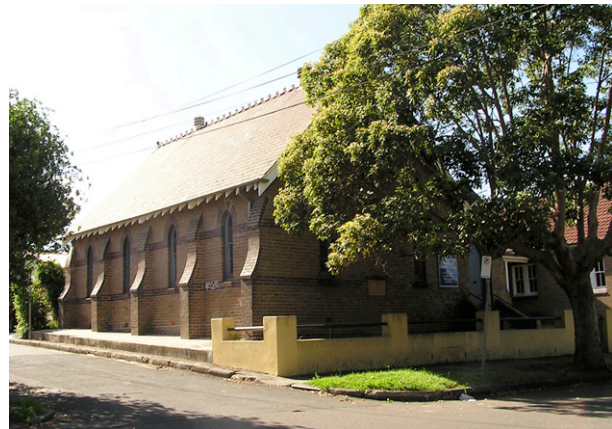
The Church at the corner of Cardigan and Bridge Streets forms a prominent termination to the streetscape and is enhanced by the prominent palm trees.
