HCA 11 North Kingston Estate Heritage Conservation Area (Newtown/Camperdown)

Figure 11.1 HCA 11 North Kingston Estate – Camperdown-Newtown - Heritage Conservation Area

11.1 LOCATION

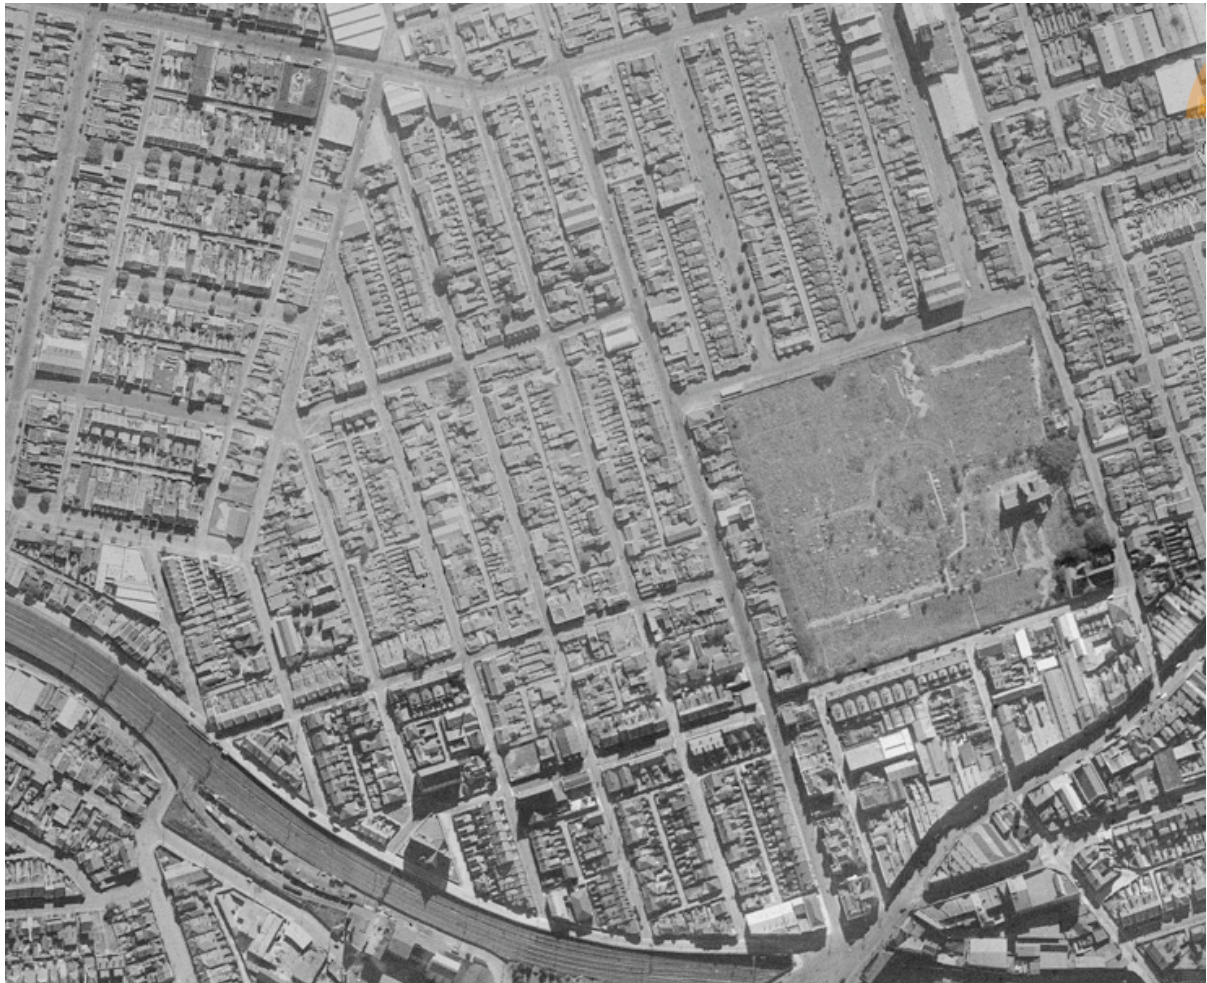
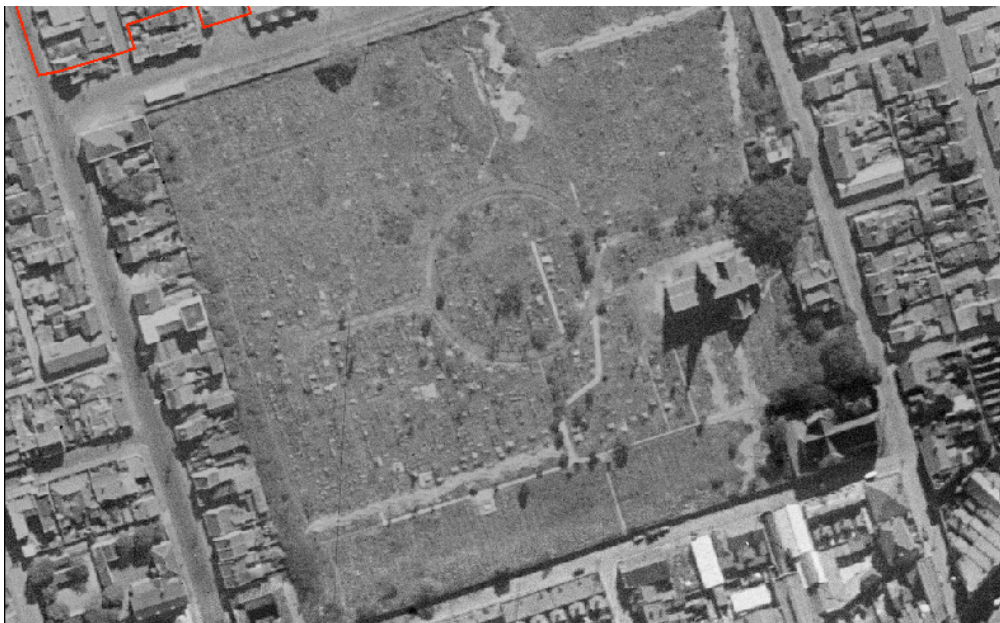
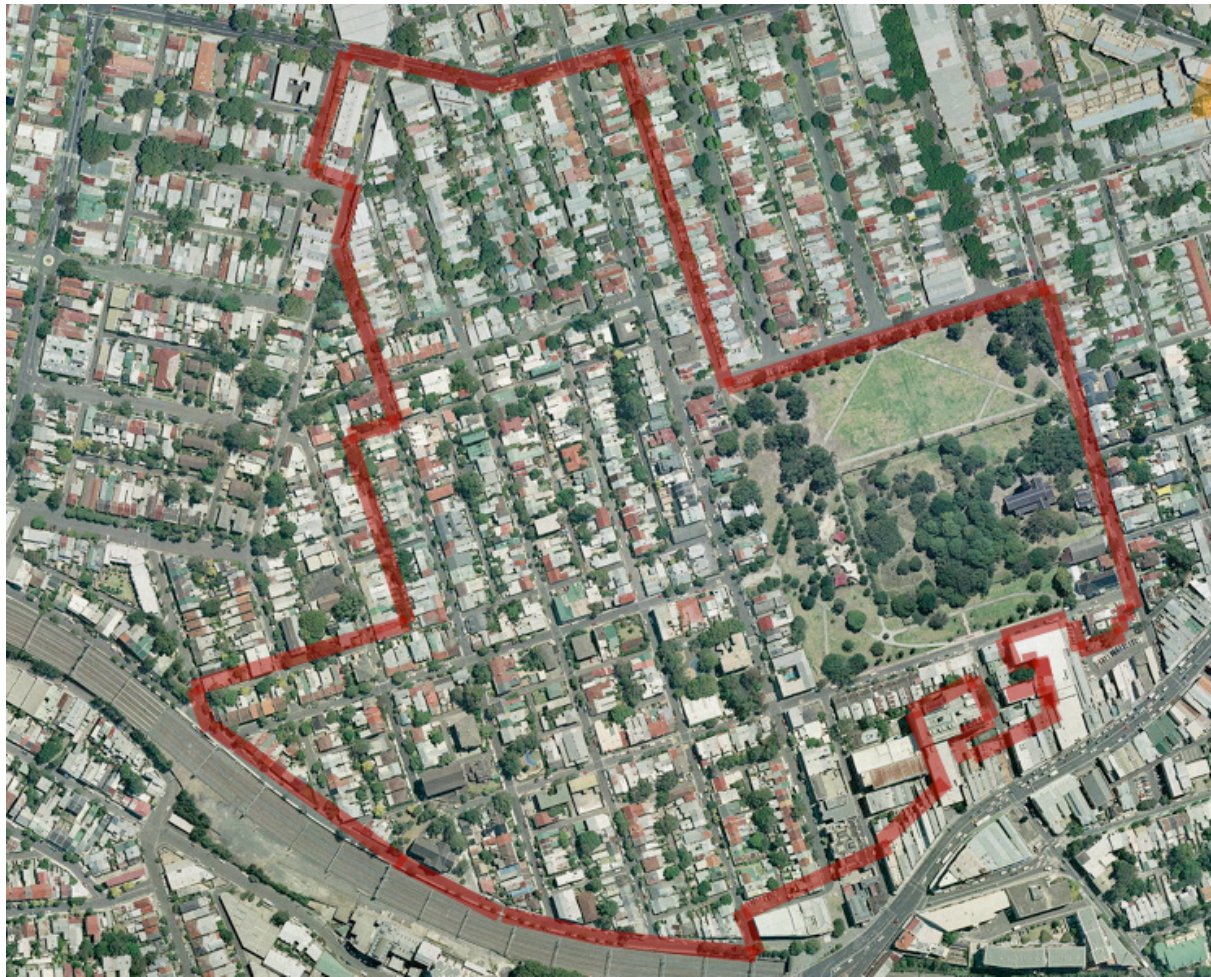
Figure 11.2 The Area in 1943 and 2009, including a detail showing the former extent and the formal path layout of the Camperdown Cemetery (source: NSW Lands Department SIX Viewer).

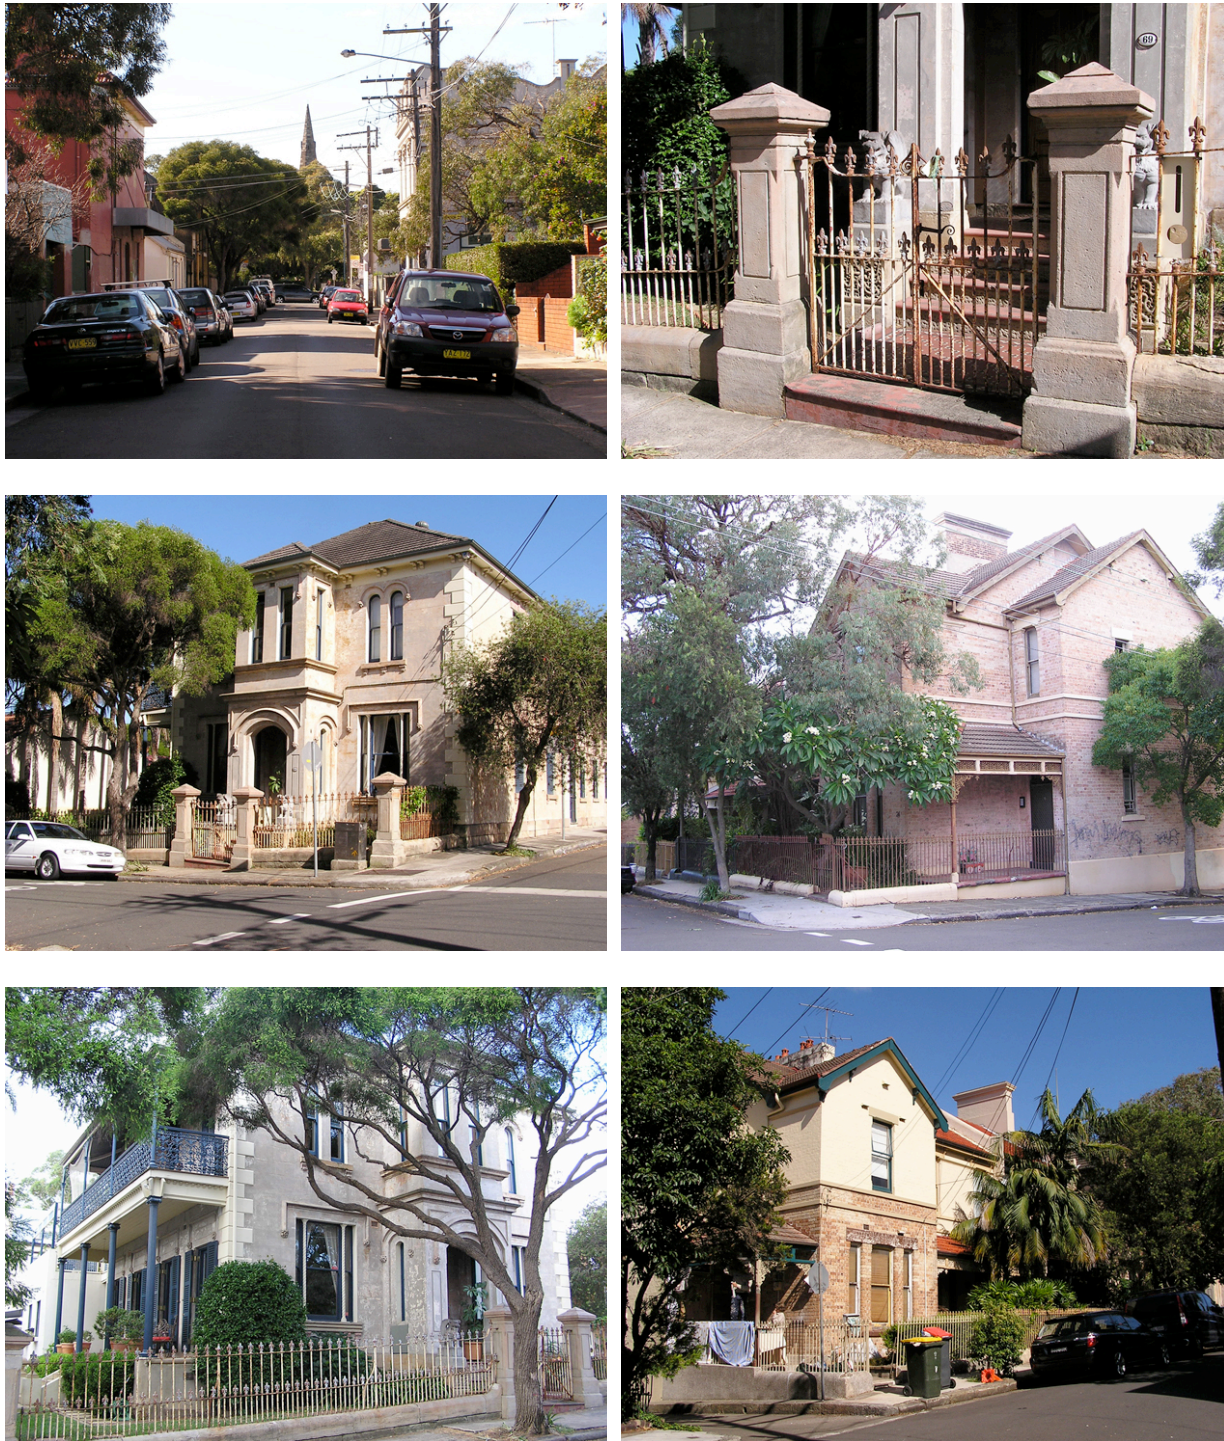
Figure 11.5 -11.12 The axial vista from Albemarle Street towards St Stephen's Church spire emphasises the role of the street as the location of several important early Victorian houses. The current spire was built after the street was formed but remains an important streetscape element.

The topography is undulating. Albermarle Street generally follows the main ridge line in the area with Australia Street describing the secondary ridge at right angles, with the other streets falling away to the low points at the outside edges of the conservation area. Opportunities for extensive or district views are limited, although some can be gained from the southern edges of the precinct. Street views are generally strongly directional and guided by the street wall of the adjacent housing. A notable

exception to this is available along the axial vista along Albemarle Street towards the spire of St Stephen's Anglican Church, which is a rare element within the Marrickville area.

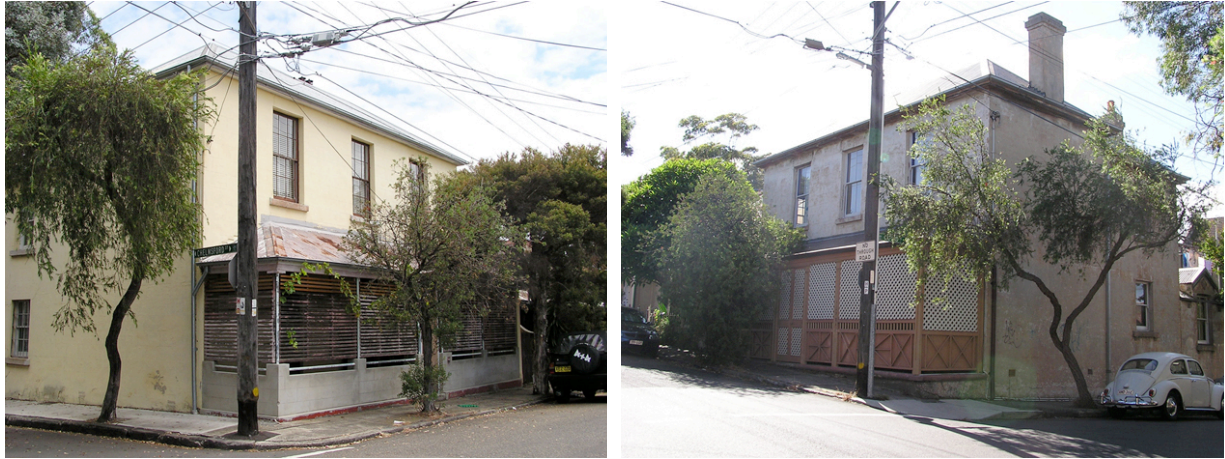
Figure 11.11 and 11.12.. These early Victorian Georgian townhouses form a bookend pair to Albermarle Street between Chelmsford and Oxford Streets.

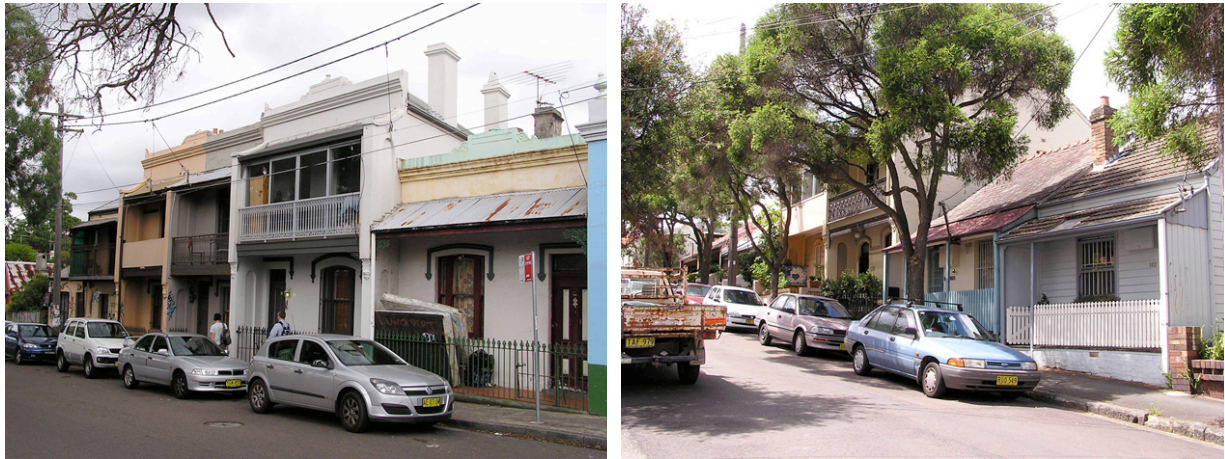
Figure 11.13 Although several substantial houses are located along the ridgeline followed by Albermarle Street most of the area is characterised by very modest workers cottages and terraces such as these groups in Bedford and Chelmsford Streets.

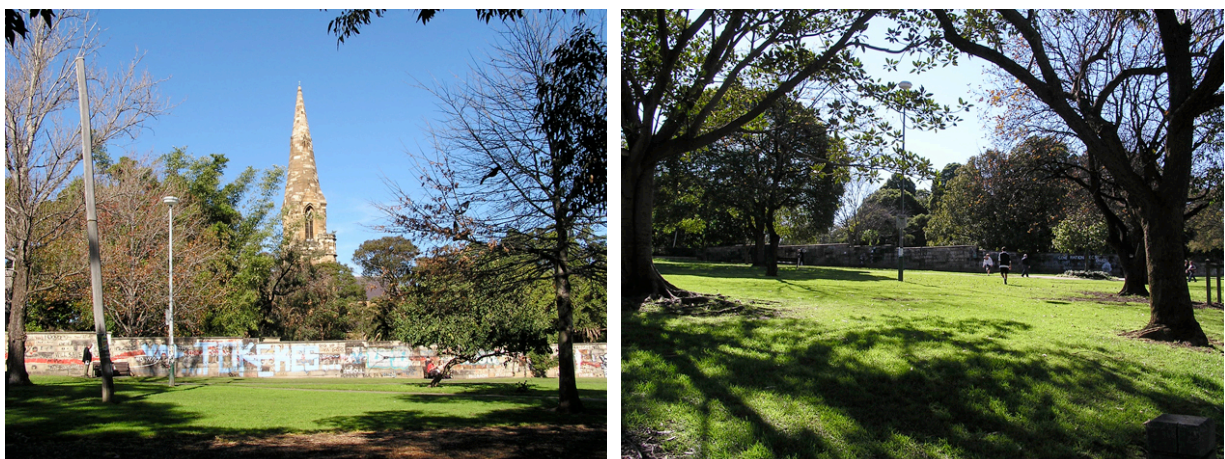
Figure 11.14 and 11.15. The cemetery was reduced in size in the 1930s and the Camperdown Memorial Rest Park established over the remainder of the site. This area now provides an important open space and recreational area for the residents of Newtown and Camperdown.

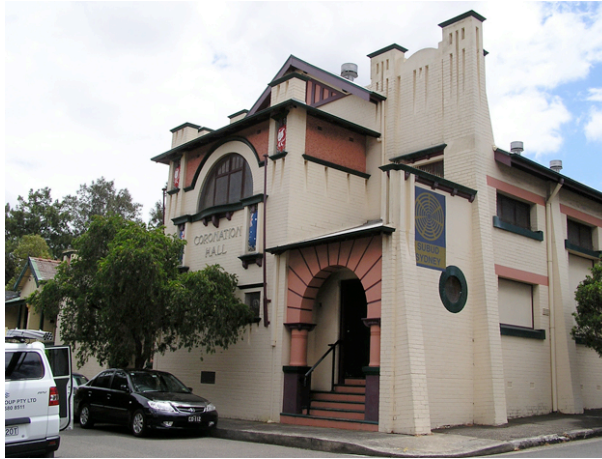
Figure 11.16. The Coronation Hall is a fine Arts and Crafts influenced building located unexpectedly surrounded by what are now minor streets. It is still used for community purposes.

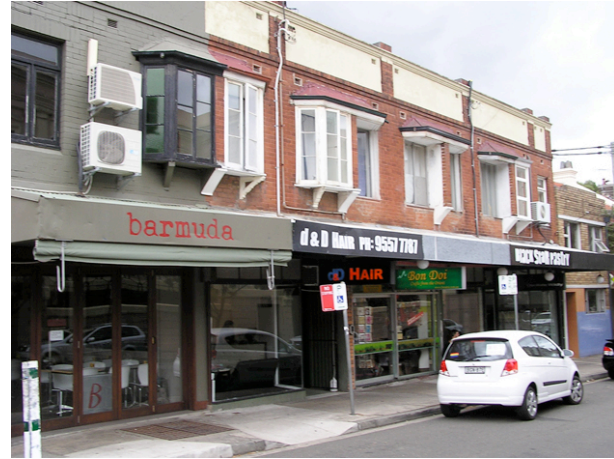
Figure 11.17. The primary thoroughfare in the Area is Australia Street. The southern end includes several groups of shops which act as an extension to the King Street commercial precinct such as this group with an unusually detailed upper level which includes boxed windows and recessed balconies. The painting of the face brickwork dark grey and attachment of air conditioning units to the main façade is an unfortunate alteration.

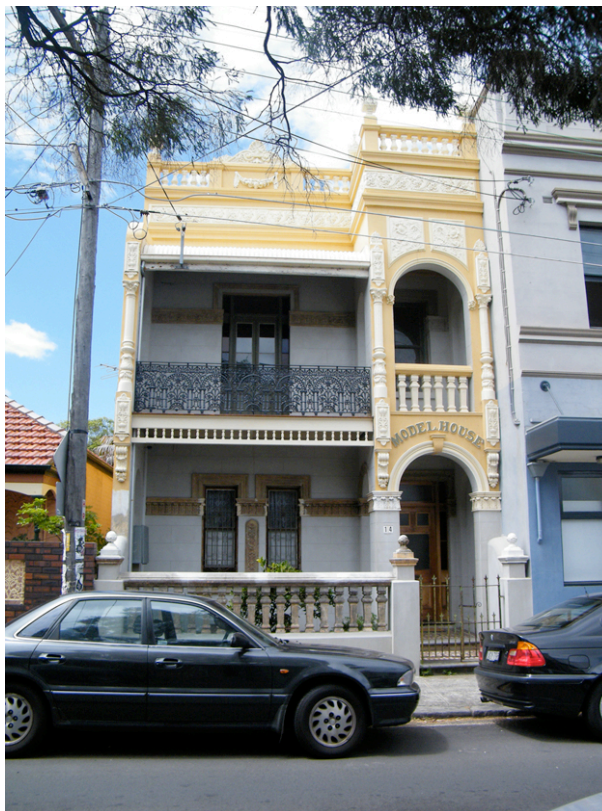
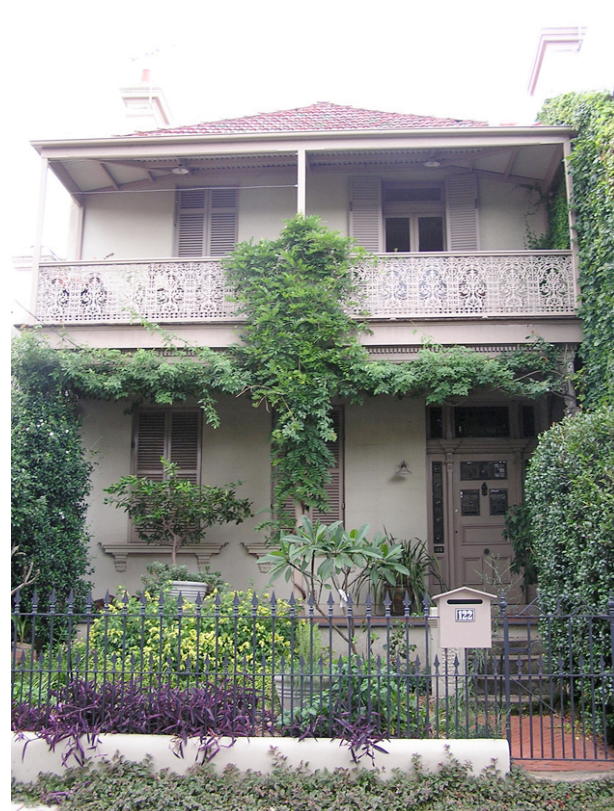
Figure 11.18 and 11.19. Setbacks from the street alignment are generally minimal even for substantial houses although the property on the right (Denison Street) is set back sufficiently to allow a small but well-planted front garden.

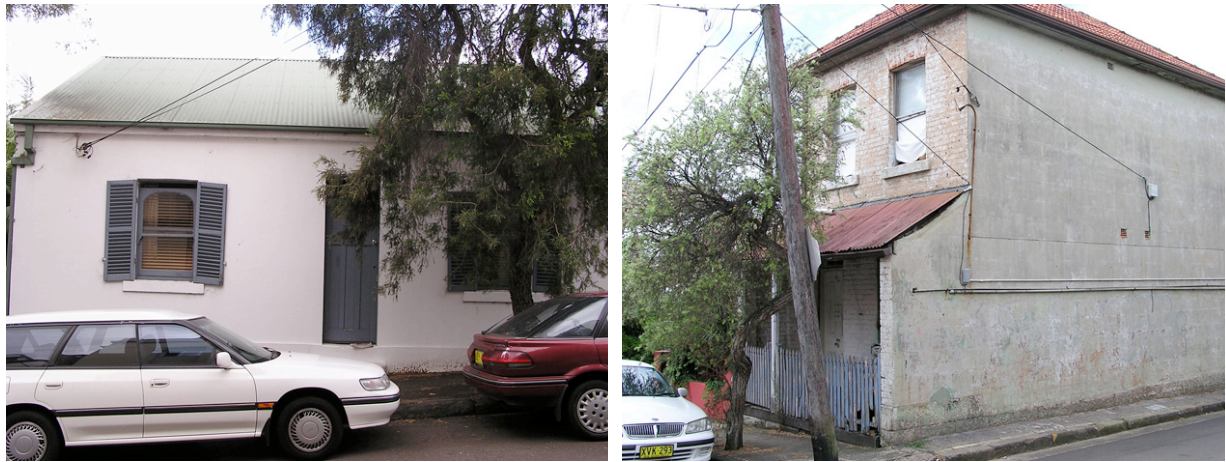
Figures 11.20 and 11.21. The area includes increasingly rare modest and substantially intact cottages which provide evidence of the housing choices available to the working classes in the mid to late 19th century..

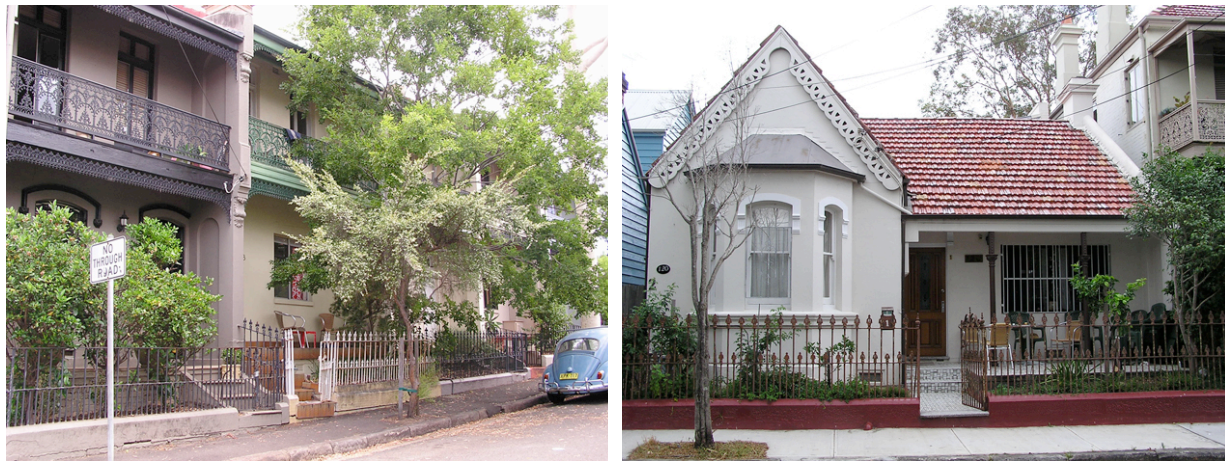
Figures 11.22 and 11.23. Examples of later development within the area.

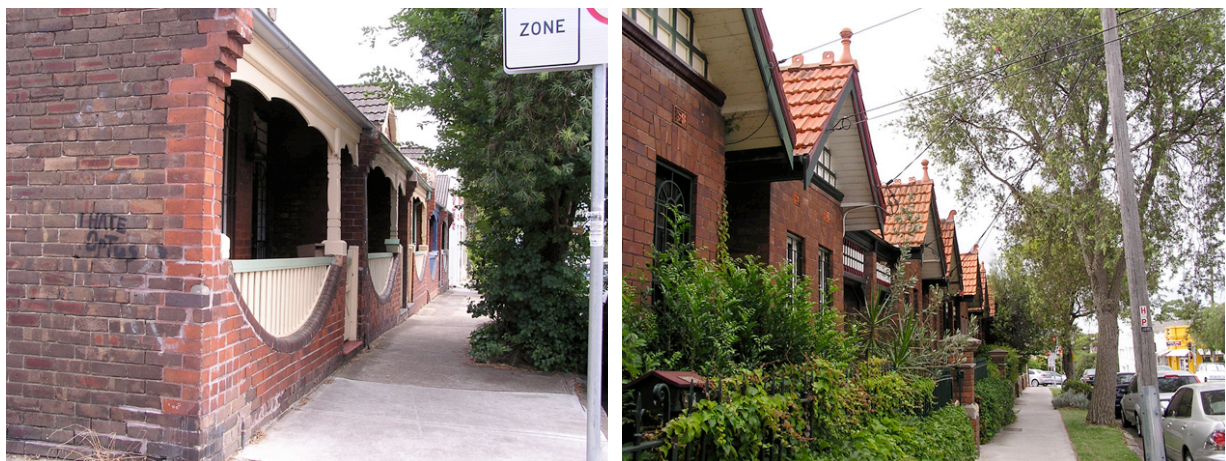
Figures 11.24 and 11.25. The area includes several very good rows of highly intact terraces that are highly contributory to the streetscape qualities of the area such as these two Federation period examples in Australia Street.

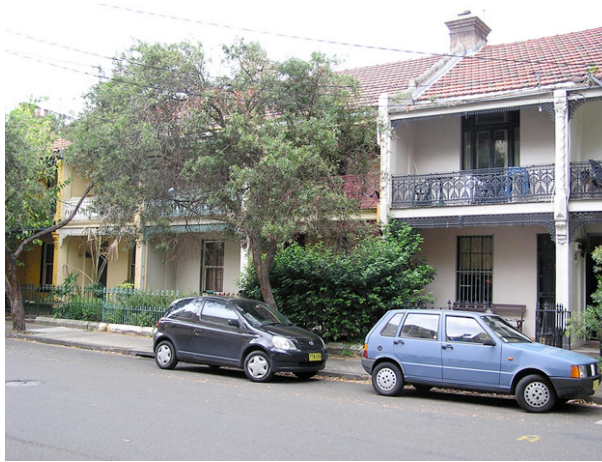
Figures 11.26 to 11.31 show some of the variations to the terrace form found in the area.

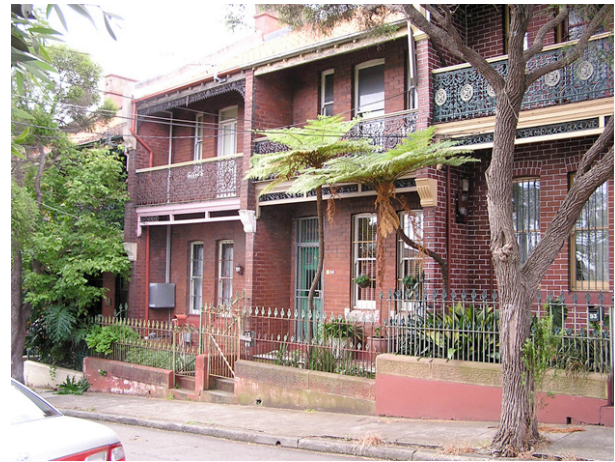
Figure 11.27. Federation face brick

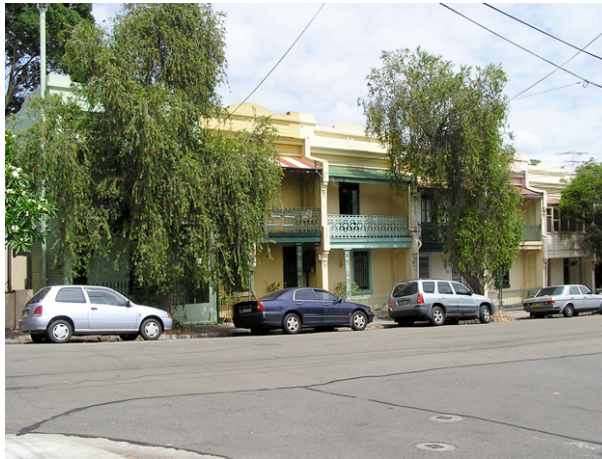
Figure 11.28 simple parapeted form

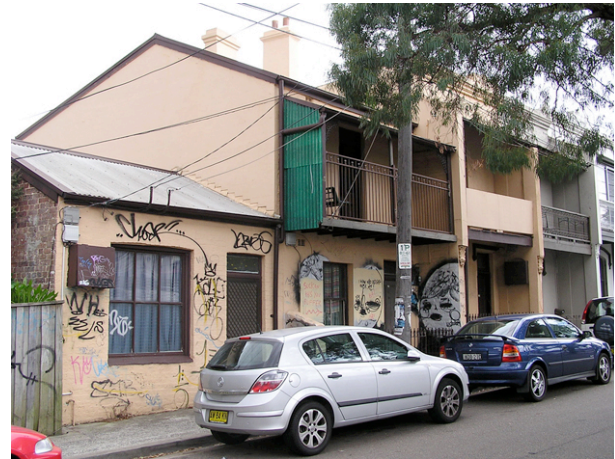
Figure 11.29 showing original shop

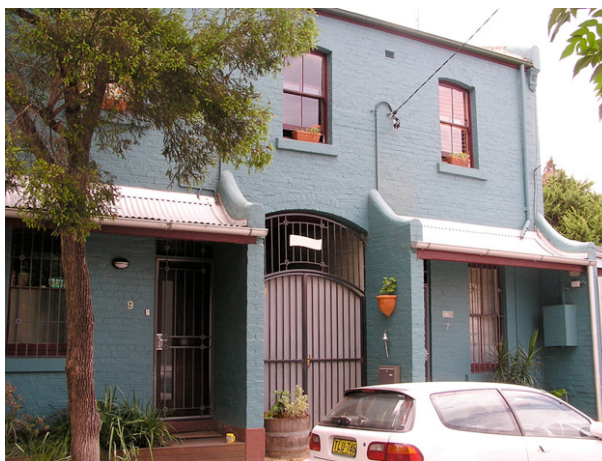
Figure 11.30 a paired terrace with carriage entry

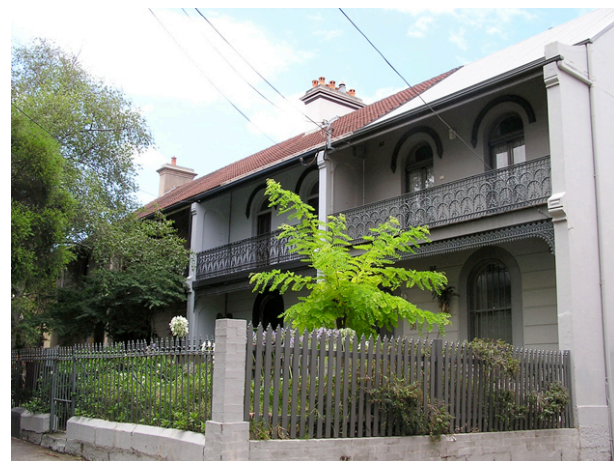
Figure 11.31 This group is set well back from the street, allowing for a comparatively substantial front garden.

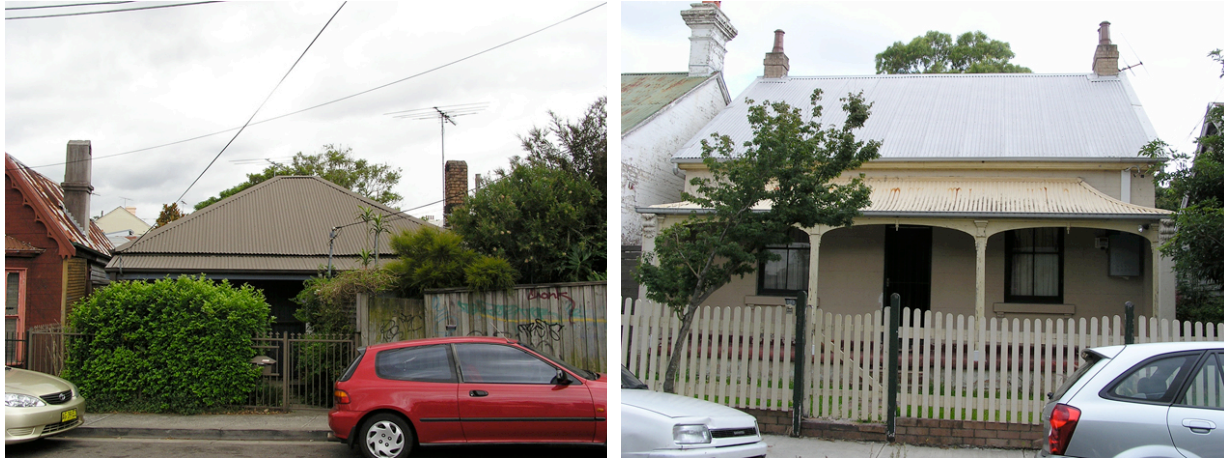
Figure 11.32 to 11.37 show a range of the modest detached cottages that characterise the area. Most are substantially intact although all have been layered in some way such as re-roofing.

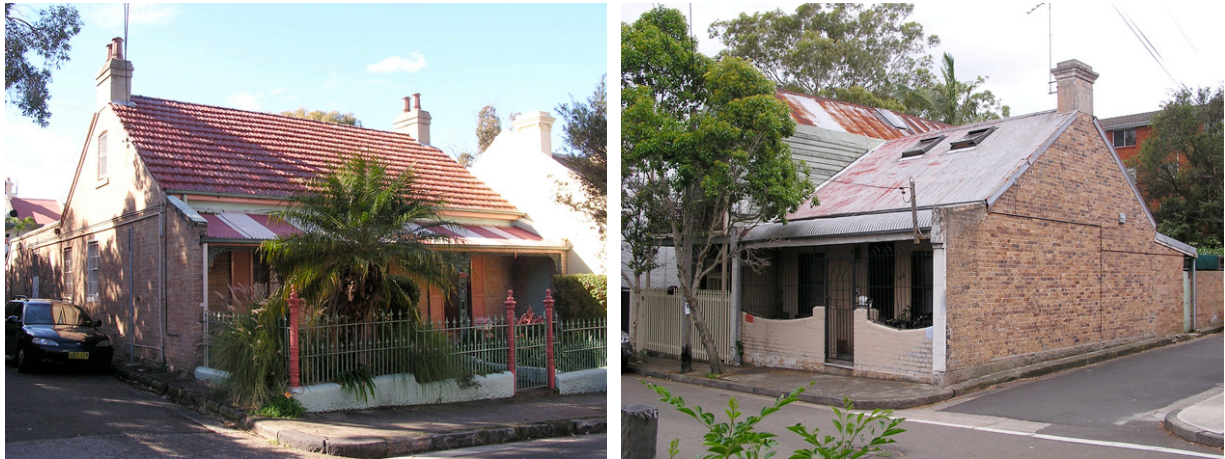
Figure 11.34. Note attic room within the roof with window to the gable end and cast iron fence posts.

Figure 11.35. Note the intact roof volume visible from the street with the rear rooms under a low skillion roof.

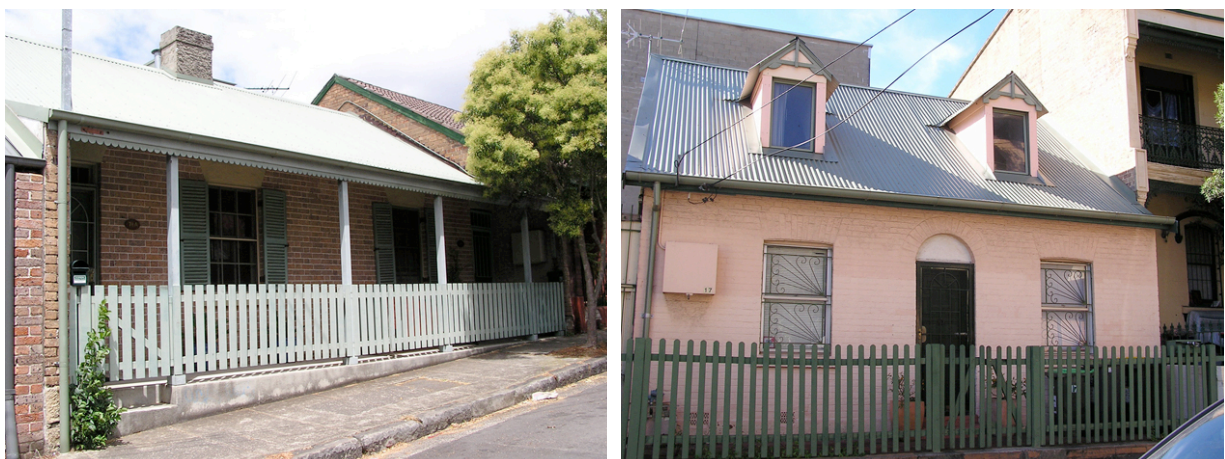
Figure 11.36. Early Victorian cottage with fenced verandah along street alignment.

Figure 11.37. A very early Victorian-Georgian cottage.

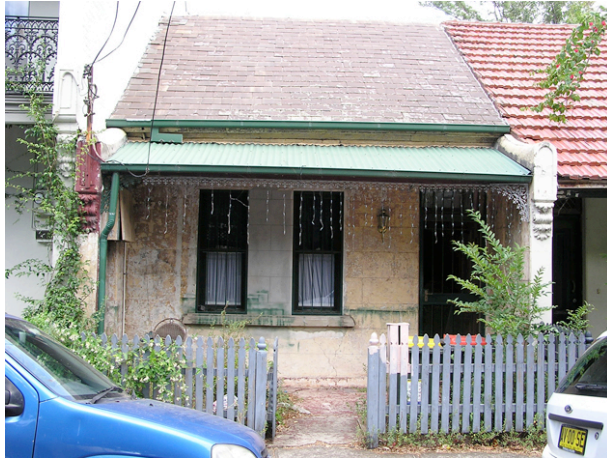
Figures 11.38 to 11.43 show a range of the single storey attached terraces that characterise the area. All are substantially intact.

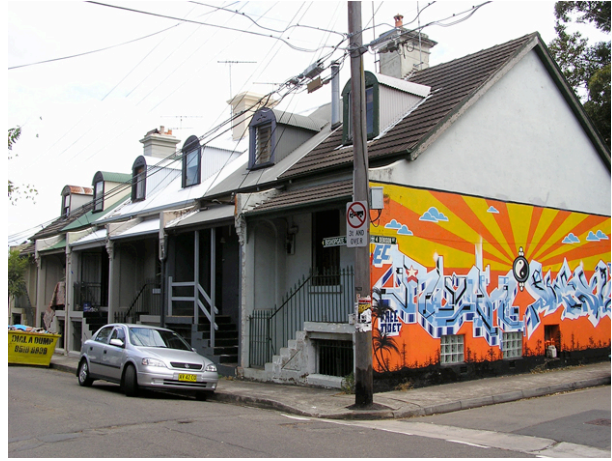
Figure 11.39. This terrace includes a rare basement level and a row of arched dormer windows that form a prominent element in the local streetscape. The side wall of the group features street art - representative of the contemporary community in the area.

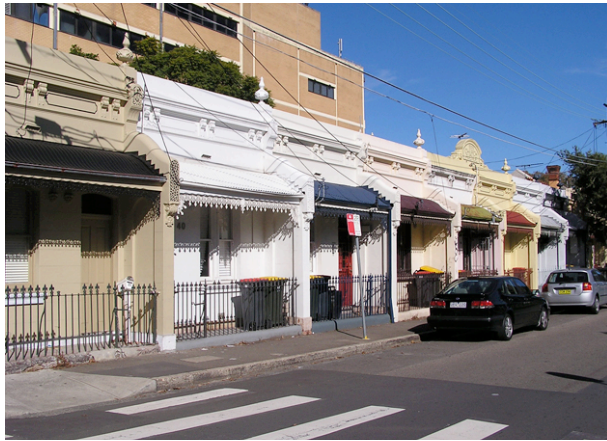
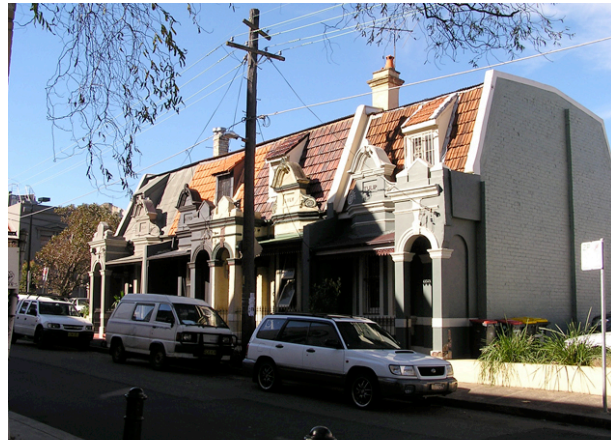
Figure 11.40, 11.41 and 11.42. The Lennox Street streetscape opposite the memorial park is characterised by three very high quality terraces, each of which is substantially intact and representative of a different architectural style. The three terraces combine to contribute significantly to the aesthetic and historic value of the area.

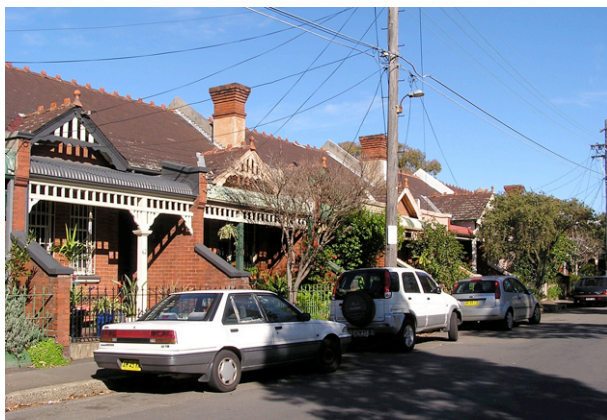
11.42. Federation terrace on the Lennox Street overlooking the park. The skyline of this group has remained intact allowing the complexities of its roofscape to be appreciated.

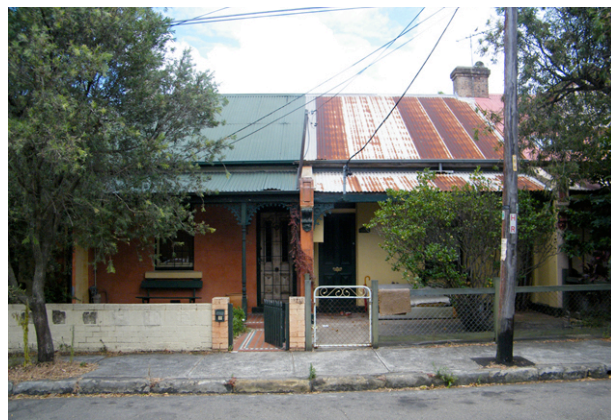
11.43. A very modest terrace on Denison Street.

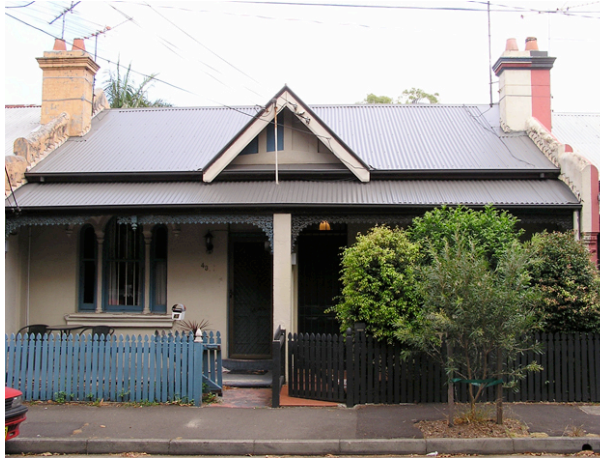
Figures 11.44 to 11.48 show a range of semi-detached cottages characteristic of those found in the area.

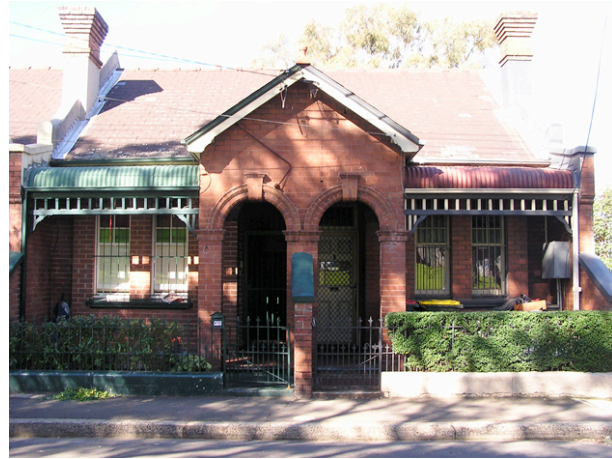
Figure 11.45. A fine Federation pair with original materials and detailing contributing to its high streetscape integrity.

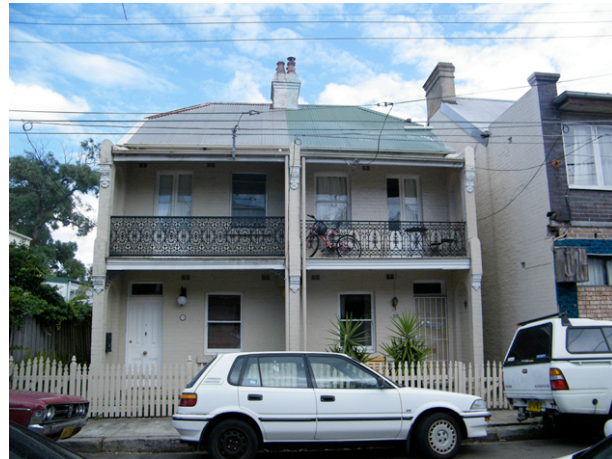
Figure 11.47. This duplex terrace demonstrates a mirror-reversal of its façade and a half-gabled roof with a shared chimney.

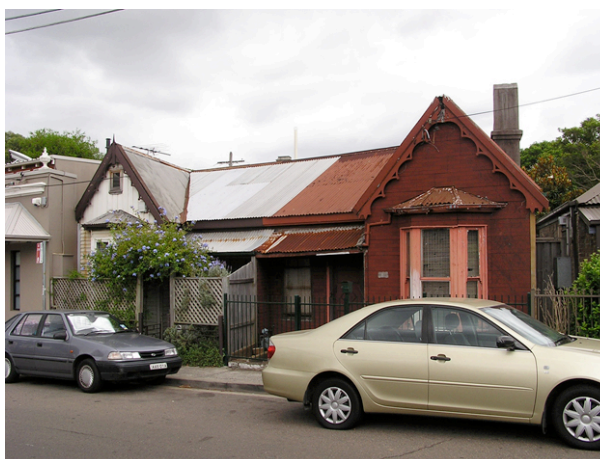
Figure 11.48. Modest Victorian Gothic.

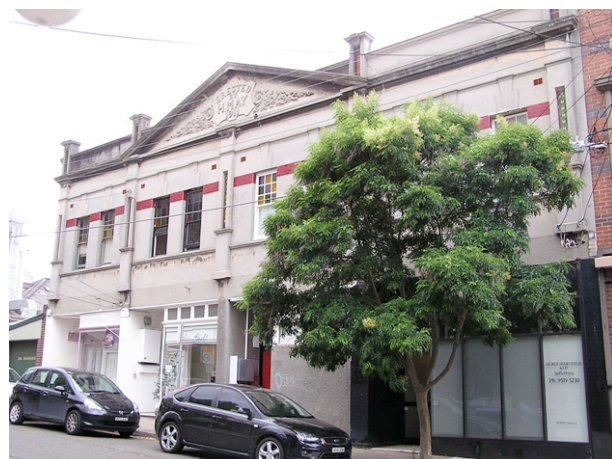
Figure 11.49. Commercial/retail premises in Australia Street

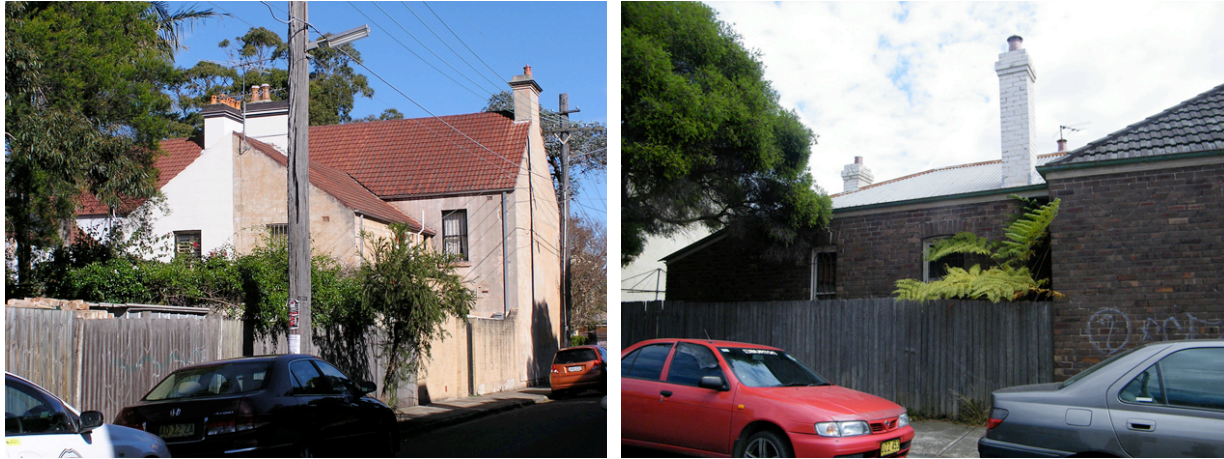
Figure 11.50 and 11.51. The tightly grained urban fabric and many laneways within the area mean that most properties are visible from several angles and the rear roofscape is as important as the main façade. The original houses are characterised by a decreasing scale and level of detailing towards the rear of the property. The rear of terraces were designed in pairs or tunnel backs, leading to a strong aesthetic quality to these rear views.

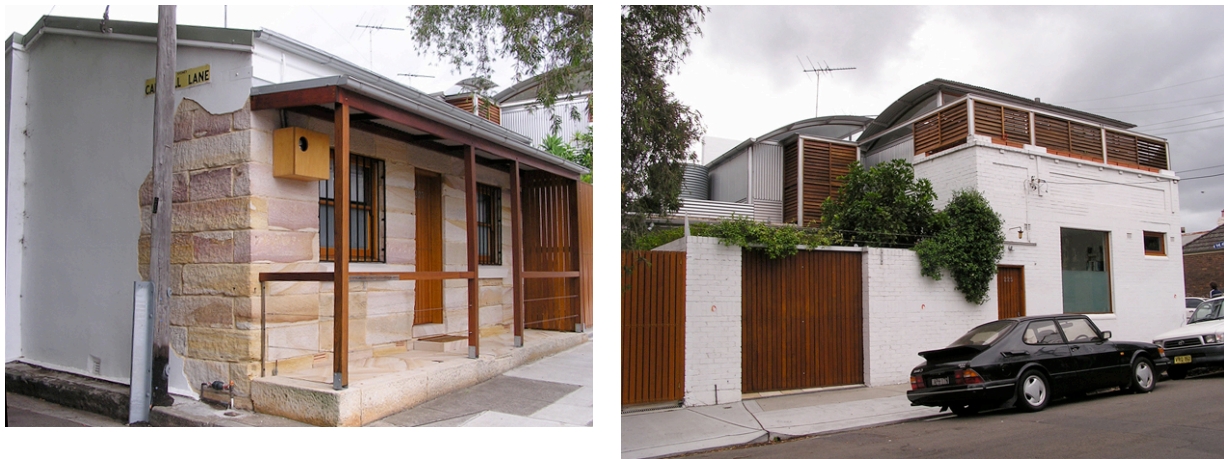
Figures 11.52 and 11.53. A contemporary alteration and addition which has included stripping the render from part of the sandstone cottage and a new structure to the street corner.

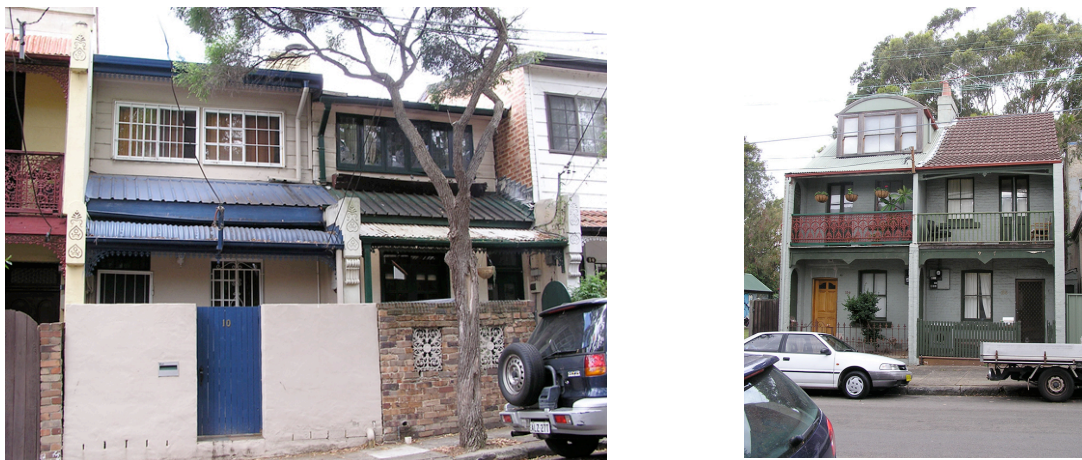
Figure 11.54. The northern end of the area contains many houses which have undergone substantial alterations and additions including the lifting of ridgelines to create a second storey.

Figure 11.55. This dormer addition overwhelms the main roof form and distracts from the quality of the pair. Most increases to the bulk of roofs are unsympathetic to the original built forms.

- Overscaled and poorly proportioned additions
- Alterations to roof forms and volumes visible from the street, including poorly sited and proportioned dormer windows and lifted ridgelines.

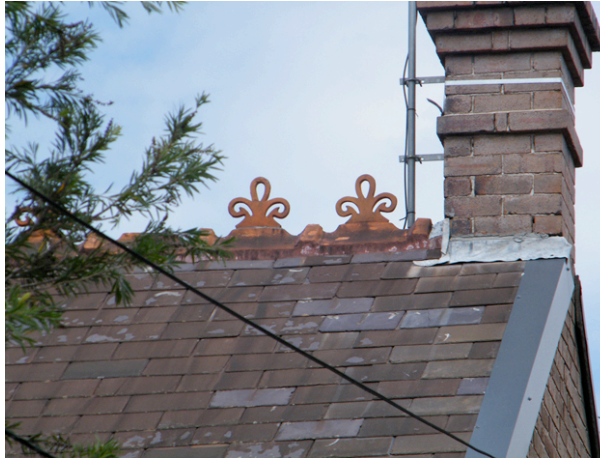
Figure 11.56. A finely detailed terracotta ridge capping to a slate roof can be overlooked in such a complex area, but adds integrity and aesthetic value to both the property and the streetscape as a whole.

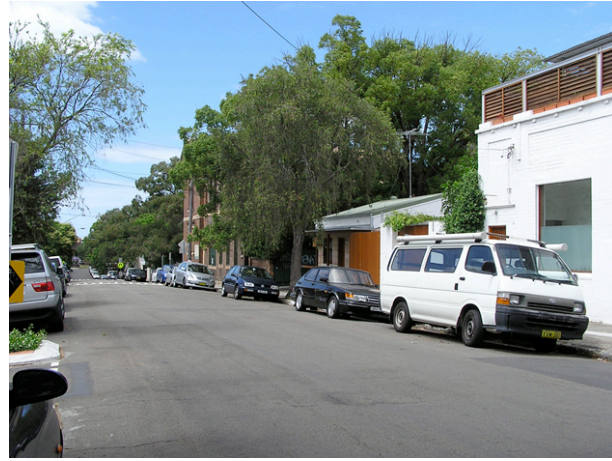
Figure 11.57. The details of the buildings within the streetscapes can be difficult to see through the 1970s native tree planting, although the planting can hide less sympathetic elements equally effectively.
