HCA 21 Rathlin Estate Heritage Conservation Area (Petersham)

21.1 LOCATION

21.2 DESCRIPTION

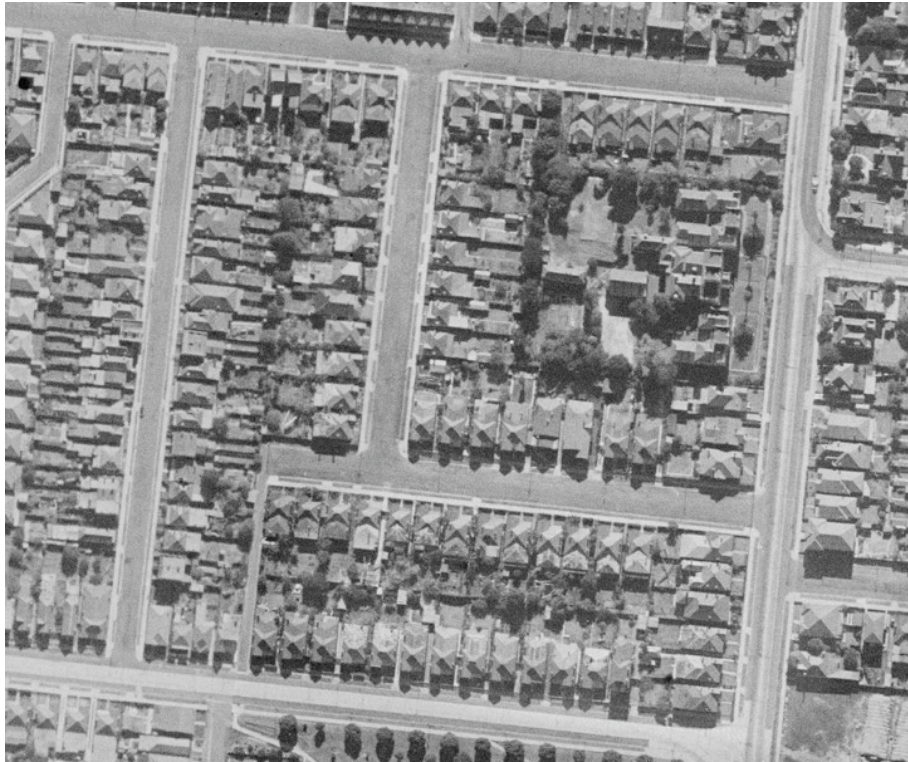
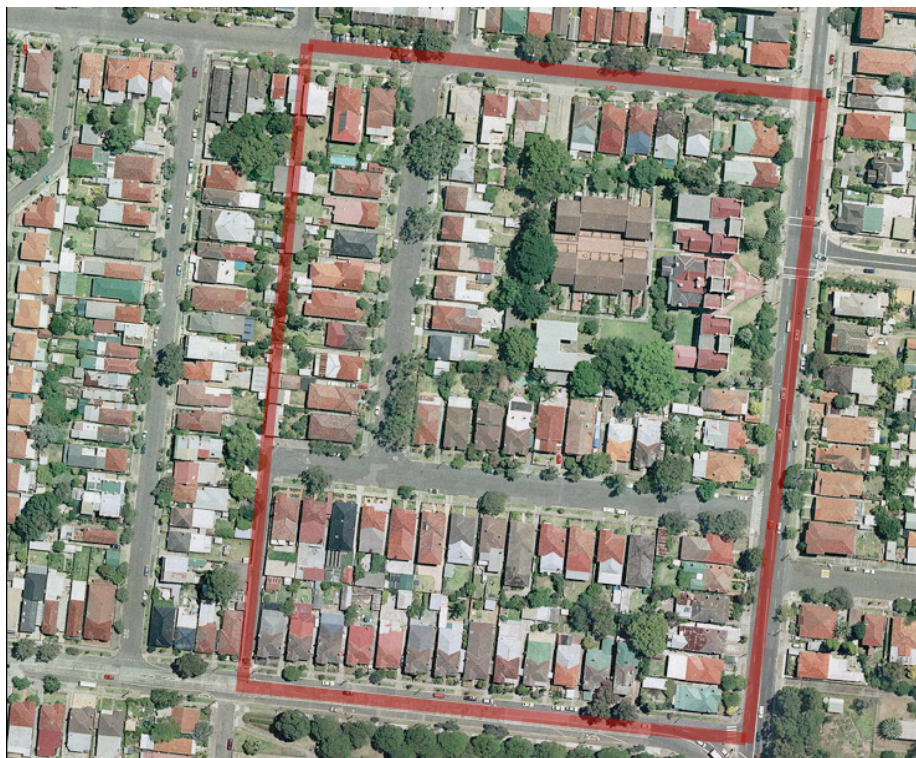
Figure 21.2 The Area in 1943 and 2009 (source: NSW Lands Department SIX Viewer)

Examination of the 1943 aerial photography reveals that many of the houses within this area were built as identical groups, or 'runs' of detached cottages, each off-set on its block of land to accommodate a driveway beside the house. Many of these have survived substantially intact and contribute to a strong and rhythmical streetscape today. All except one is a single storey, and the exception is contemporary with the remainder of the area. The area also contains the castellated façade marking the original grand Villa Estate of Rathlin, from which the Area was subdivided before the main house was sold to the Salvation Army and substantially altered for use as a Training College. It was layered yet again in the 1980s for residential development by the Department of Housing, although it has retained its prominent role in the local landscape.

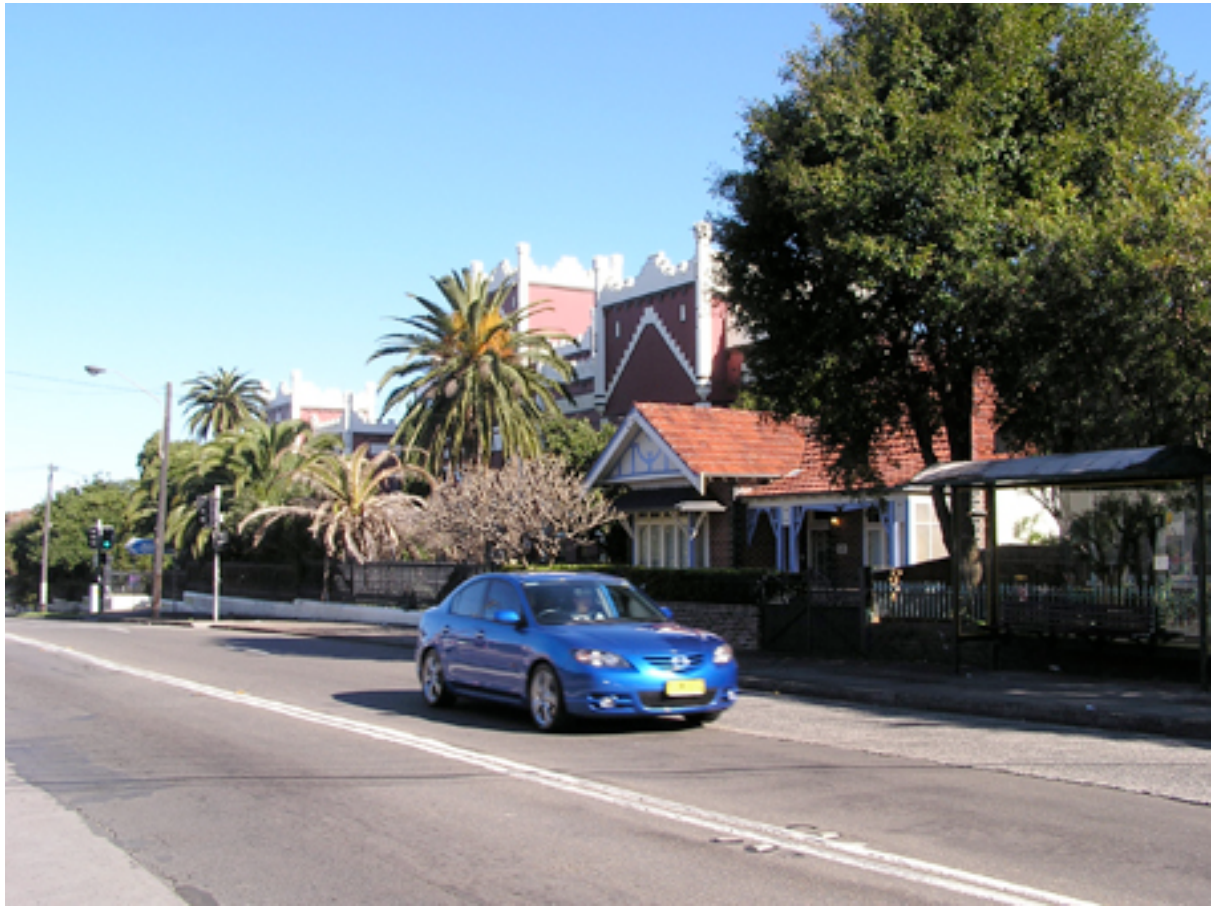
Figure 21.3. The original Rathlin Estate was a large Victorian villa set in substantial grounds that covered the area of the Conservation Area. It was purchased by the Salvation Army and used as its main training College for many years until adapted for further reuse as a residential flat development. The castellated façade added by the Salvation Army has been retained and provides a strong street address for the precinct. The remainder of the precinct is strongly suburban in its character, with detached Federation period houses set on relatively large lots, allowing side driveways and access to the rear for off-street parking. The consistency of built forms and setbacks have resulted in a cohesive aesthetic quality to the contemporary streetscape.

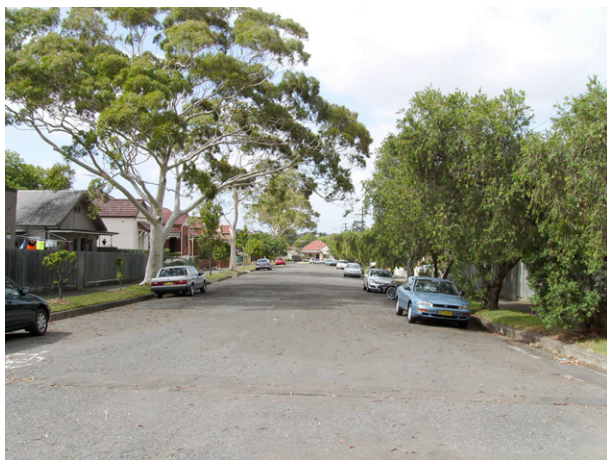
Figure 21.4. The suburban character of this area is demonstrated clearly in this view of Napier Street. The road reservation is wide and the single storey houses are set back from the street, allowing

for a small front garden.

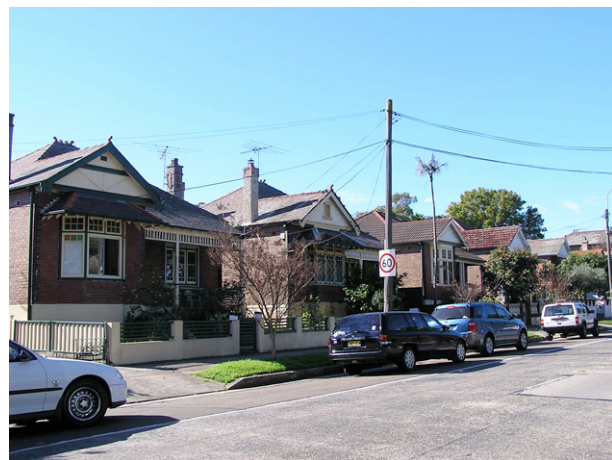
Figure 21.5. The houses in Frazer Street overlook Marrickville Park. This group includes some of the most intact examples within

the Conservation Area.

The area is notable for its many substantially intact and well detailed bungalows, particularly those on Frazer Street overlooking Marrickville Oval, which form a particularly good group with original slate roofs, chimneys, brickwork and timber detailing. Although two houses in this group have been rendered and significantly layered in the migrant style, their overall form is substantially intact and does not affect the high quality roofscape of the group.

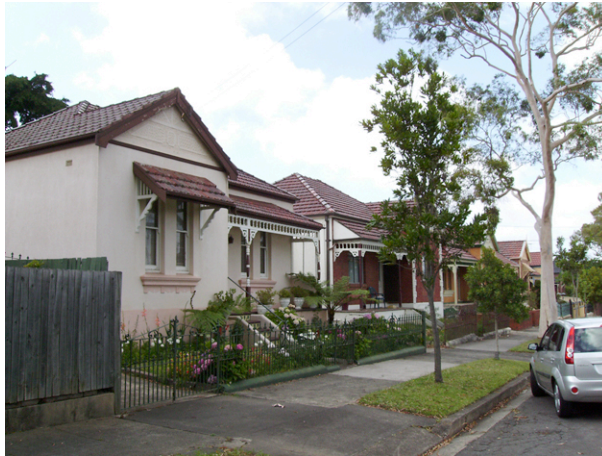
Figure 21.6. Many of the houses along Napier Street have been rendered and subjected to other alterations. Their overall form, and in particular their roof forms and volumes, remain substantially intact.

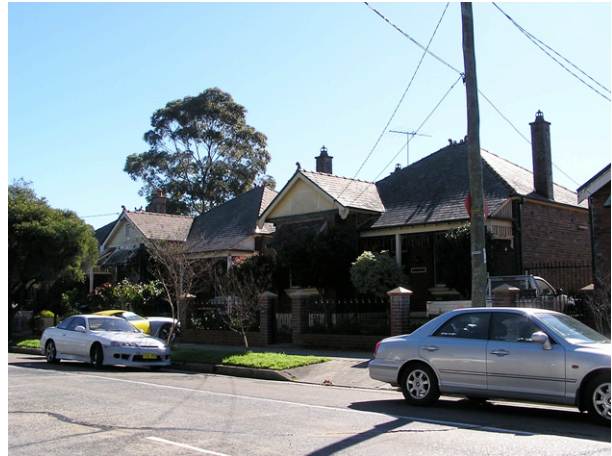
Figure 21.7. These houses in Frazer Street have retained their original slate roofs and chimneys.

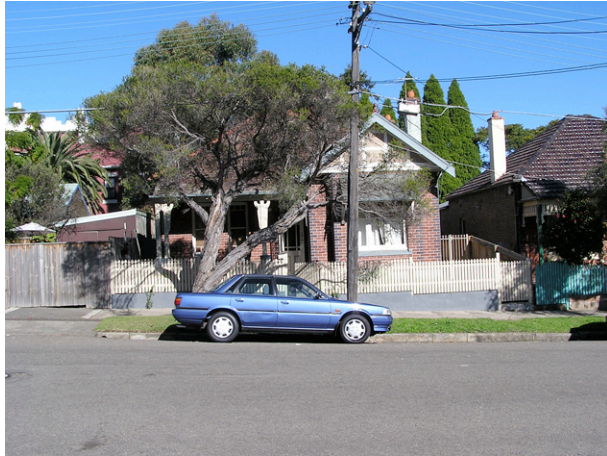
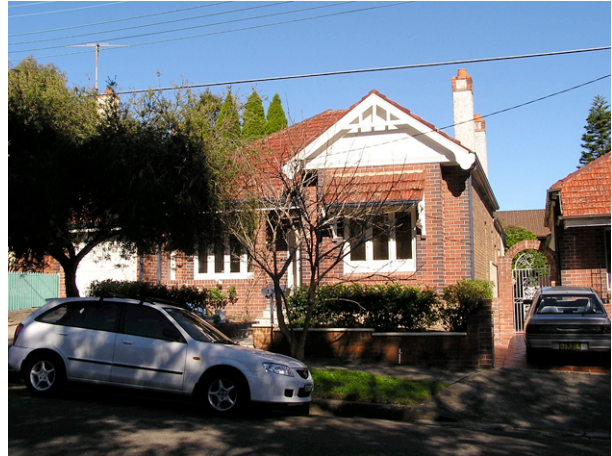
Figure 21.12 to 21.15. Morgan Street contains many good examples of the simple Federation cottage.

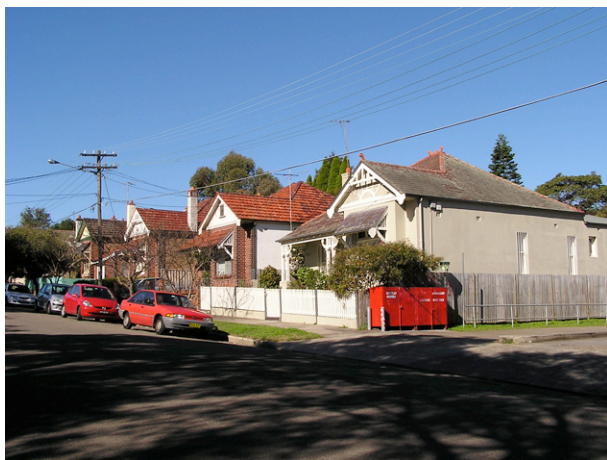
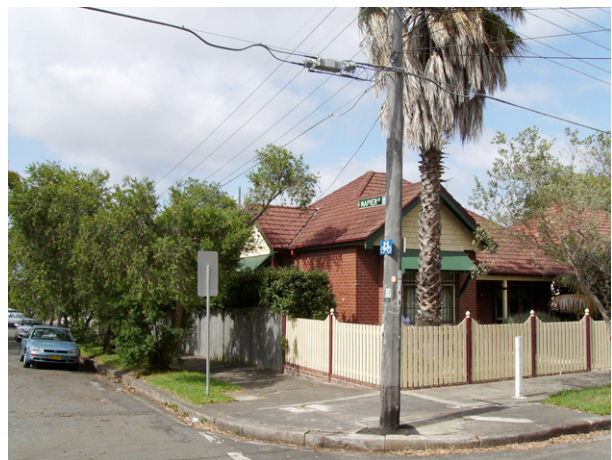
Figure 21.14 The consistency of houses in the area contributes to its high streetscape values. This group in Morgan Street have matching form, setbacks and roof volumes and although the house closest to the camera has been rendered, the group still reads as a cohesive one.

Figure 21.15 This house at the corner of Morgan and Napier streets is a good example of the simple Federation cottage.

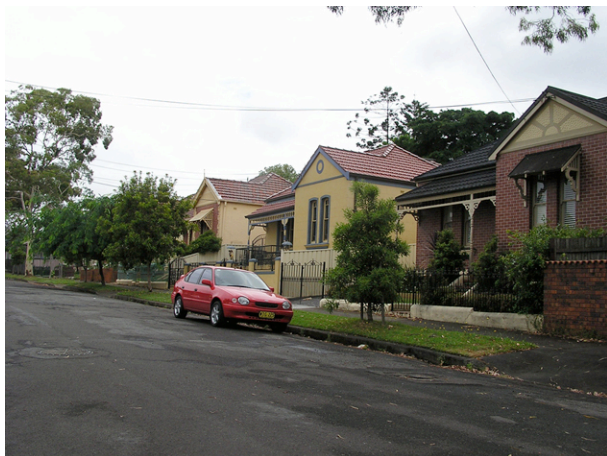
Figure 21.16. Many of the houses in Napier Street have been rendered or painted, an action which draws attention to the house instead of respecting the value of the group as a whole.

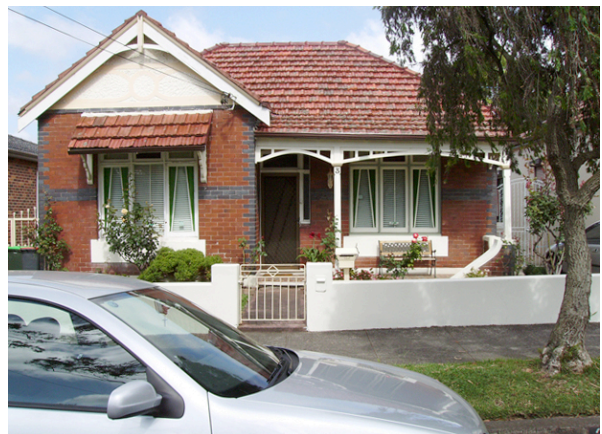
Figure 21.17 Other houses in Napier Street have remained substantially intact and continue to express their original character through their attention to detail in the quality of brickwork, joinery and unusual window glazing pattern.

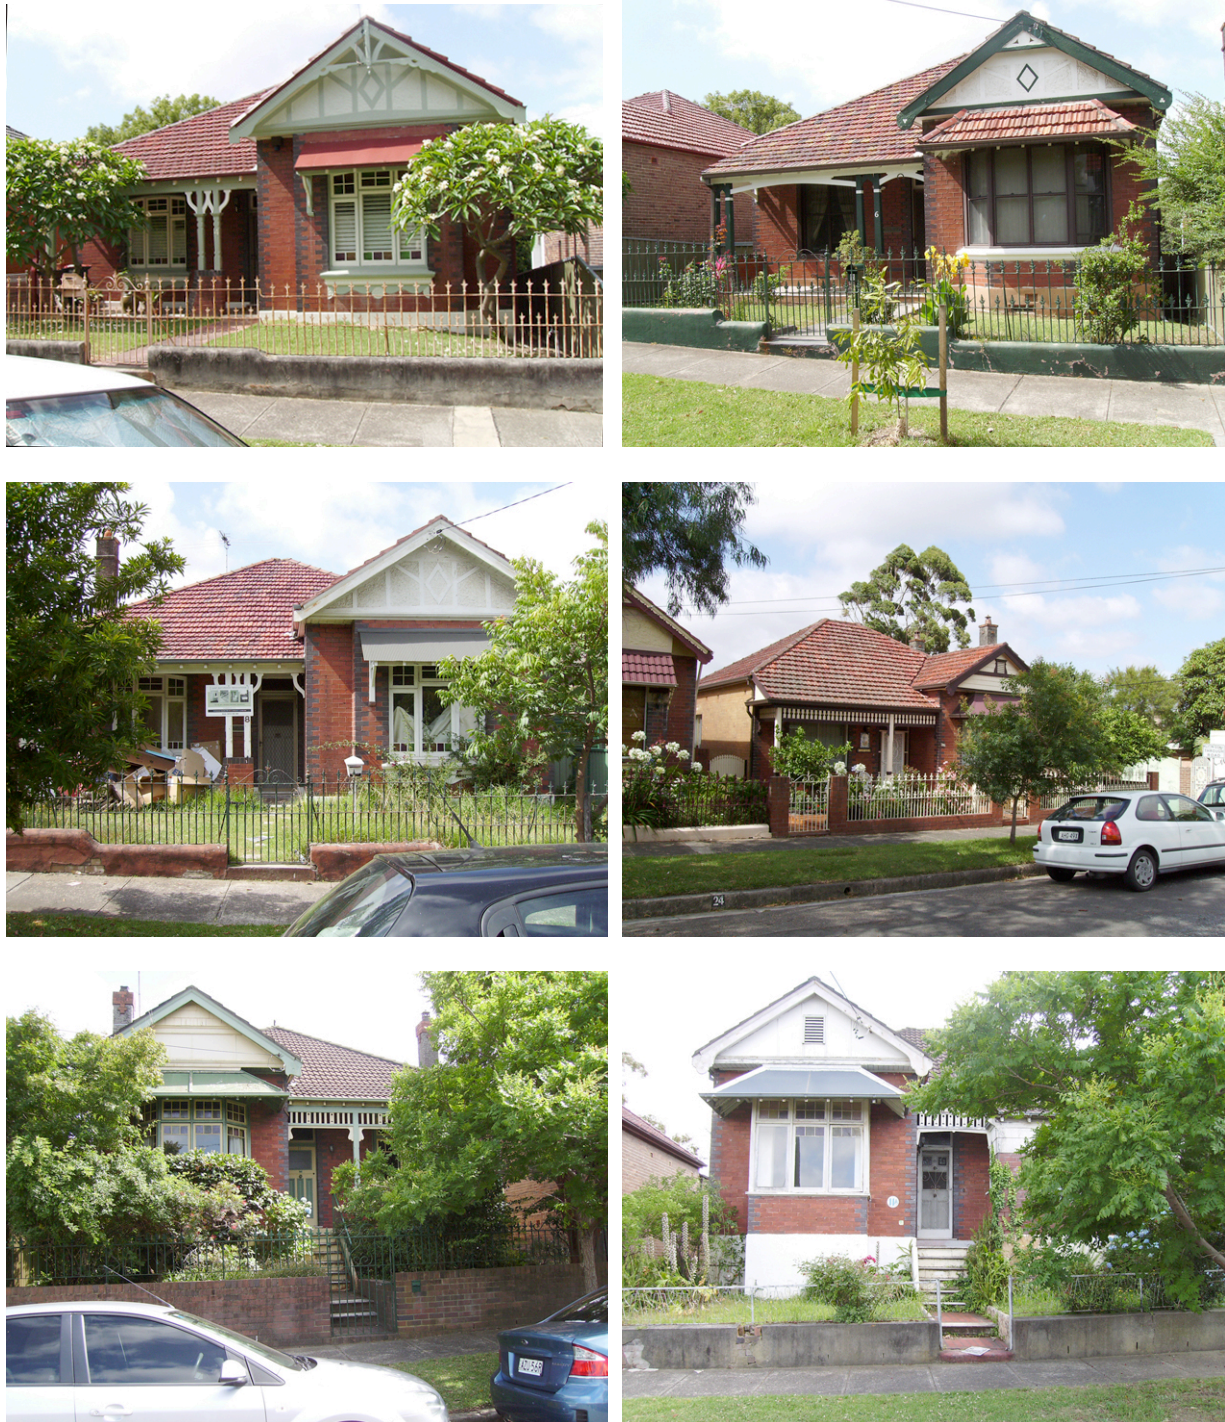
Figure 21.18 to 21.23. The original houses in Miller Street form a distinct subgroup within the precinct. The houses are wider and lower profiled, and include bay windows and duochrome brickwork in the style of imitation quoining.

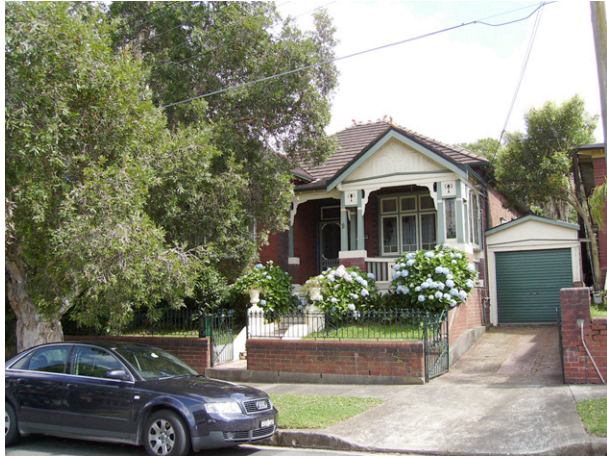
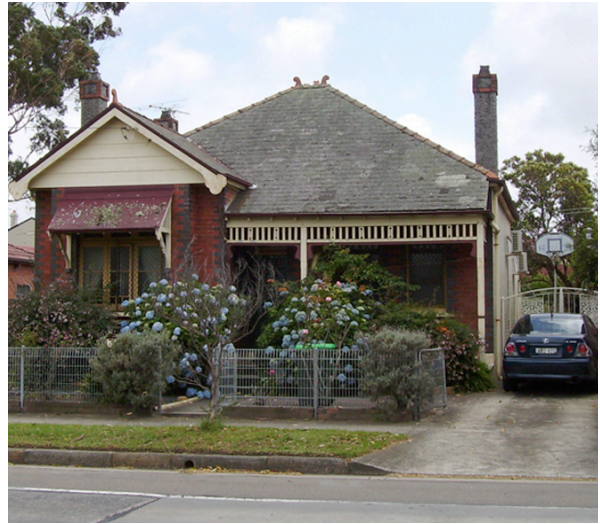
Figure 21.24 A variation on the Federation form found elsewhere in the area with a second gable over the verandah.

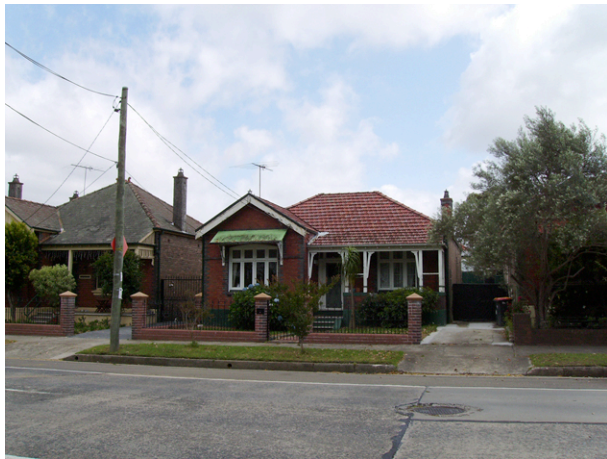
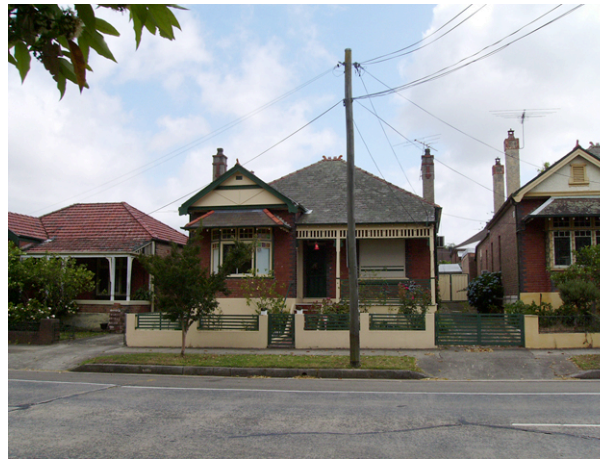
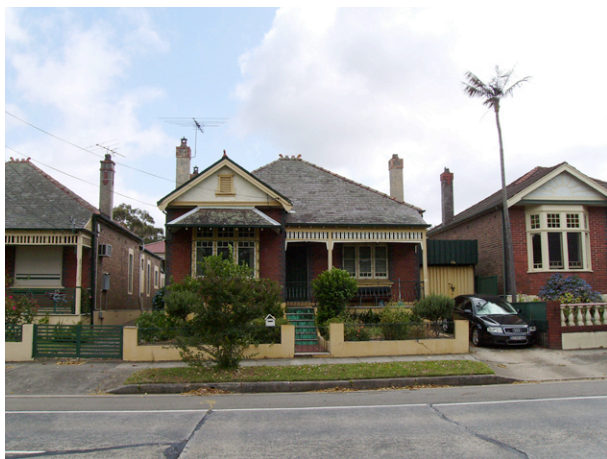
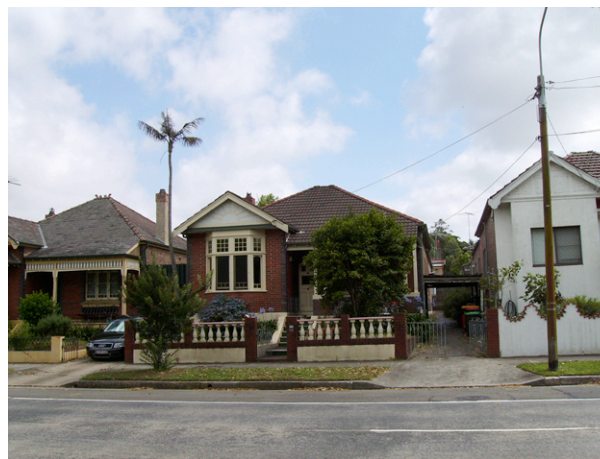
Figure 21.25 to 21.32. Frazer Street. This very good group has retained their original form, roofs (including slate roofs and slender chimneys) and attention to fine details such as timberwork, duochrome brickwork and tiling to stairs. Two have a form matching that found in Miller Street with a half-hipped hood to the front window, suggesting that the same builder was responsible.

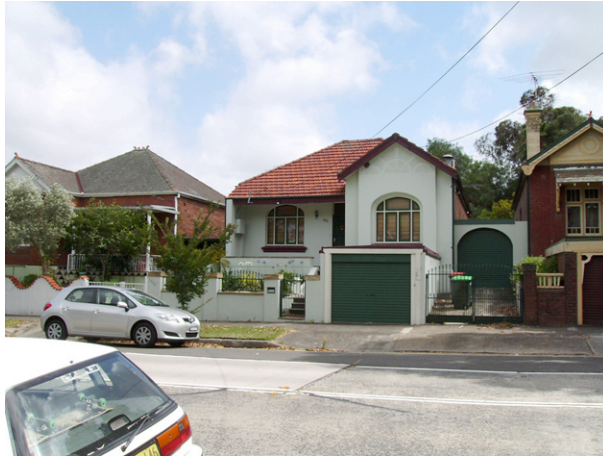
Figure 21.30 . Frazer Street (con't.) This example has been rendered and painted and its setting compromised by the insertion of a garage between the house and the street.

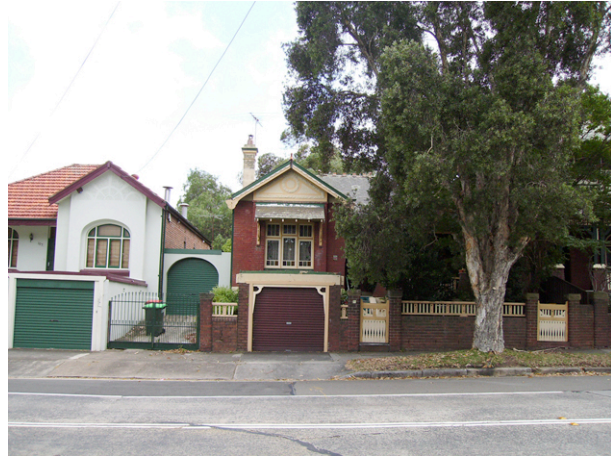
Figure 21.31 Frazer Street. This example follows the form common in this part of Marrickville, with the gable being an extension of the main roof, and the ridge forming an 'L' shape (see also HCA 29 – South Dulwich Hill.)

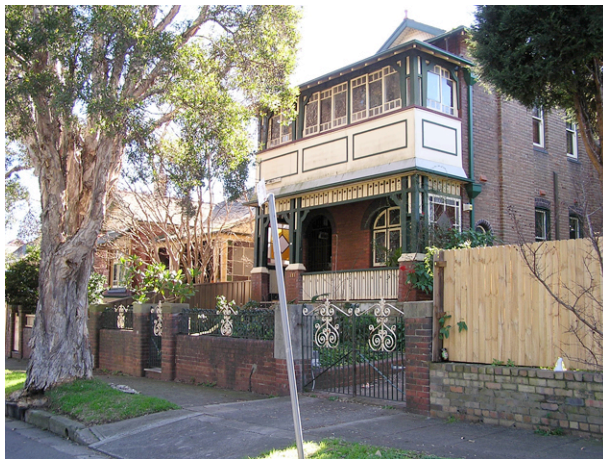
Figure 21.32 . Frazer St. The only two-storey house in the Area

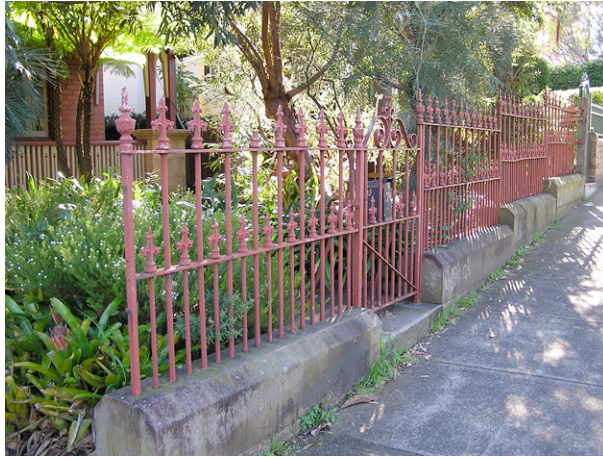
Figure 21.36. Detail of iron palisade fence set in chamfered base and stepping down to follow the slope of the hill

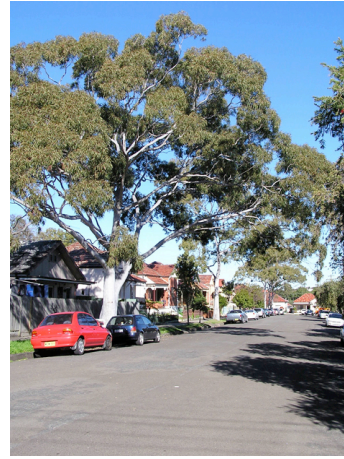
Figure 21.37. The streetscape of Napier Street is dominated by this mature eucalypt which dominates the street tree planting.

Street plantings are typical of the miscellaneous native plantings from the early environmental movement that are found throughout Marrickville although the tall eucalypts planted in the eastern verge of Napier Street are a distinctive local streetscape feature. Although not within the area, the Frazer Street edge of Marrickville Oval is marked by a notable double row of mature Brush Box trees. Rear gardens are generally devoid of significant planting although good groups of trees provide a soft backdrop to properties at the eastern end of Miller and Frazer Streets and along the eastern side of Napier Street.

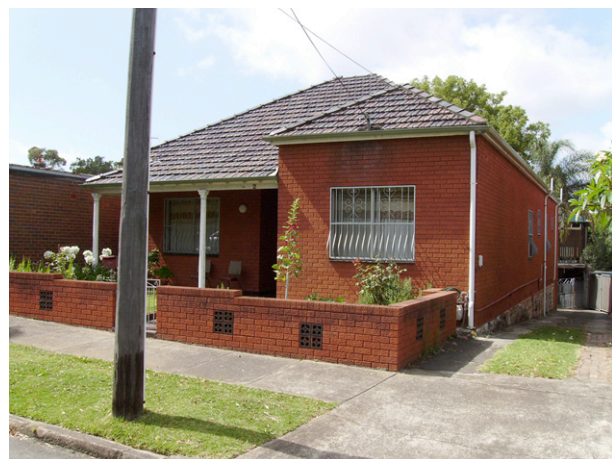
Figure 21.41. Example of irreversibly layered house in Miller Street which has retained its basic footprint but little other evidence of the original Federation form.

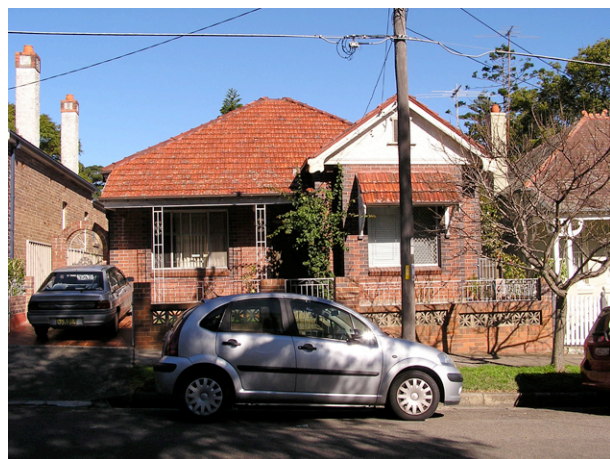
Figure 21.42. Replacement of timber joinery windows and veranda detailing with aluminium was a common form of layering in the 1970s and 1980s.

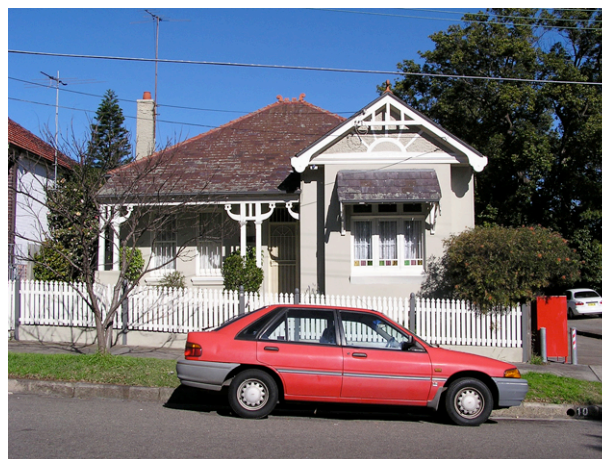
Figure 21.43. Recent gentrification trends are having a significant impact on the fabric of the Conservation Area.
