HCA 29 South Dulwich Hill Heritage Conservation Area (Dulwich Hill/Marrickville)

29.1 LOCATION

29.2 DESCRIPTION

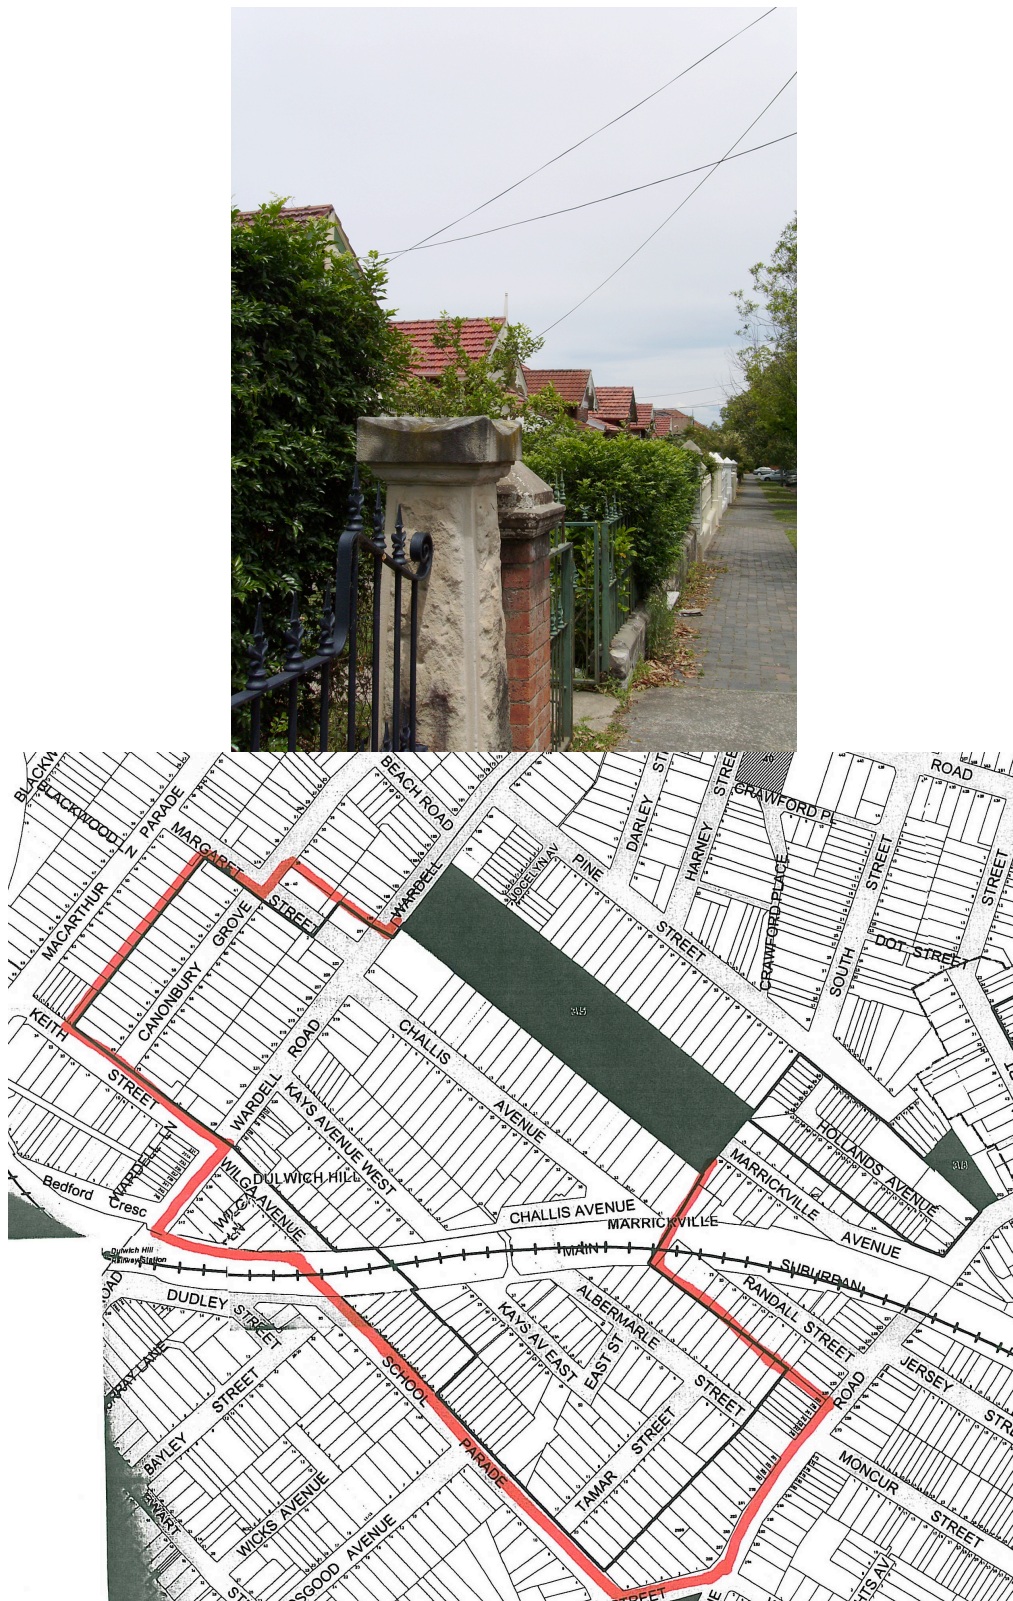
Figure 29.1 HCA 29 – South Dulwich Hill Heritage Conservation Area

The South Dulwich Hill Heritage Conservation Area is located between Cannonbury Grove and Livingstone Road in Marrickville/Dulwich Hill.

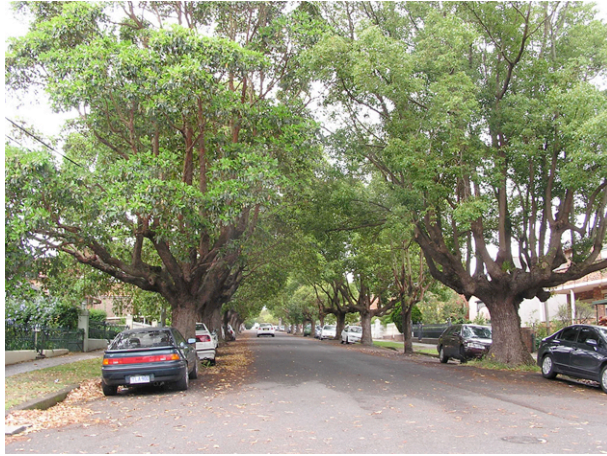
Figure 29.3 The streetscape of Cannonbury Grove is of high aesthetic value due to its mature Brush Box Street tree planting within the road reservation and the quality of the houses within the group.

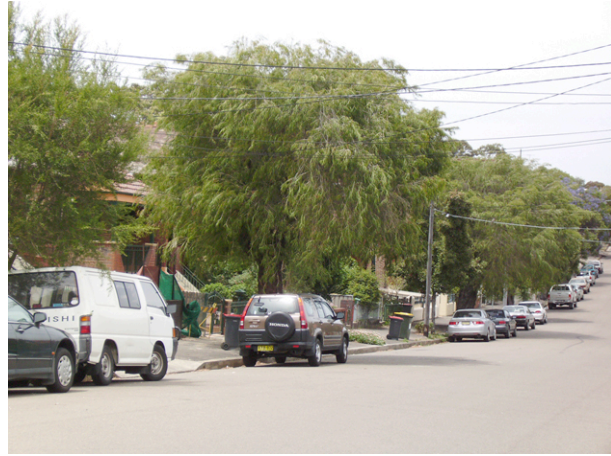
Figure 29.4. Although School Parade contains some good-quality built elements the streetscape value is not as high as that of Cannonbury Grove due to the nondescript street planting which obstructs oblique views of the streetscape.

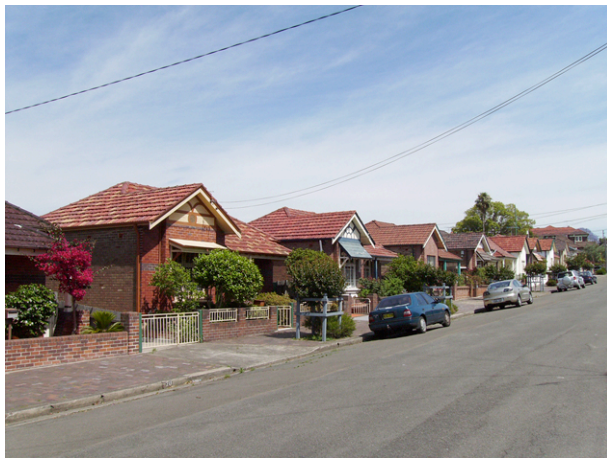
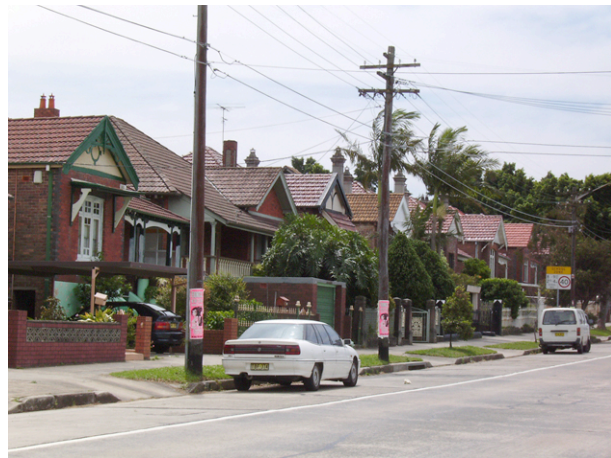
Figure 29.5 and 29.6. The streetscapes of Kays Avenue West (left) and Wardell Road (right) in contrast are barren of significant street planting and demonstrate a strongly patterned built form when viewed as a streetscape group.

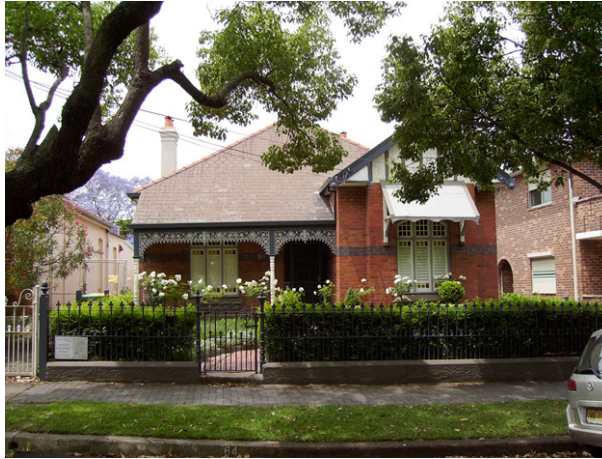
Figure 29.13 Cannonbury Grove

The figures on this and following pages illustrate the built forms found throughout the area. Although almost all dwellings within the area from the Federation period and appear to be identical, careful observation reveals that there are several distinct sub-types distributed through the area which are likely to be the work of individual builders. One type demonstrates an unusual variation of the usual high pitched Federation roof with a L-shaped ridgeline joining the gable and main roof form. Where chimneys have survived these form an important part of the local streetscape.

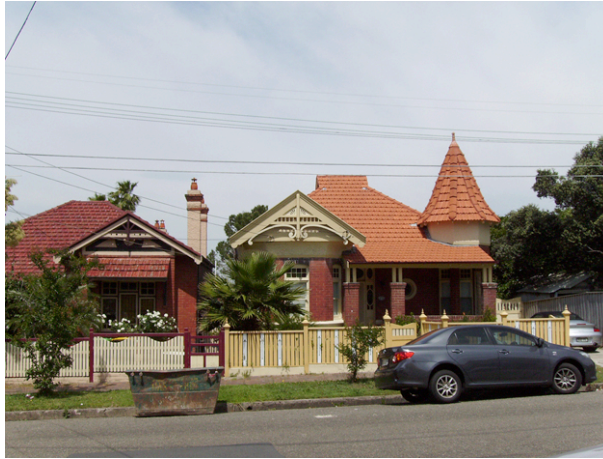
Figure 29.19 Challis Avenue. The candle snuffer roof is original, although re-tiled. It is the only such roof in the area and is rare in Marrickville.

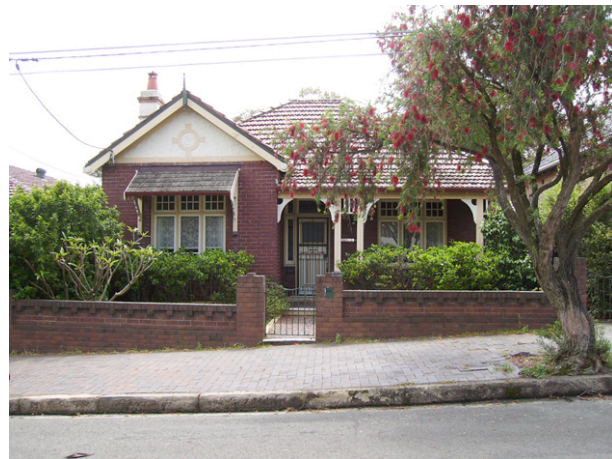
Figure 29.22 Tamar Street. Note also the brick paved footpath.

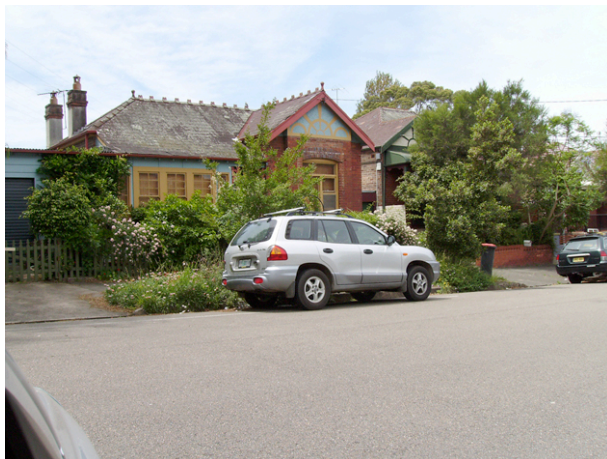
Figure 29.29 School Parade – the unusual L-shaped variation found in Marrickville.

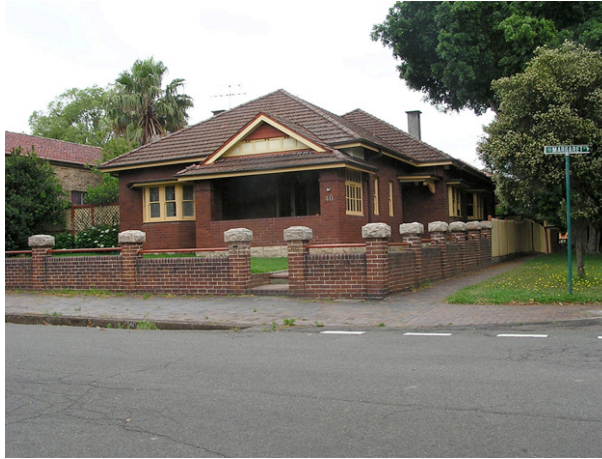
Figure 29.37. Substantial interwar bungalow located at the corner of Margaret Street and Cannonbury Grove.

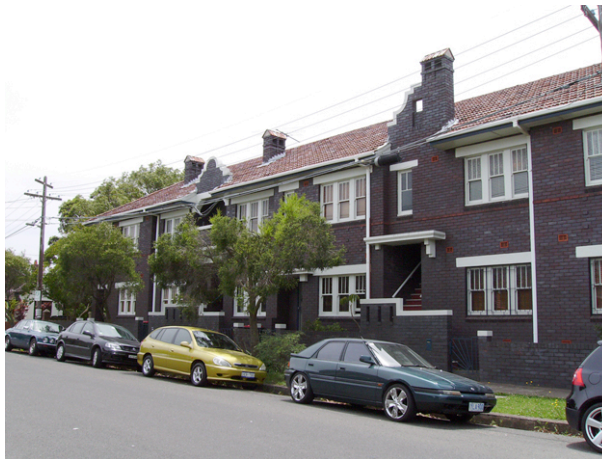
Figure 29.38. Imposing black brick interwar residential flat building with Anglo-Dutch influenced detailing at the corner of Cannonbury Grove and Keith Street

The area also contains several notable examples of Inter-War residential flat building development, including the blue-black brick development with Dutch detailing in Keith Street and the P&O influenced block in Wardell Street.

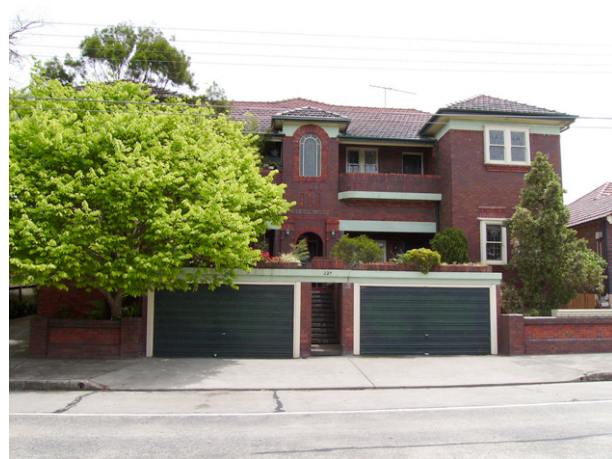
Figure 29.39. Interwar residential flat building and integrated the garaging on Wardell Road

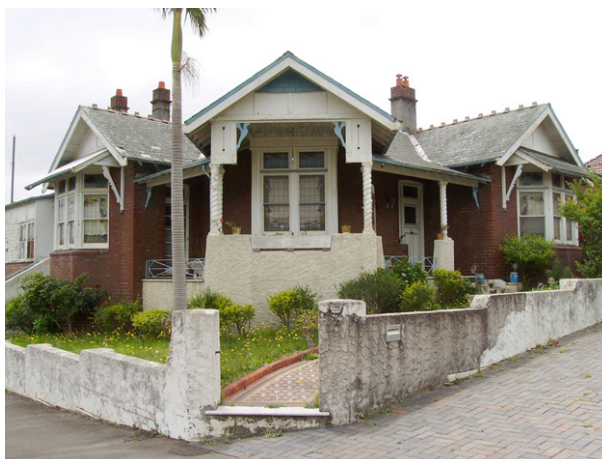
Figure 29.40. Substantial Federation house addressing the corner of Tamar Street and School Parade

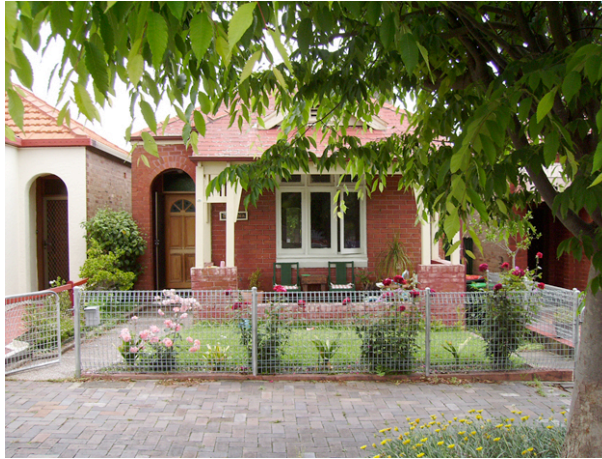
Figure 29.42 - Kays Avenue East. A more modest cottage

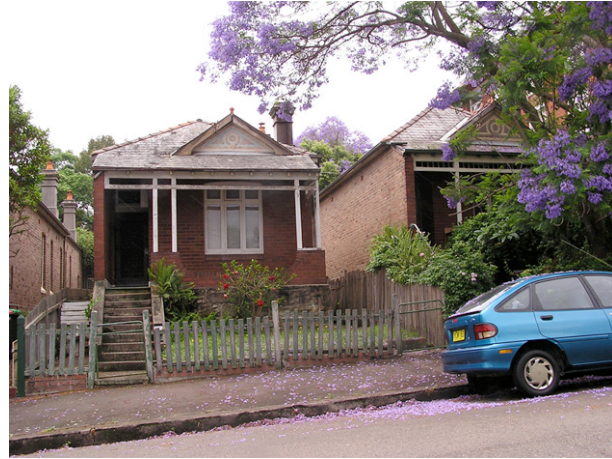
Figure 29.43. School Parade - a more modest cottage

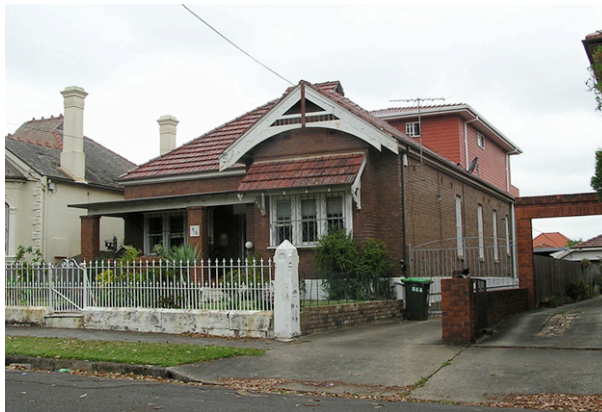
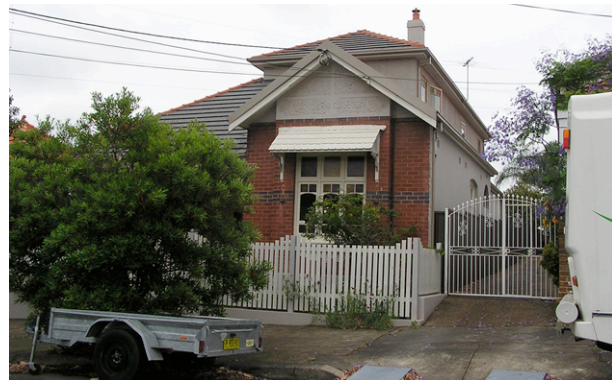
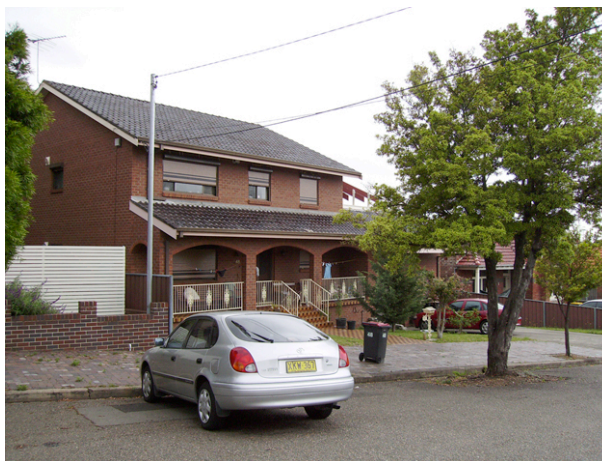
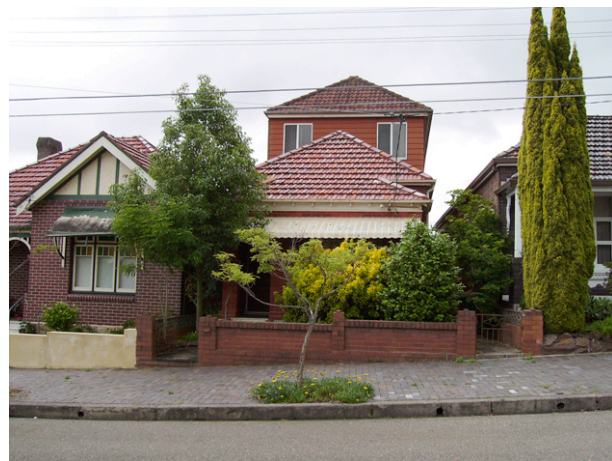
Figure 29.44. to 29. 47. Extensions to the rear of houses must be managed carefully to ensure that they do not intrude into the view of the roof volume or skyline.

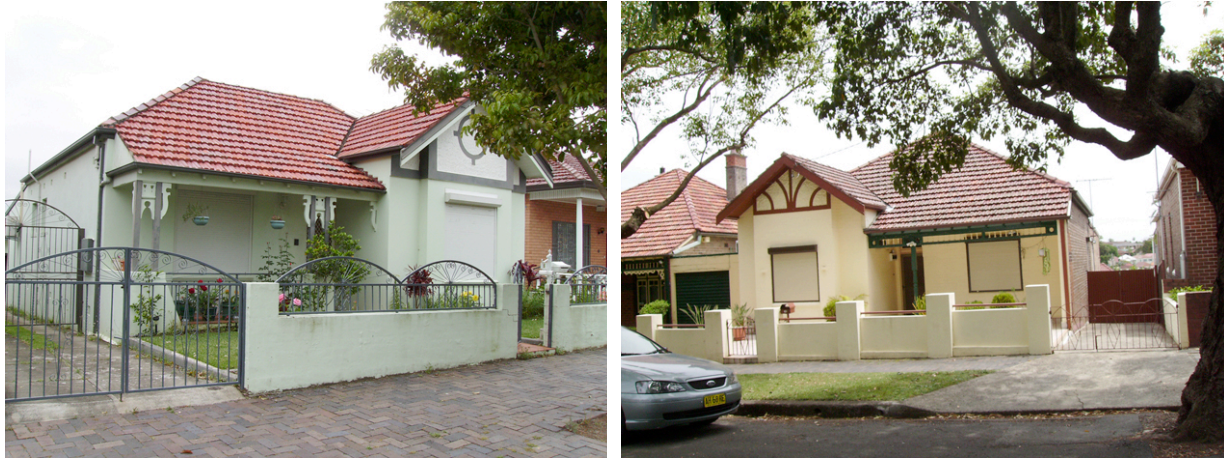
Figure 29.48 and 29.49 demonstrate the impact of rendering, painting and applying roller shutters to windows. The house loses its personality and presents a blank face to the streetscape.
