## HCA 32 Collins Street Heritage Conservation Area (Tempe)

### 32.1 LOCATION

## 32.2 DESCRIPTION

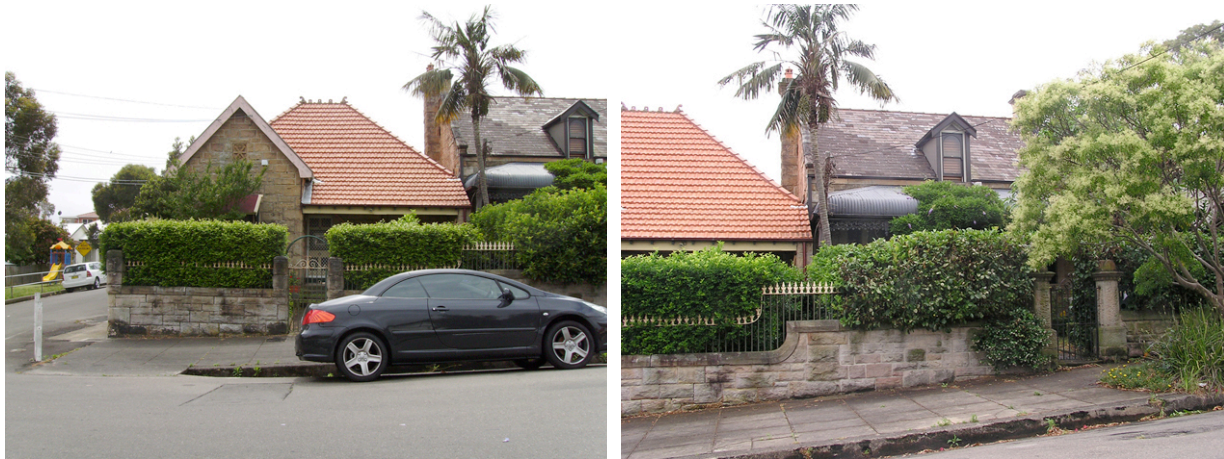
Figure 32.3 to 32.6. This row of solid sandstone houses were probably built by the masons who worked in the adjacent quarry to the north. They demonstrate a range of popular Victorian domestic architecture. They are substantially intact although the house at Figure 32.3 has been recently reroofed in unglazed orange Marseilles pattern terracotta tiles; and a dormer window has been added to the house in Figure 32.4. The house shown in Figure 32.6 has been retiled and an unsympathetic cement block fence added. The two houses above have retained their original sandstone walls which contribute significantly to the quality of the streetscape.

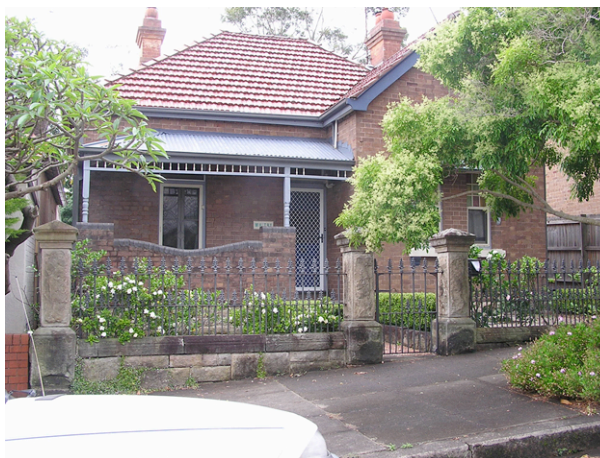
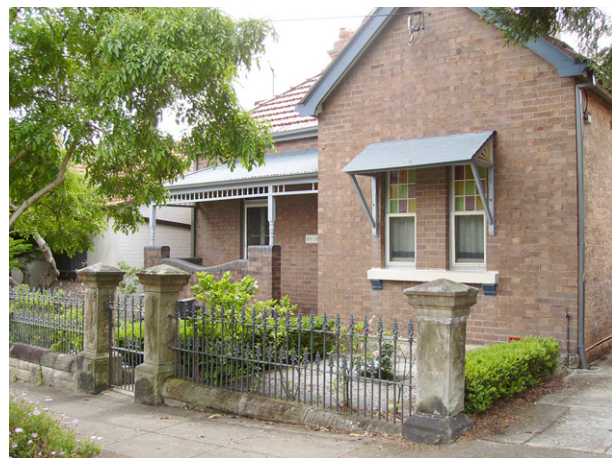
Figure 32.7 and 32.8. This simple federation style cottage has been built of common bricks and forms a significant contrast to its sandstone neighbours. It is a significant variation of its style, the use of common brick to the front facade being rare. The front fence is a particularly good example of the iron palisade with substantial sandstone pillars.

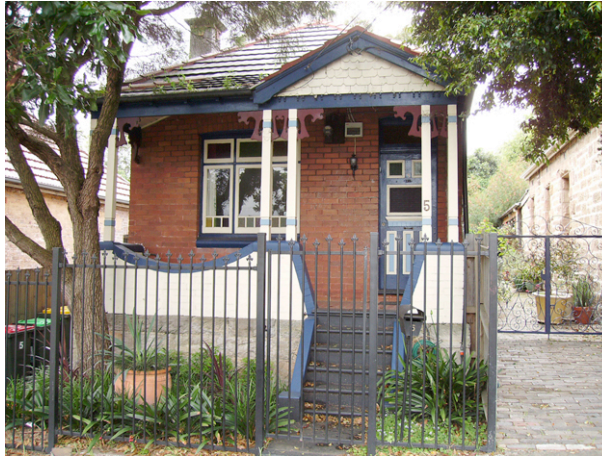
Figure 32.9 this modest single fronted Federation cottage has been reroofed and the fence replaced by a modern replica which is significantly taller than the original form, but it has been painted a dark colour and is not unduly intrusive. The plain brickwork and simple detailing of this house contribute positively to the significance of the Collins Street area. Note also the wide setback to the adjoining sandstone house allowing a good view of the full sandstone construction.

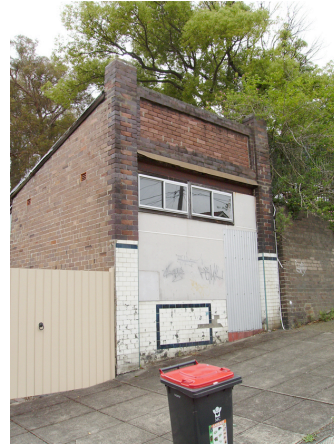
Figure 32.10. This small building is a remnant shop, the glass tiles to the facade suggesting that it was a possibly a butcher or similar type of retail shop.

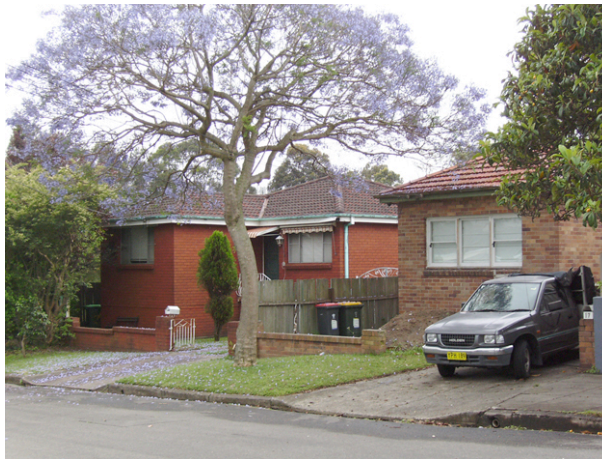
Figure 32.11 and 32.12. The streetscape group extends to the west of Toyer Street, with a pocket park located on the corner and a small Victorian vernacular cottage adjacent. The houses closer to the Railway line were built in the post-war period and contribute to the significance of this Area primarily through their sympathetic scale. The Jacaranda street planting on the footpath verge is a prominent streetscape element when in flower and creates a focal point to the area.

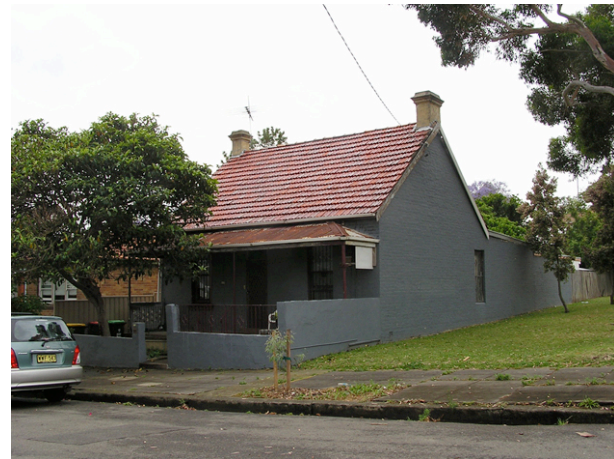
Figure 32.12. This Victorian vernacular cottage has been subjected to some gentrification layering but its scale and form remains substantially intact.

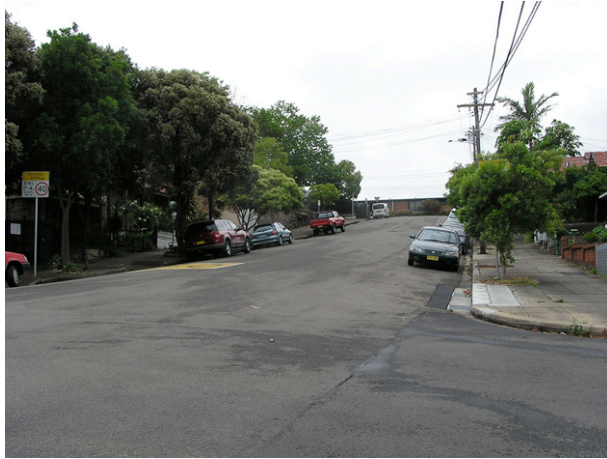
Figure 32.13. Streetscape view looking towards Unwins Bridge Road. The houses are largely hidden by the screening vegetation.

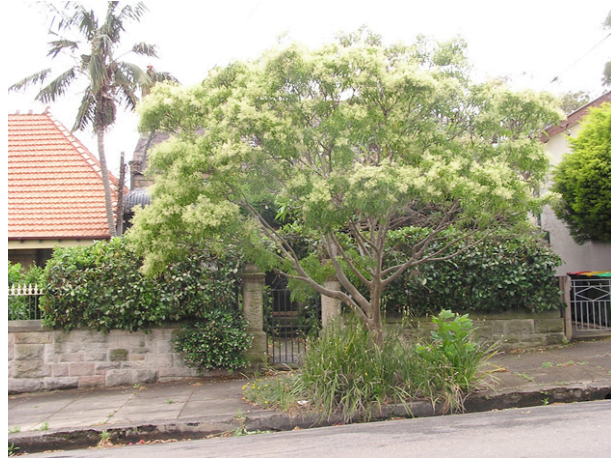
Figure 32.14 detail of sandstone and iron front fence.
