National Storage

Acid Sulfate Soils Assessment:
11 and 11A Edinburgh Road,
Marrickville, NSW

P2108688JR02V01
June 2022

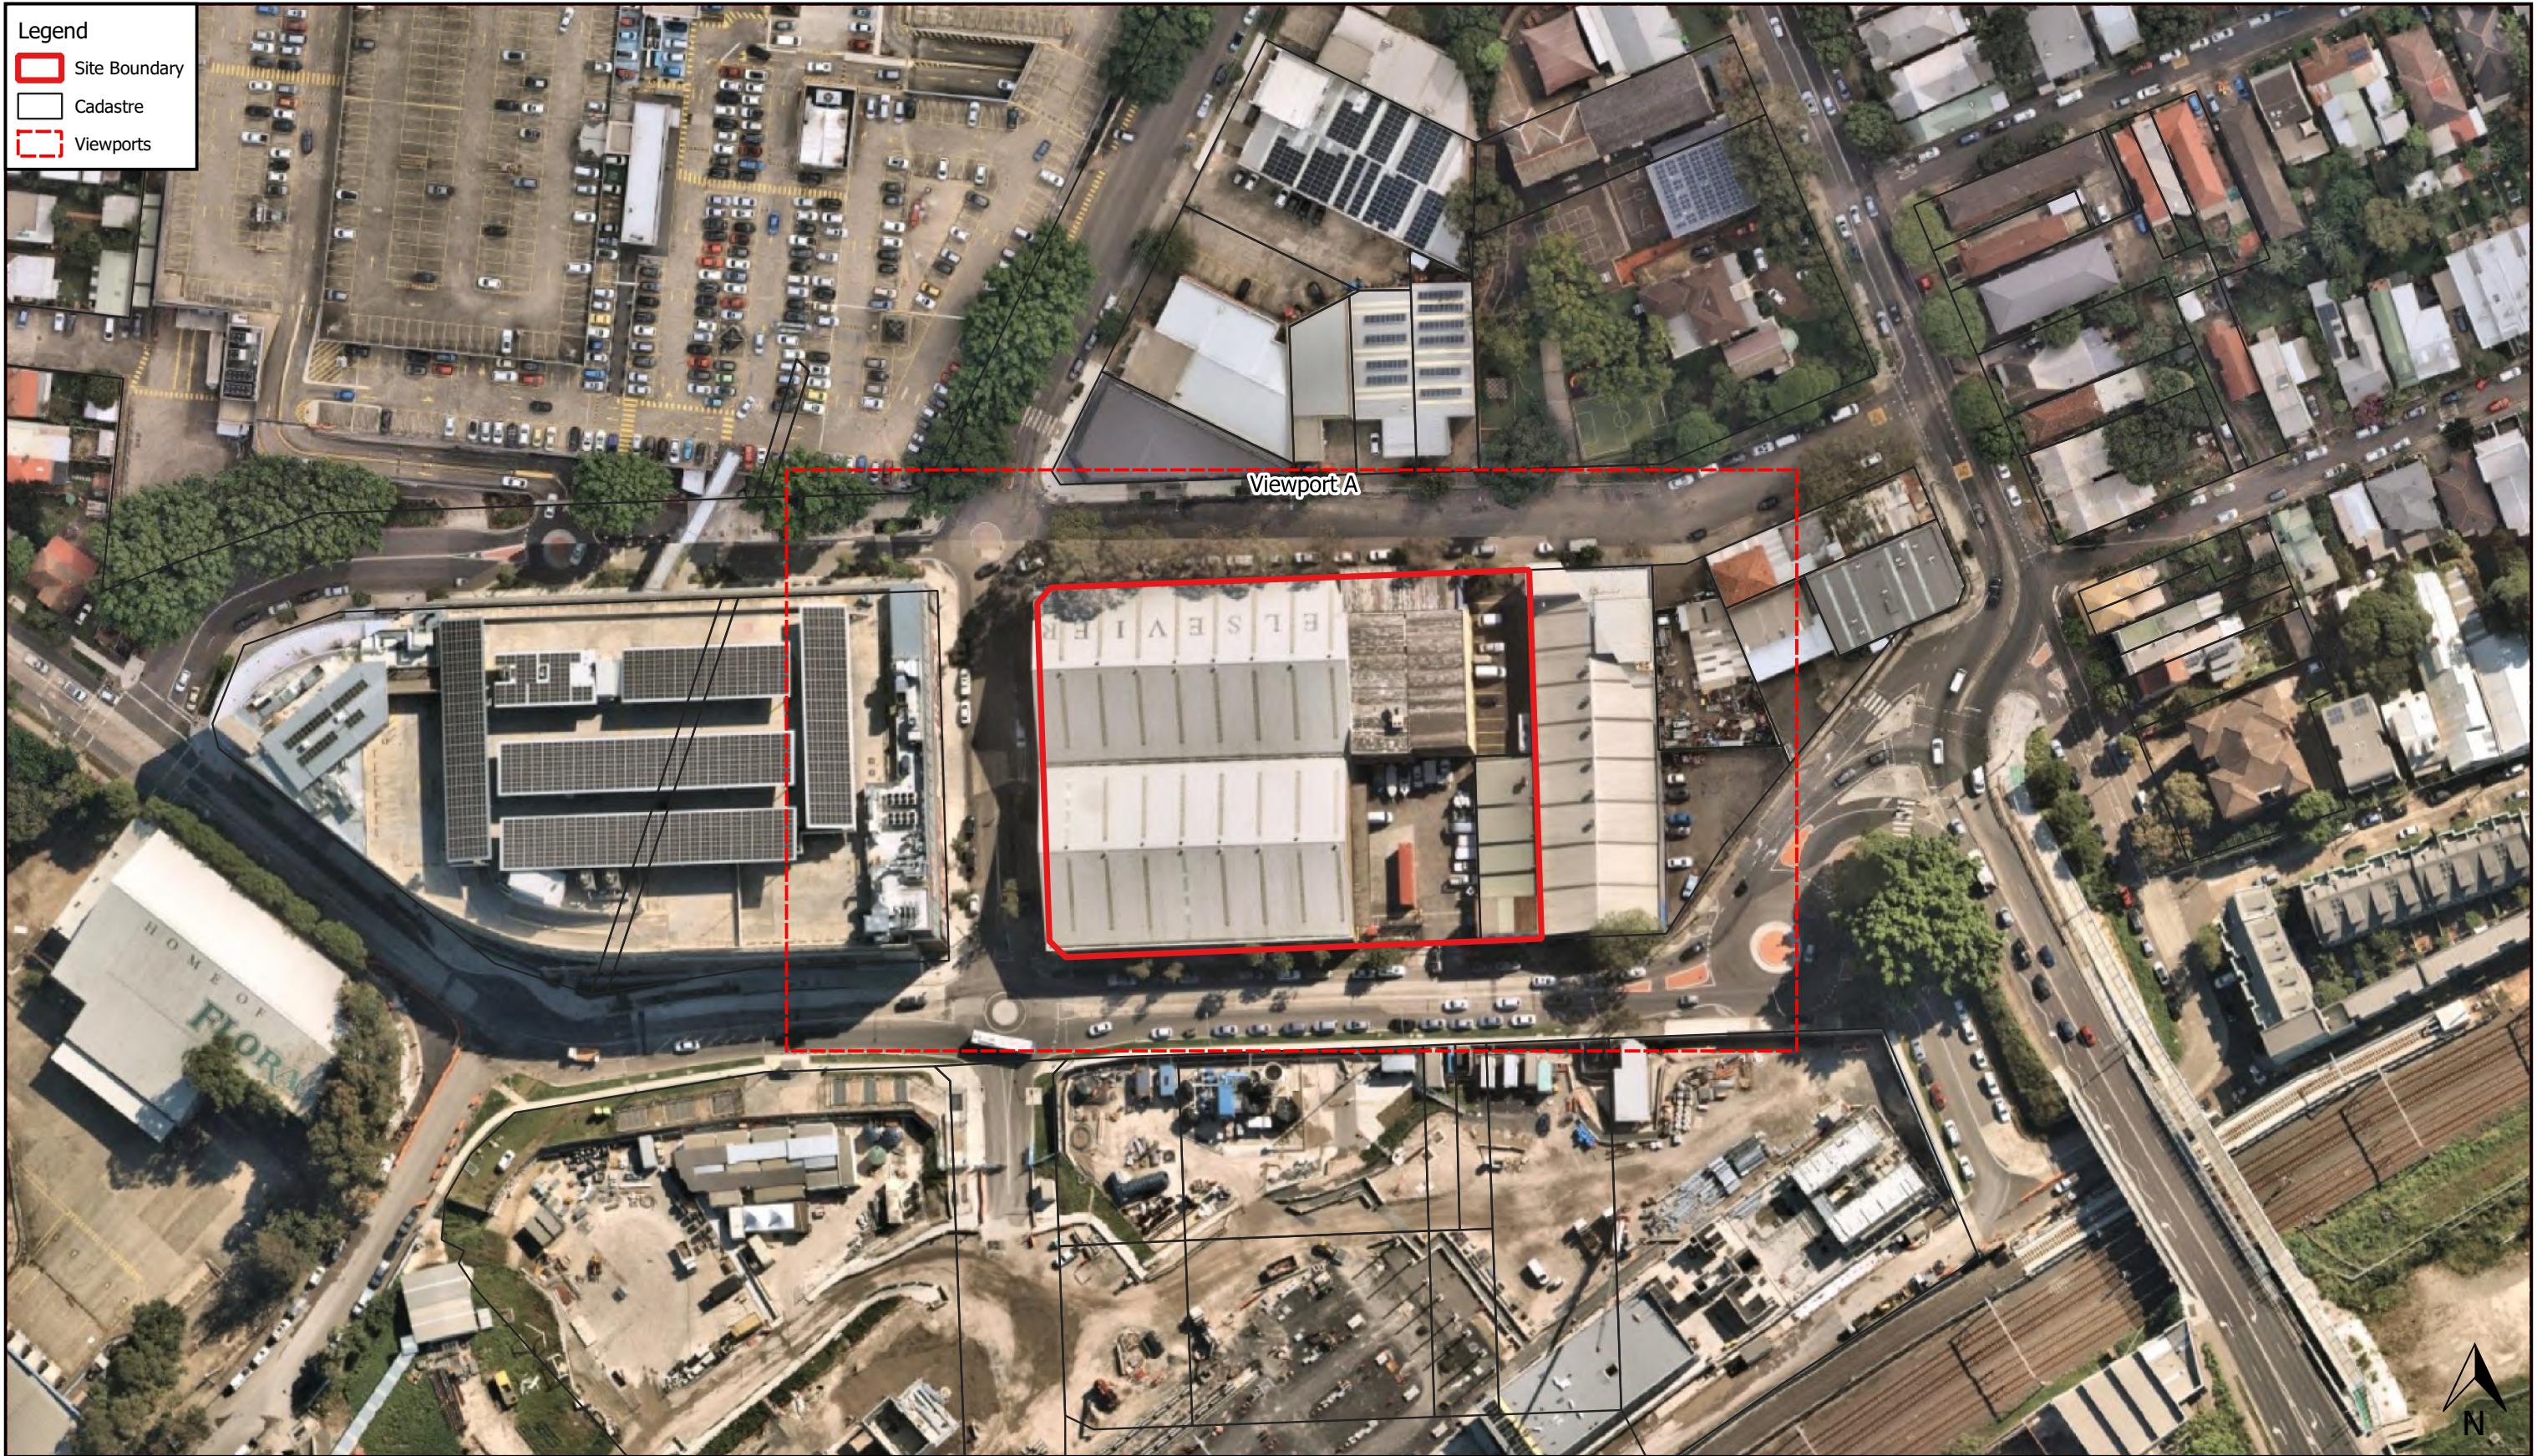
Map 01
 11 & 11A Edinburgh Road, Marrickville, NSW
 Engineering Services
 Acid Sulfate Soils Assessment
 National Storage C/- LRM Global Pty Ltd
 12/04/2022

Map Title / Figure:
Site Overview

Site information is summarised in Table 1. The site location and general surrounds are shown in Attachment A.

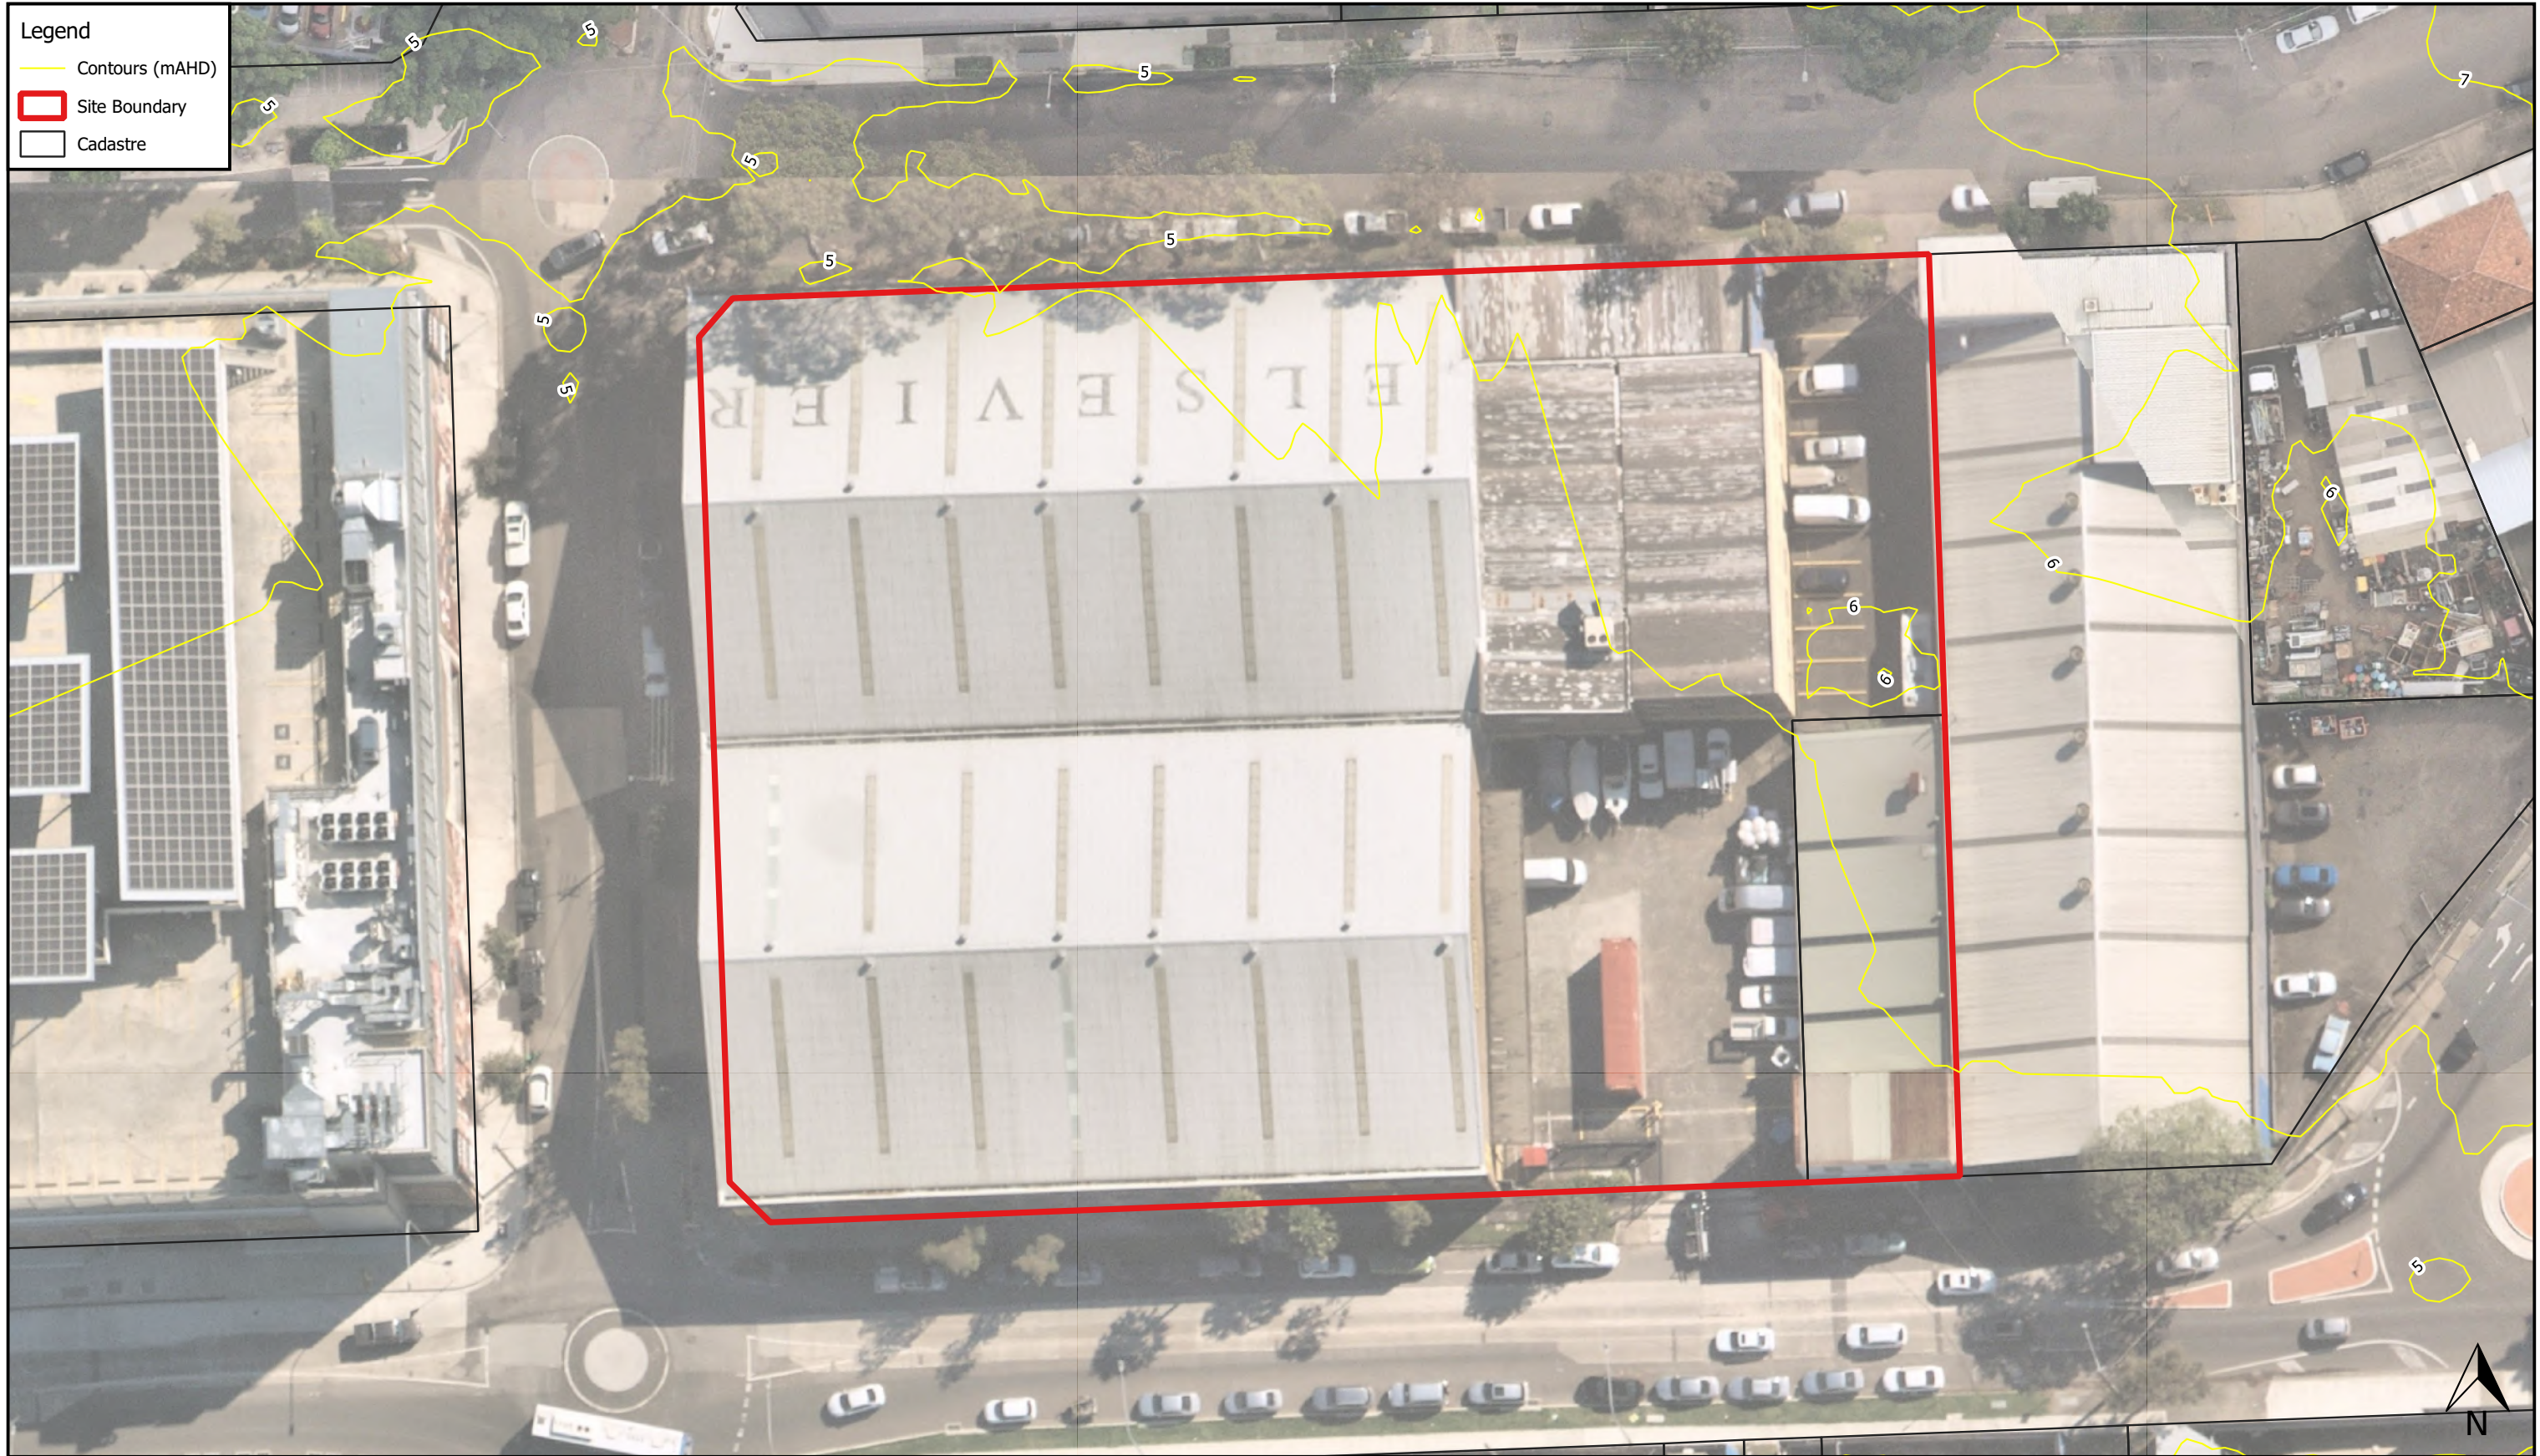
Map Title / Figure:
Contours

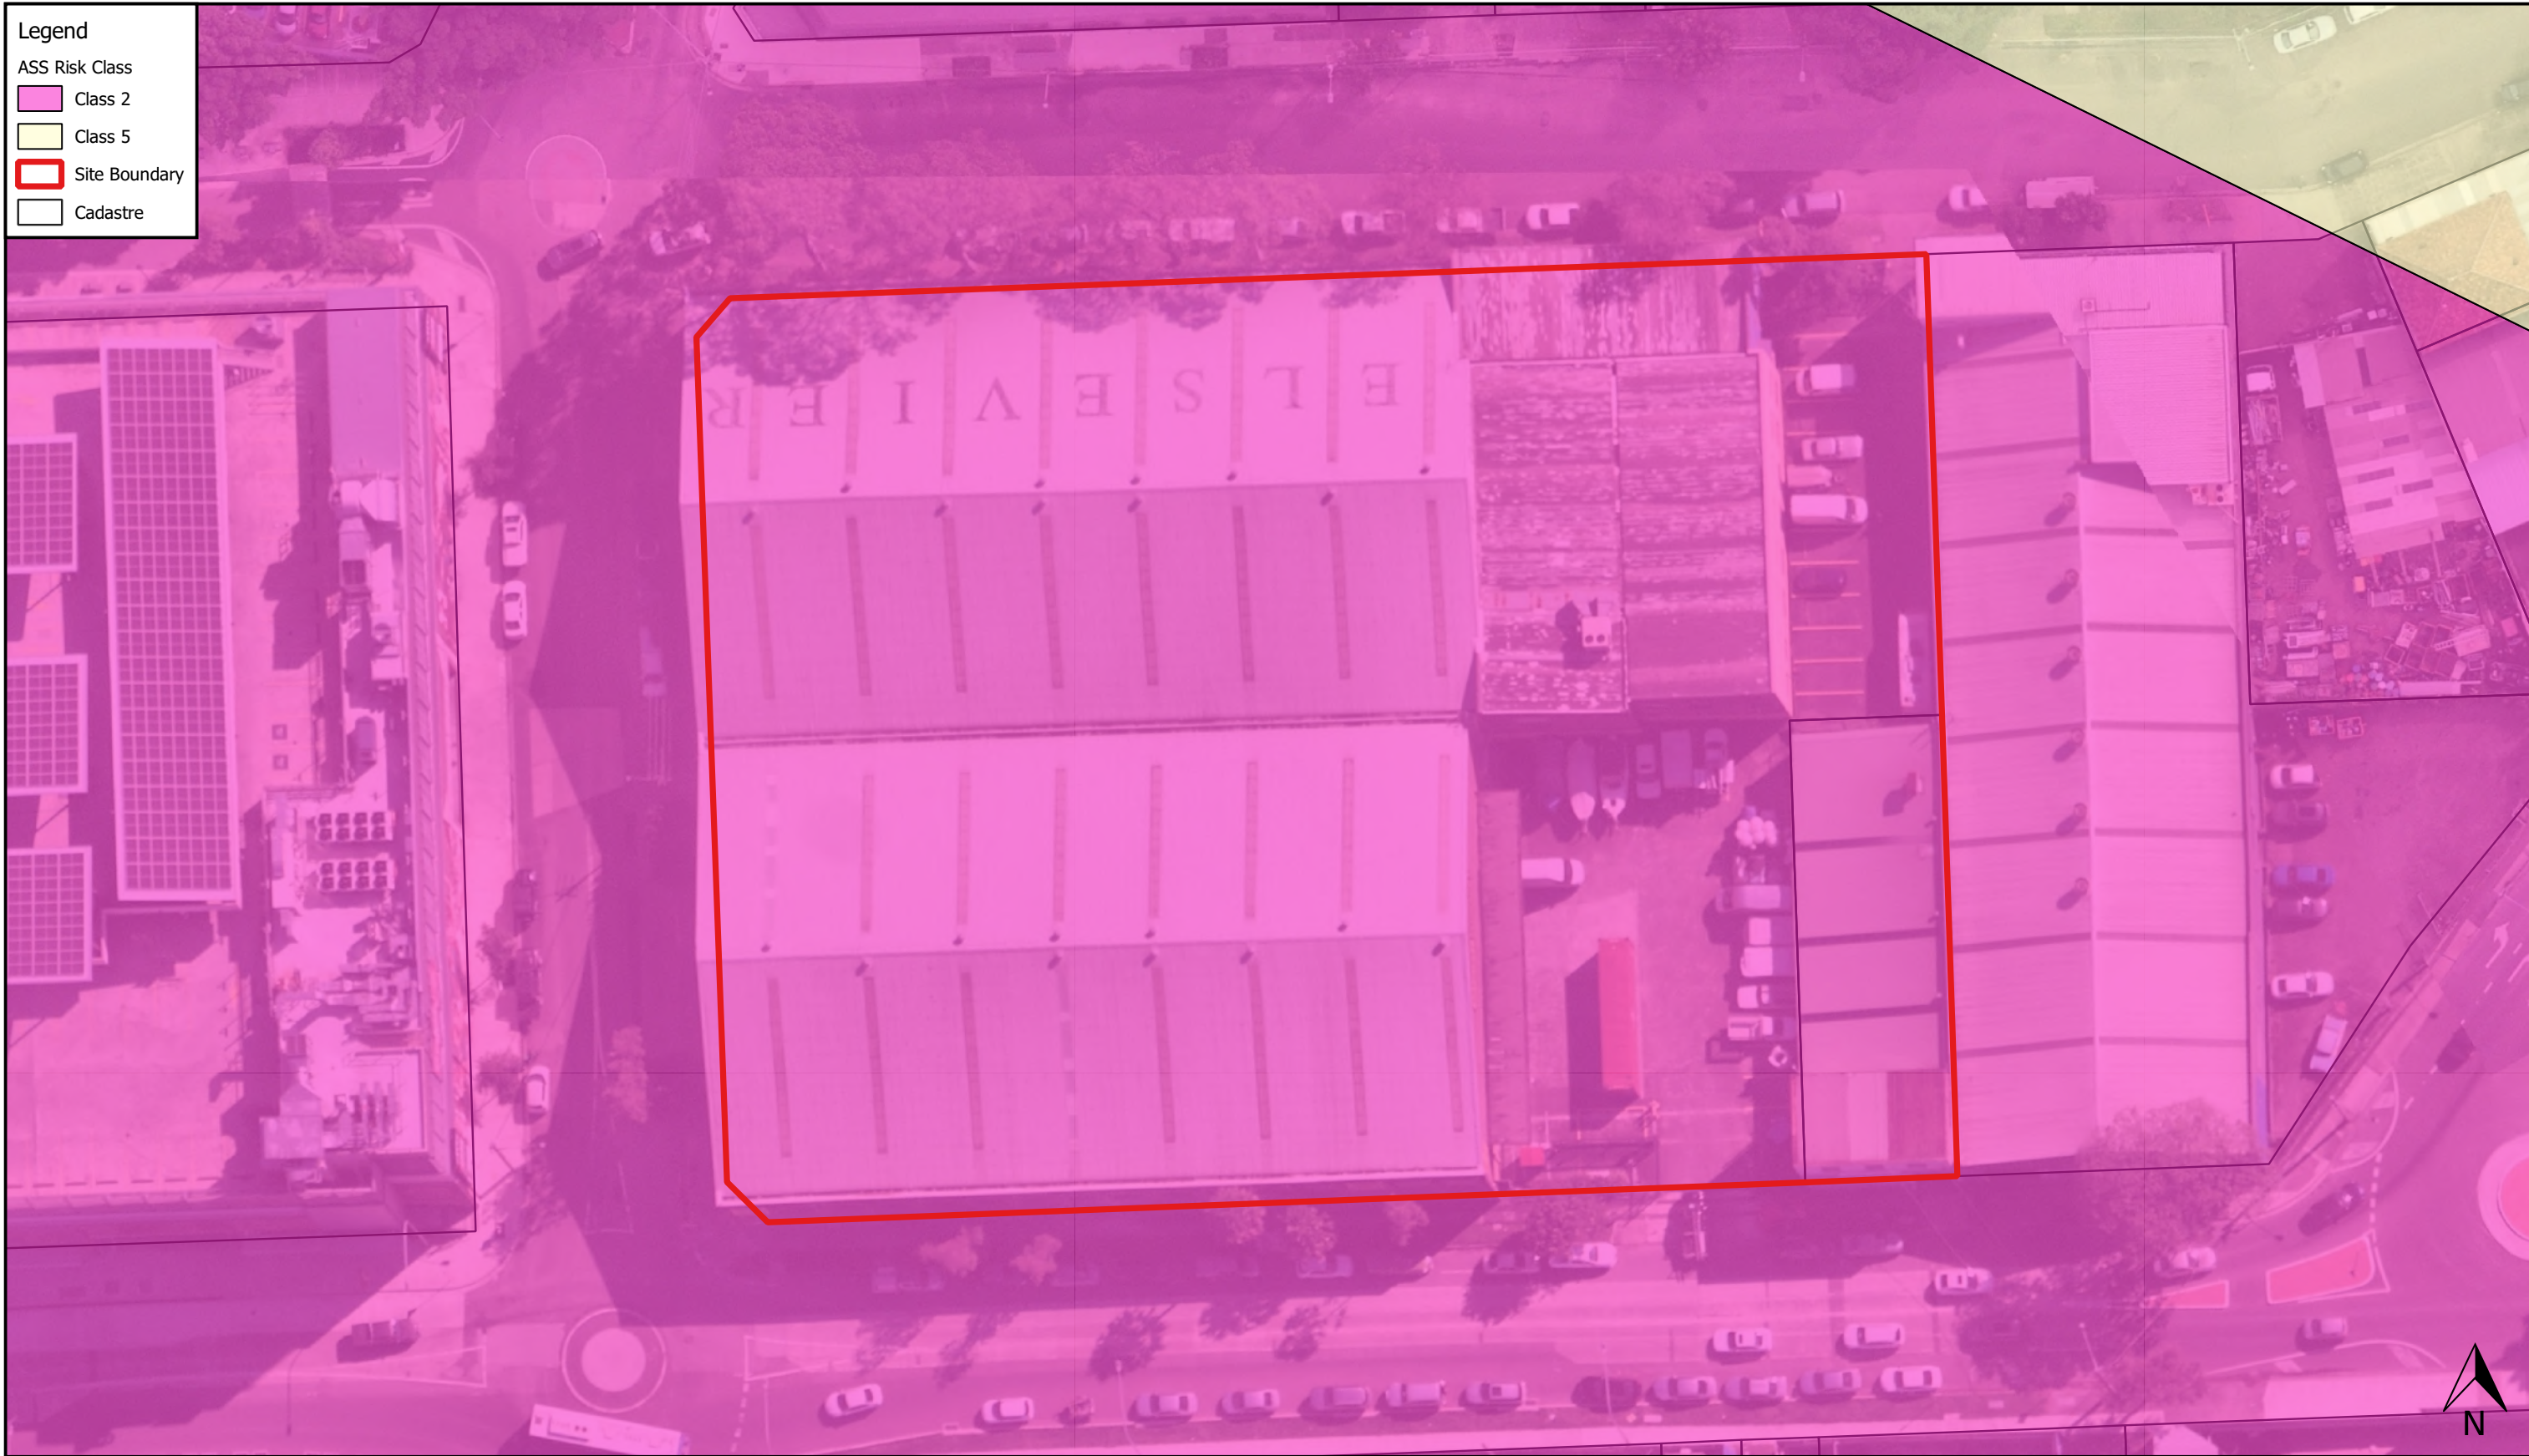
Map Title / Figure:
ASS Risk Map

The Marrickville Local Environmental Plan (2011) ASS risk map indicates that the entire site is located within a Class 2 risk area for ASS. Class 2 risk designates that any works undertaken below the natural ground surface, or by which the water table is likely to be lowered, will require an ASSMP or a preliminary assessment as per ASSMAC (1998) prior to development consent.

Site location relating to ASS risk is presented on Map 03 in Attachment A.

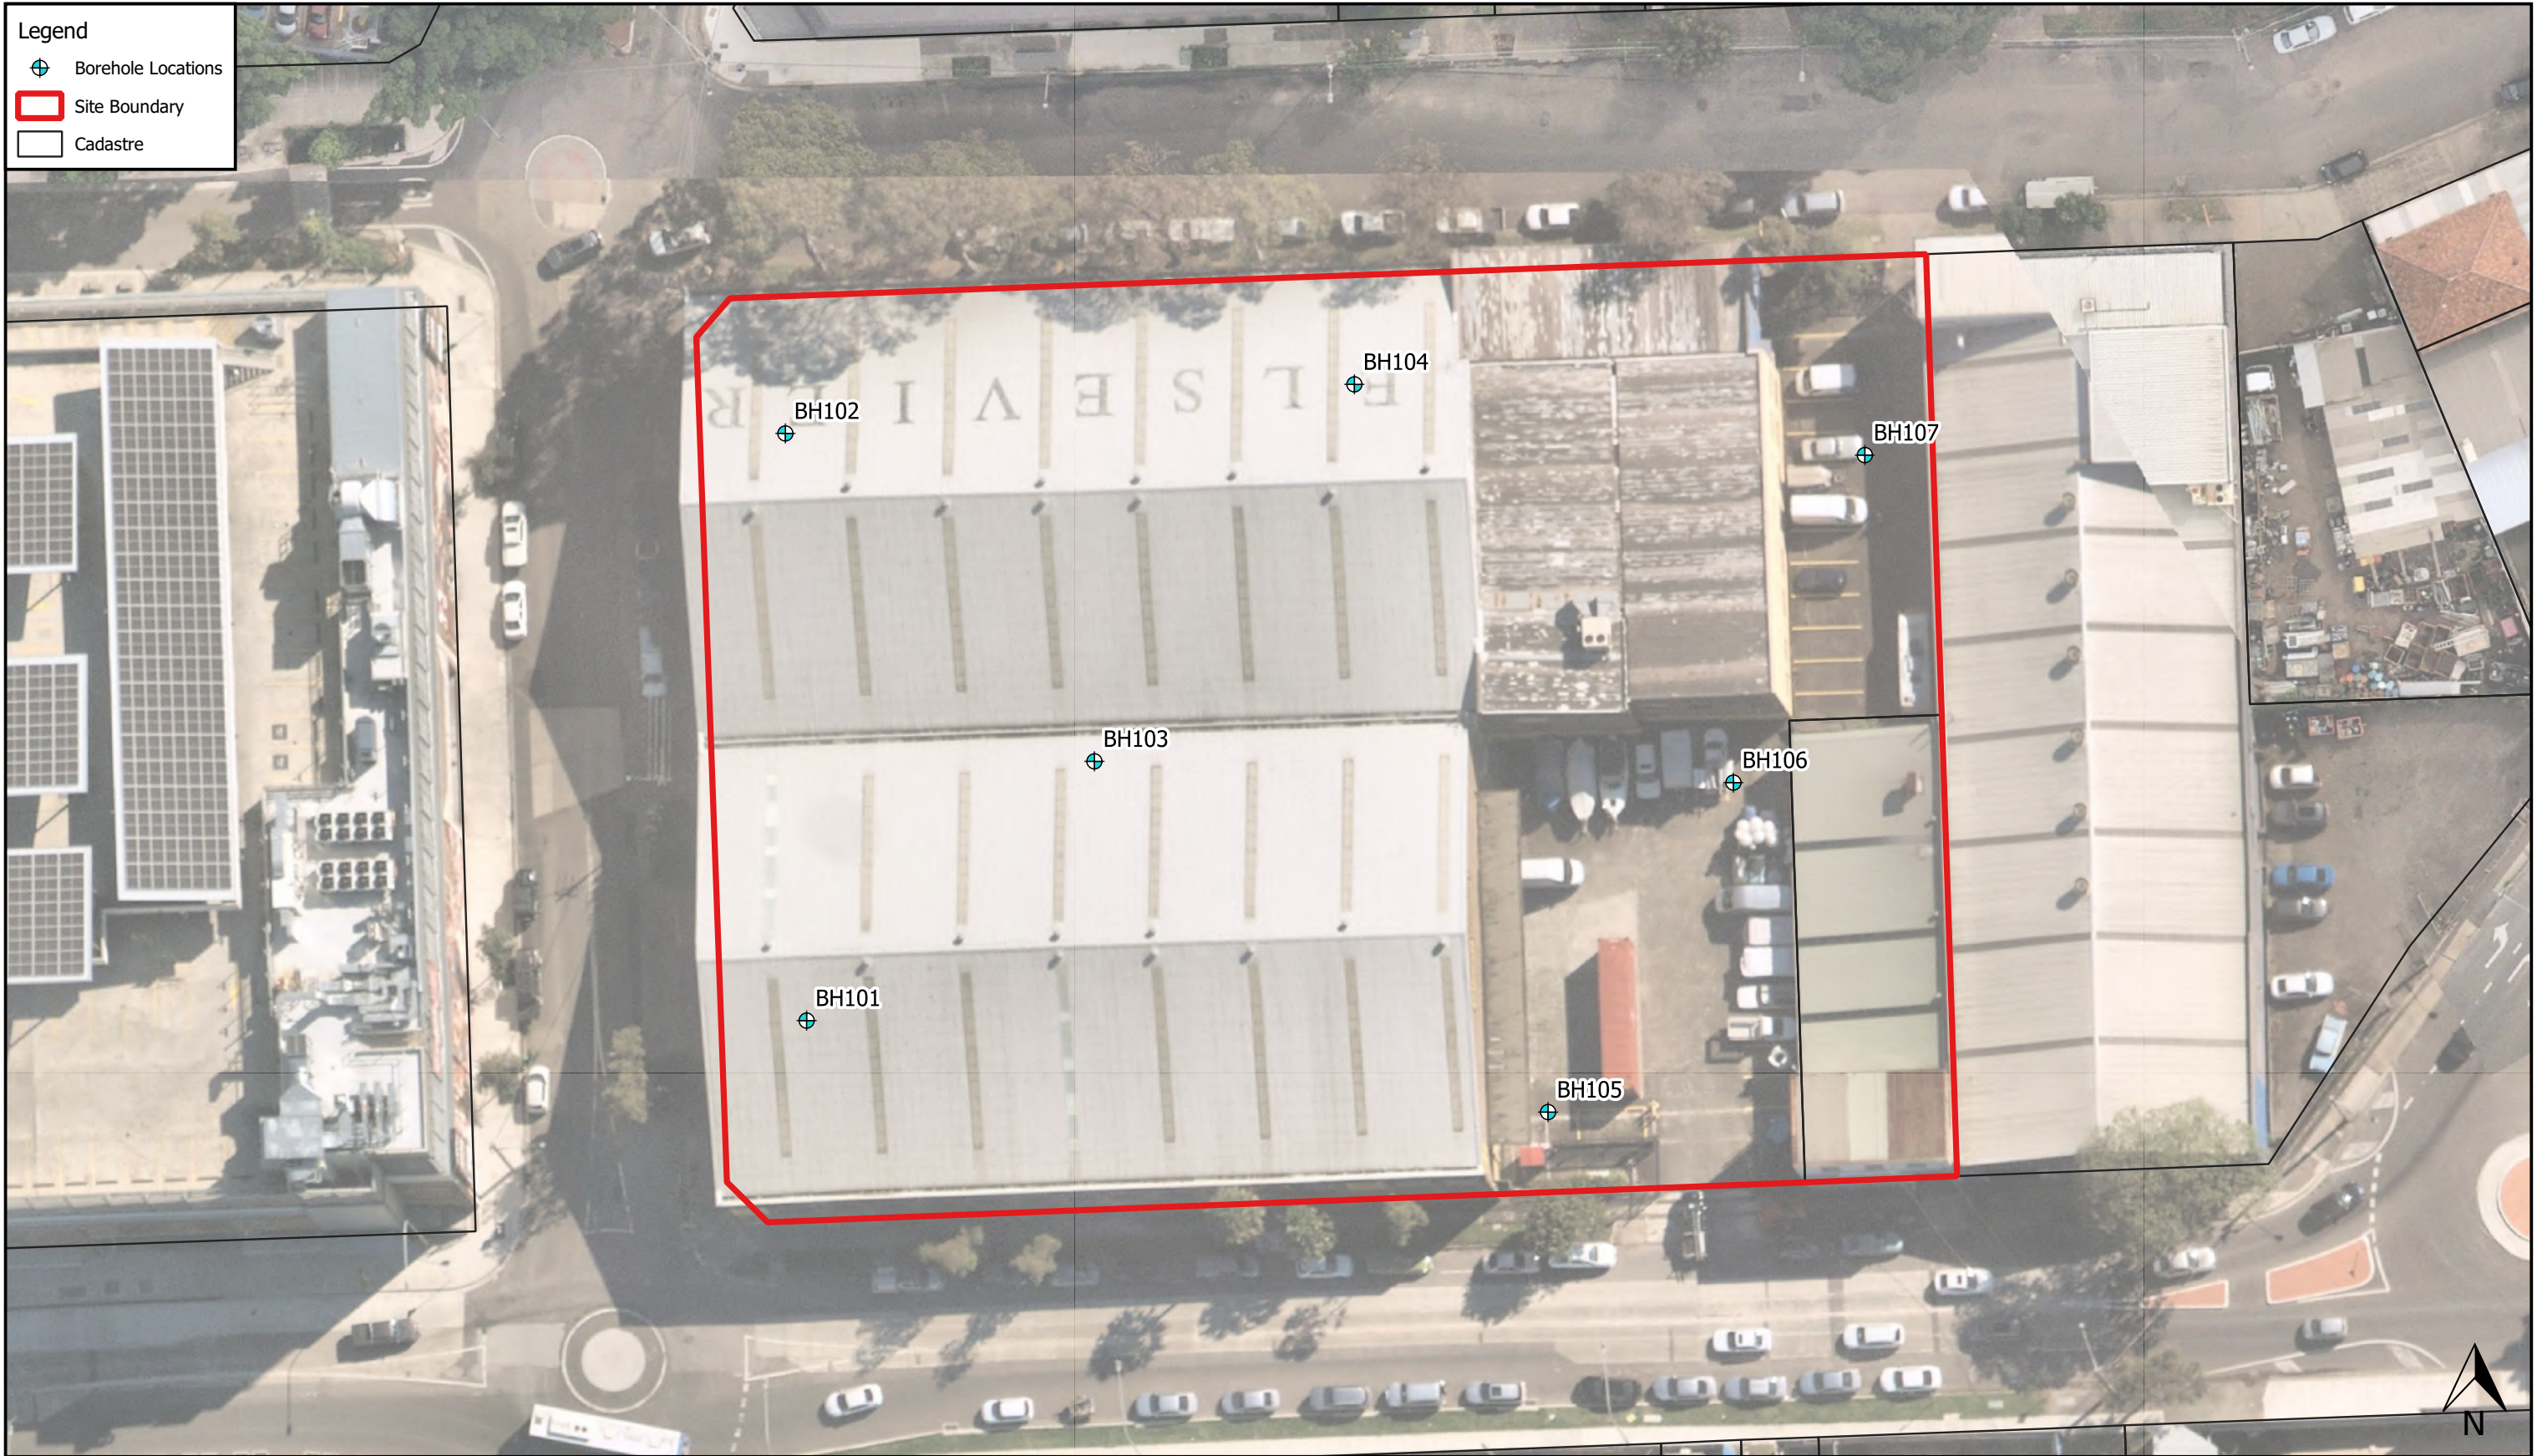
Map Title / Figure:
Testing Plan

- Excavation of four boreholes (BH101 – BH104) using a hand auger / push tube to a maximum depth of 2.0 mbgl.
- Excavation of three boreholes (BH105 – BH107) using a truck mounted drill rig fitted with solid flight augers, to a maximum depth of 7.5 mbgl.
- Collection of representative soil samples from all boreholes for laboratory ASS analysis and future reference purposes.

Testing locations are shown on Map 04 in Attachment A.
