Hazardous Building Materials Assessment

Cottage 11

11 Marion Street
Leichhardt NSW 2040

Inner West Council
January 2018

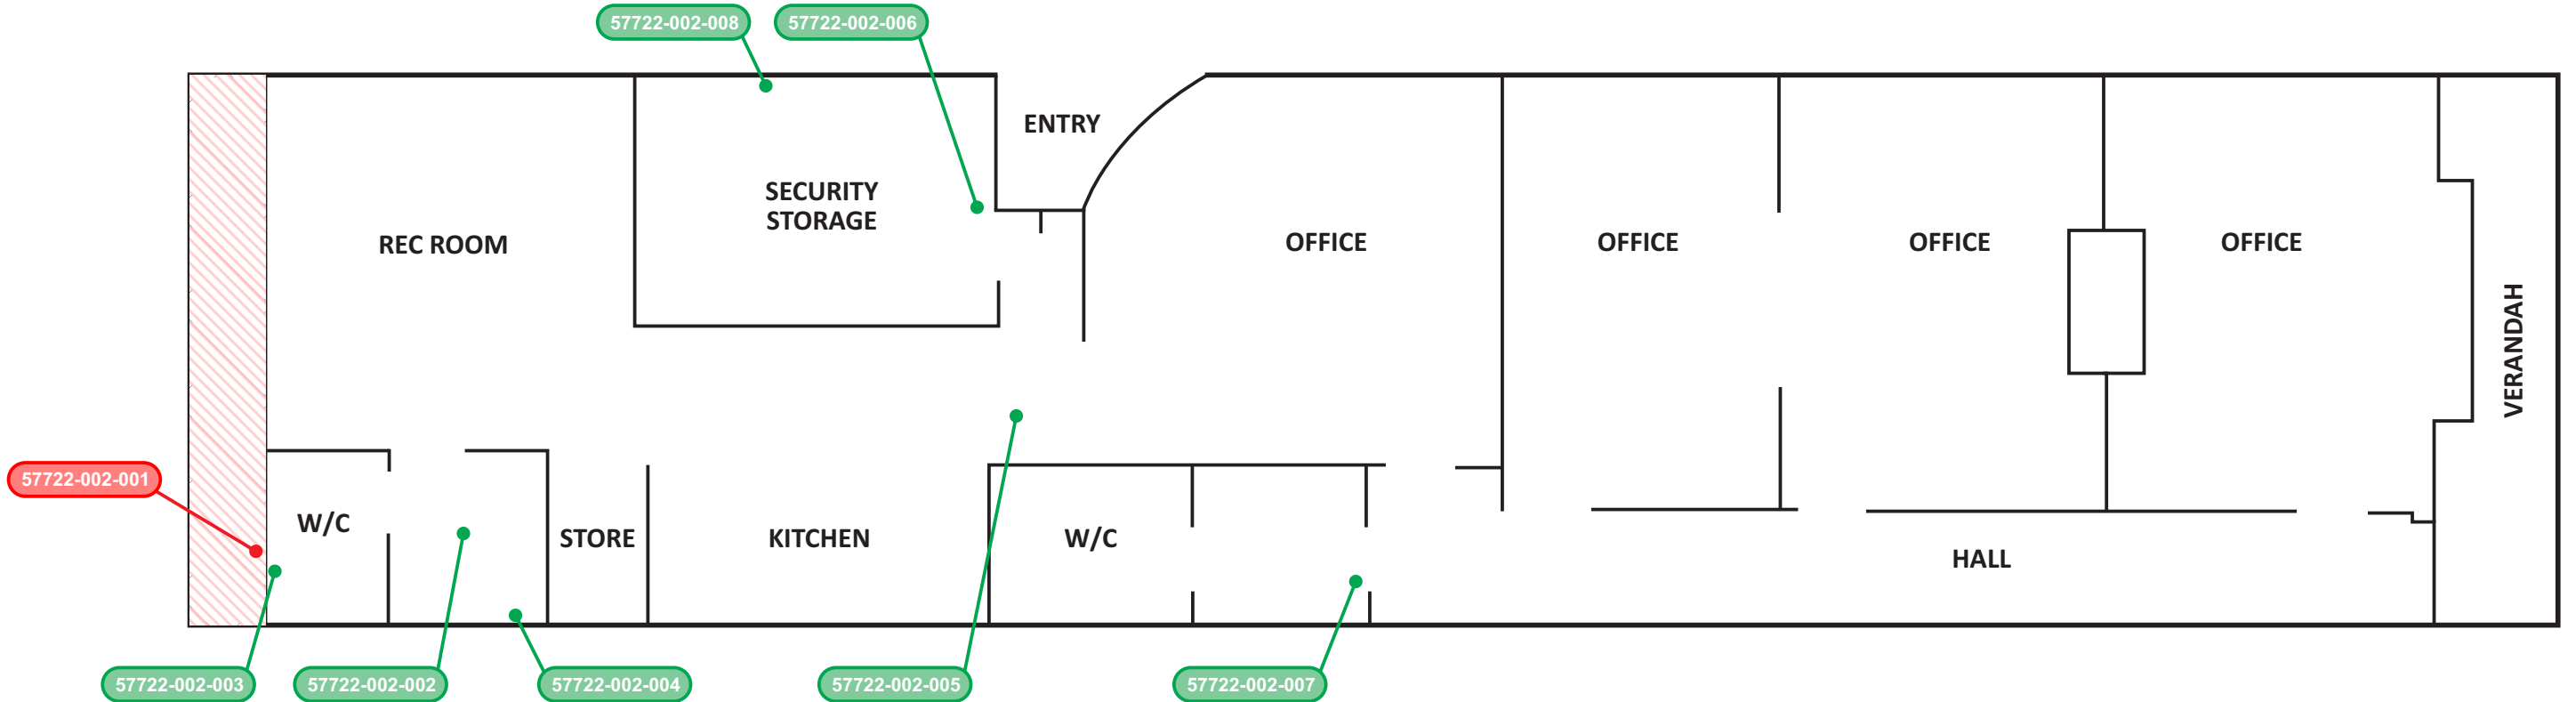
Cottage 11, 11 Marion Street, Leichhart - Ground Level

Only asbestos containing materials (ACM) have been labelled on the attached site plan to prevent confusion and ensure that these materials are given priority for action. Therefore, other hazardous materials may be present within the building and the register attached in section 1 should be consulted prior to work commencing.
