Hazardous Building Materials Assessment

Cottage 9

9 Marion Street

Inner West Council
January 2018

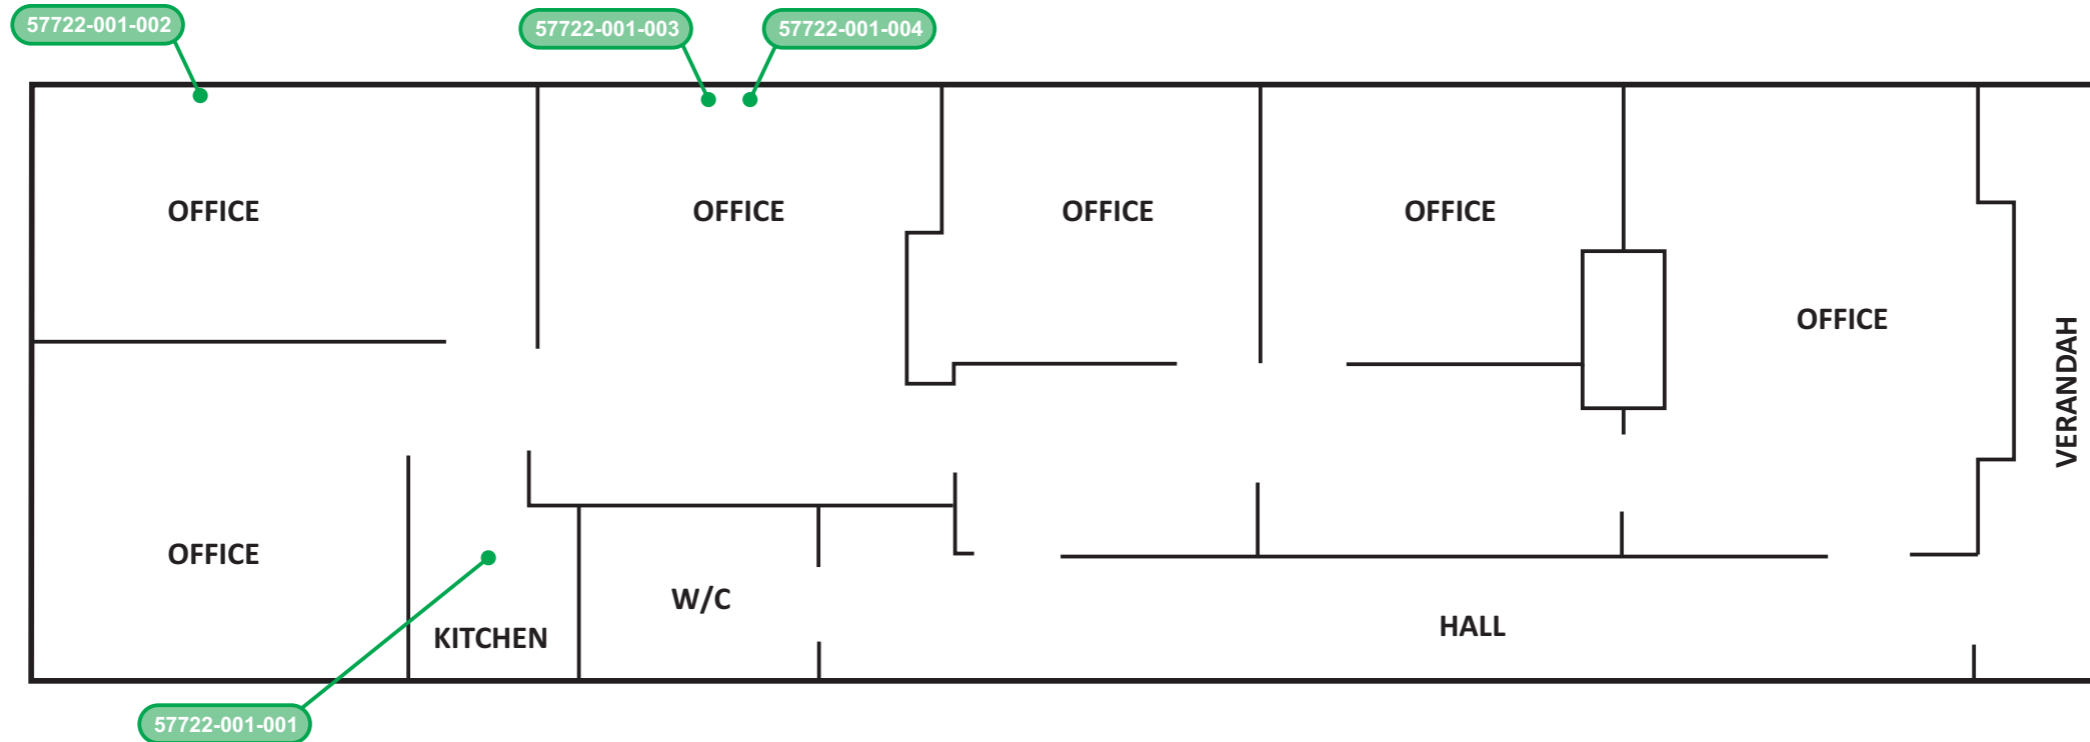
Cottage 9, 9 Marion Street, Leichhart - Ground Level

Only asbestos containing materials (ACM) have been labelled on the attached site plan to prevent confusion and ensure that these materials are given priority for action. Therefore, other hazardous materials may be present within the building and the register attached in section 1 should be consulted prior to work commencing.
