# Hazardous Building Materials Assessment Leichhardt Town Hall Caretakers Flat 107 Norton Street Leichhardt NSW 2040

Inner West Council  
January 2018

Job No.: 57722-003

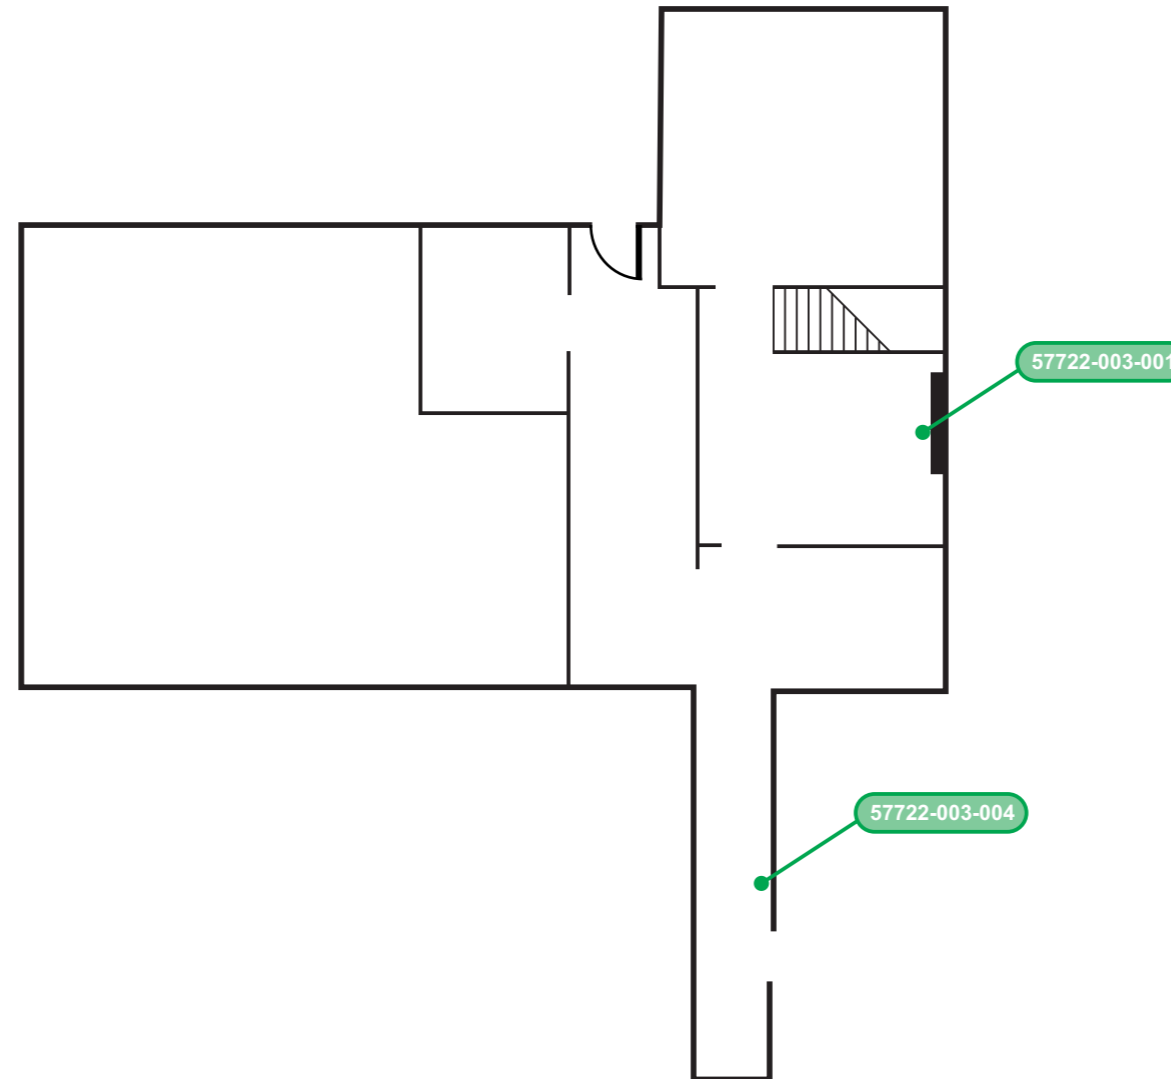
# Caretakers Cottage, Leichhardt Town Hall - Ground Level

*Only asbestos containing materials (ACM) have been labelled on the attached site plan to prevent confusion and ensure that these materials are given priority for action. Therefore, other hazardous materials may be present within the building and the register attached in section 1 should be consulted prior to work commencing.*
