Hazardous Building Materials Assessment Leichhardt Depot Recycling Facility 229 Catherine Street Leichhardt NSW 2040

Inner West Council
February 2018

Job No: 57722-037

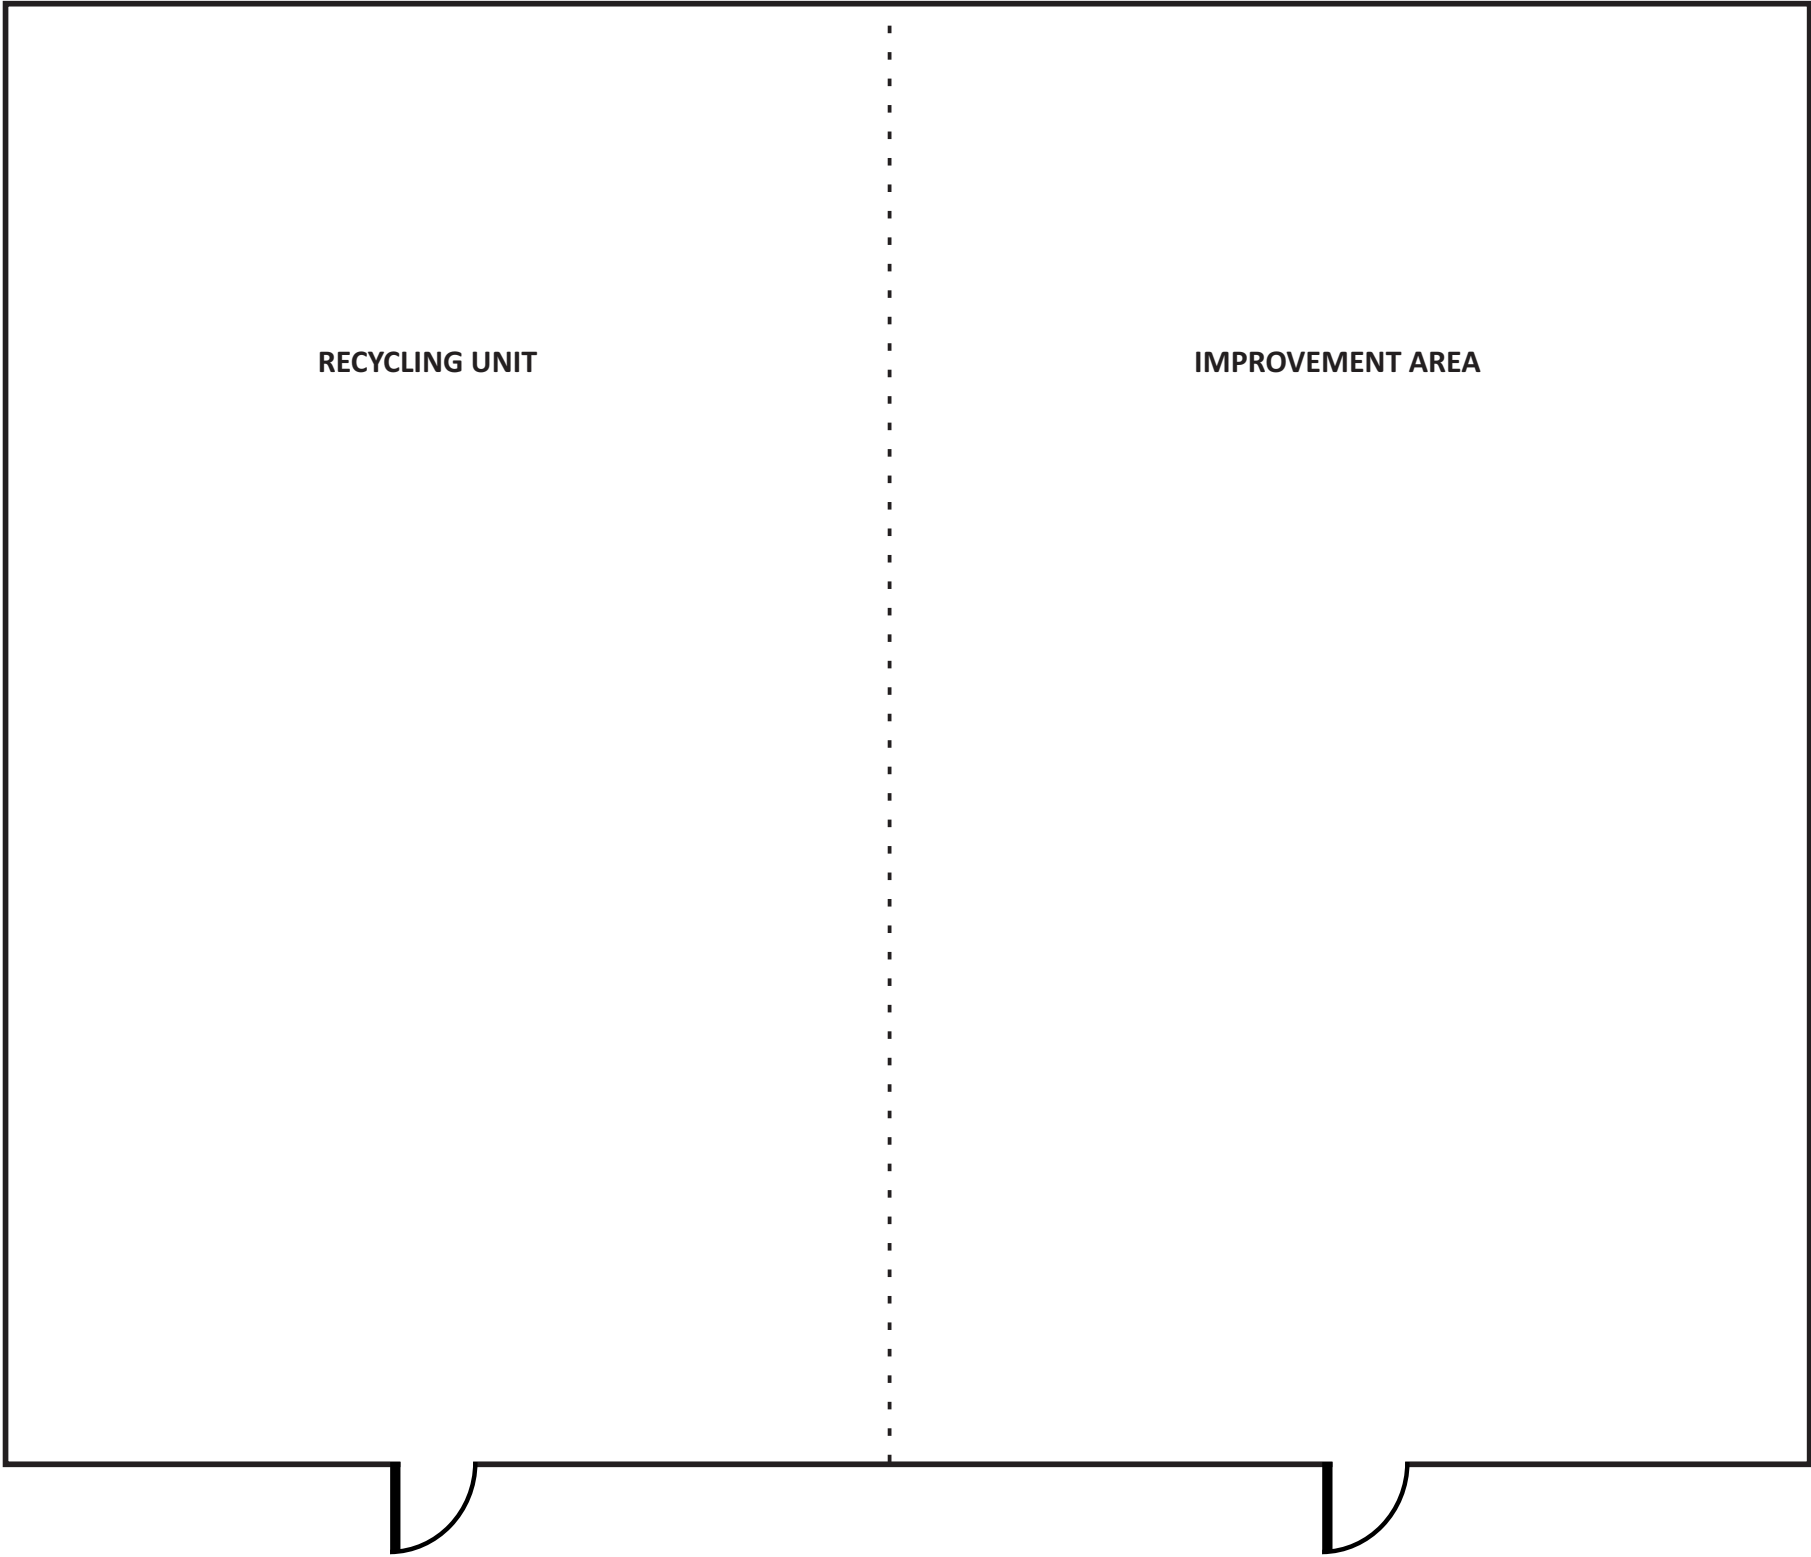
Leichhardt Depot Recycling Facility Ground Level

*Only asbestos-containing materials (ACM) have been labelled on the attached site plan to prevent confusion and ensure that these materials are given priority for action. Therefore, other hazardous materials may be present within the building and the register attached in **Section 1** should be consulted prior to work commencing.*
