# Hazardous Building Materials Assessment Leichhardt Town Hall 107 Norton Street Leichhardt NSW 2040

Inner West Council  
February 2018

Job No.: 57722-004

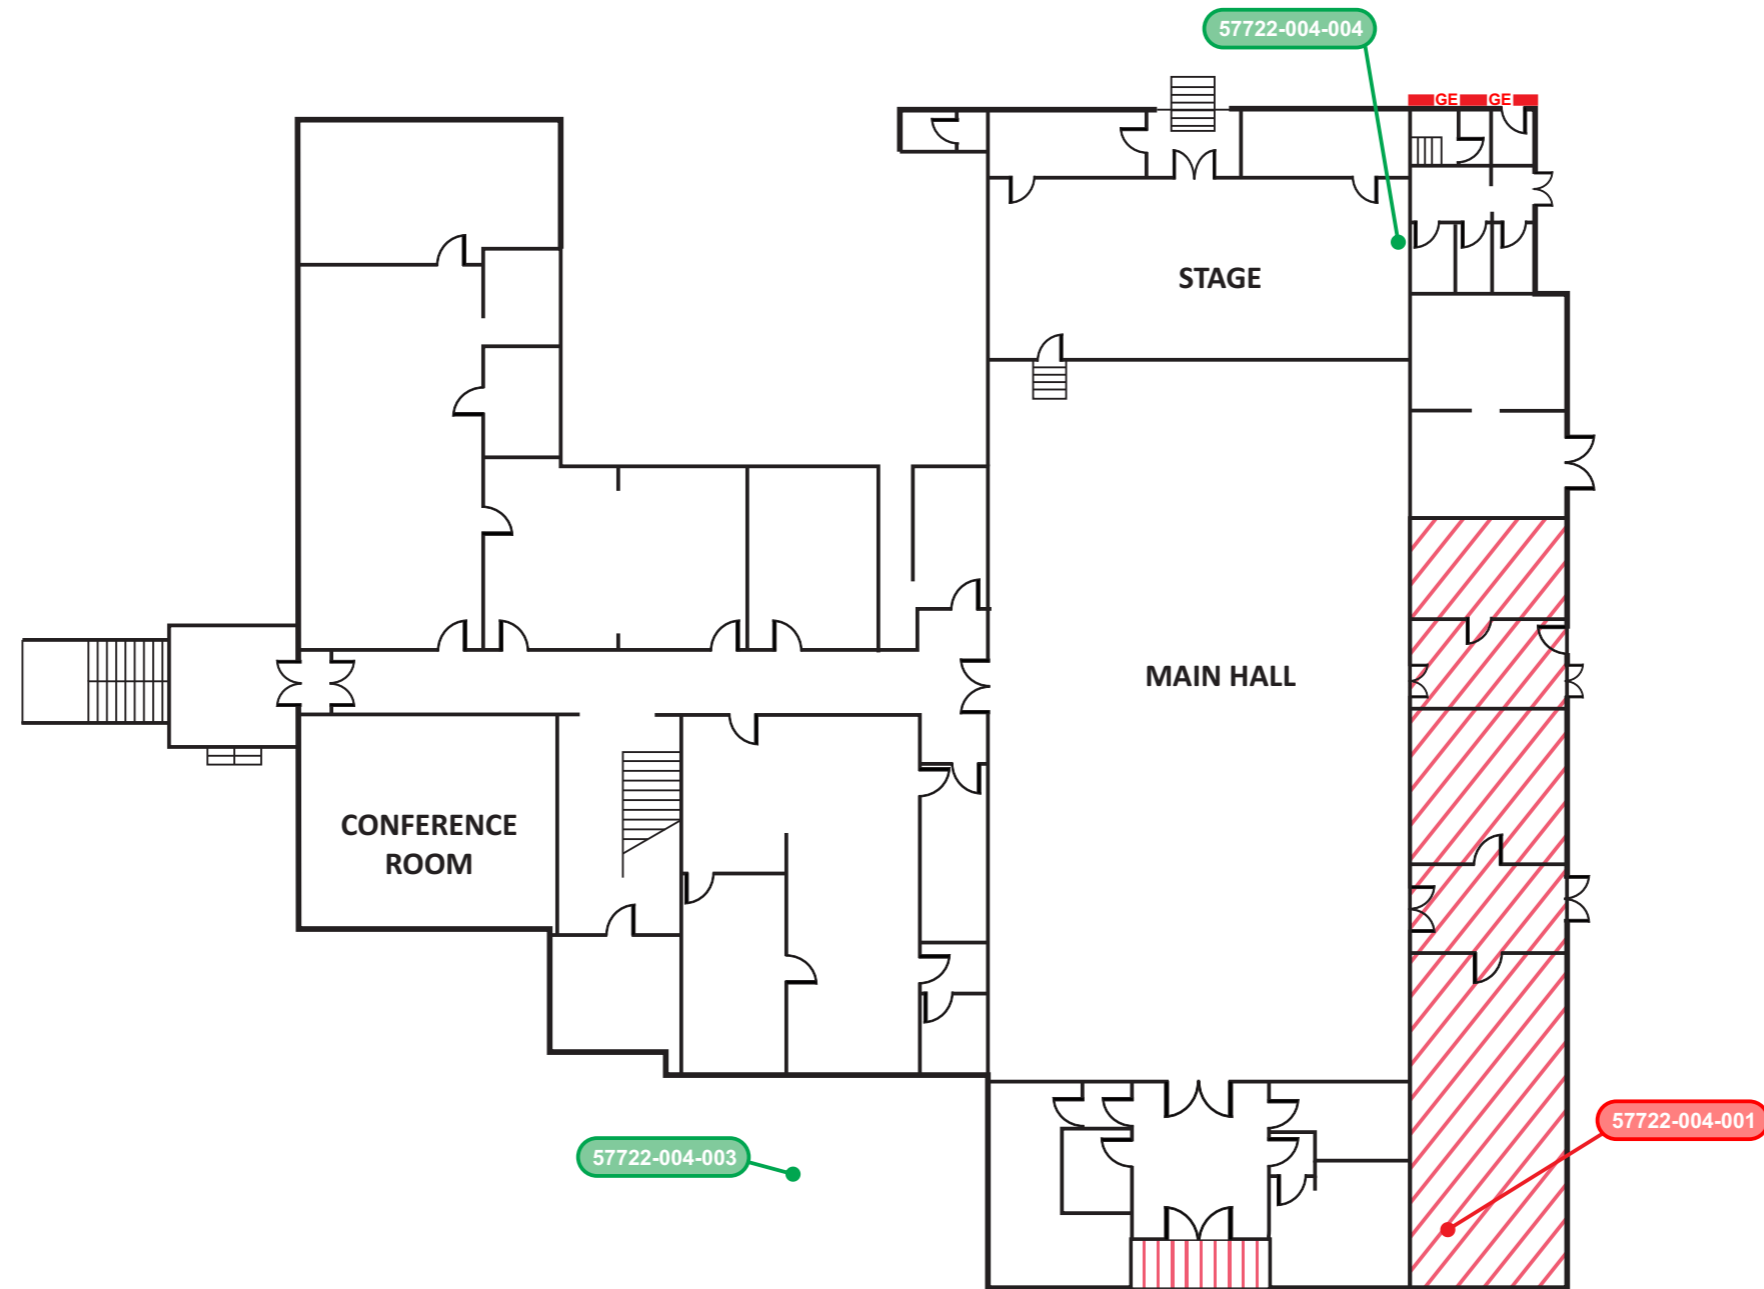
# Leichhardt Town Hall - Ground Level

*Only asbestos containing materials (ACM) have been labelled on the attached site plan to prevent confusion and ensure that these materials are given priority for action. Therefore, other hazardous materials may be present within the building and the register attached in section 1 should be consulted prior to work commencing.*
