Hazardous Building Materials Assessment Tempe Reserve - Tempe Jets Club Holbeach Avenue Tempe NSW 2044

Inner West Council
February 2018

Job No.: 57722-143

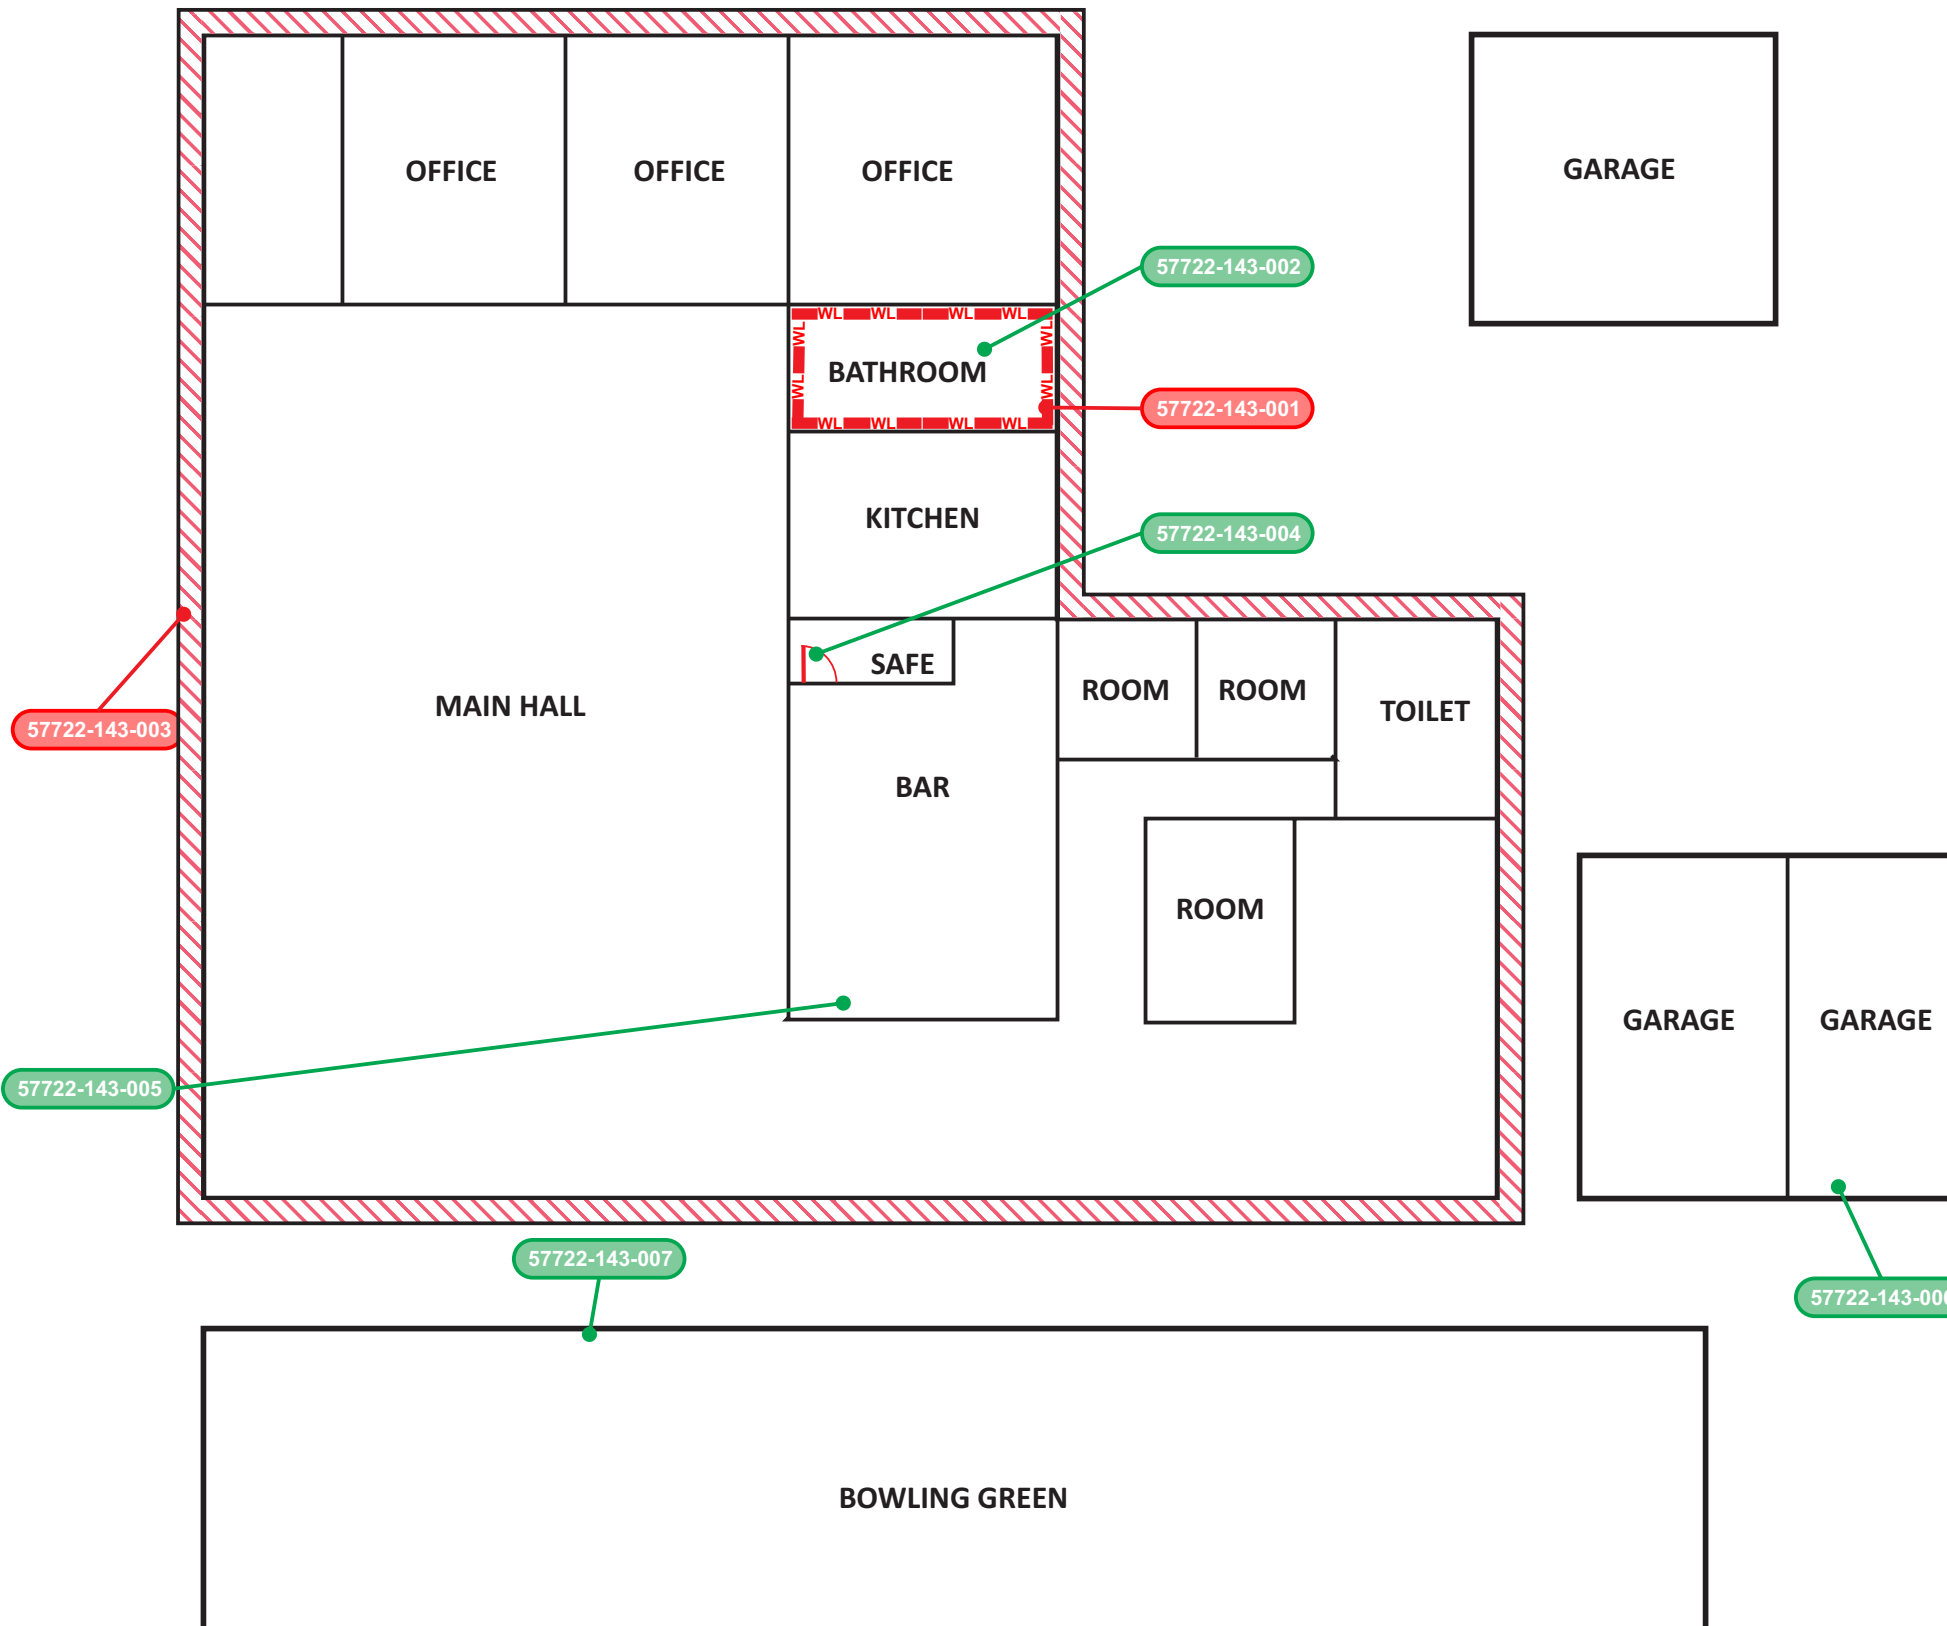
Tempe Reserve Tempe Jets Club Tempe - Ground Level

*Only asbestos-containing materials (ACM) have been labelled on the attached site plan to prevent confusion and ensure that these materials are given priority for action. Therefore, other hazardous materials may be present within the building and the register attached in **Section 1** should be consulted prior to work commencing.*
