# Hazardous Building Materials Assessment

## Pratten Park Bowling Club

Arthur Street  
Ashfield NSW 2131

Inner West Council  
March 2018

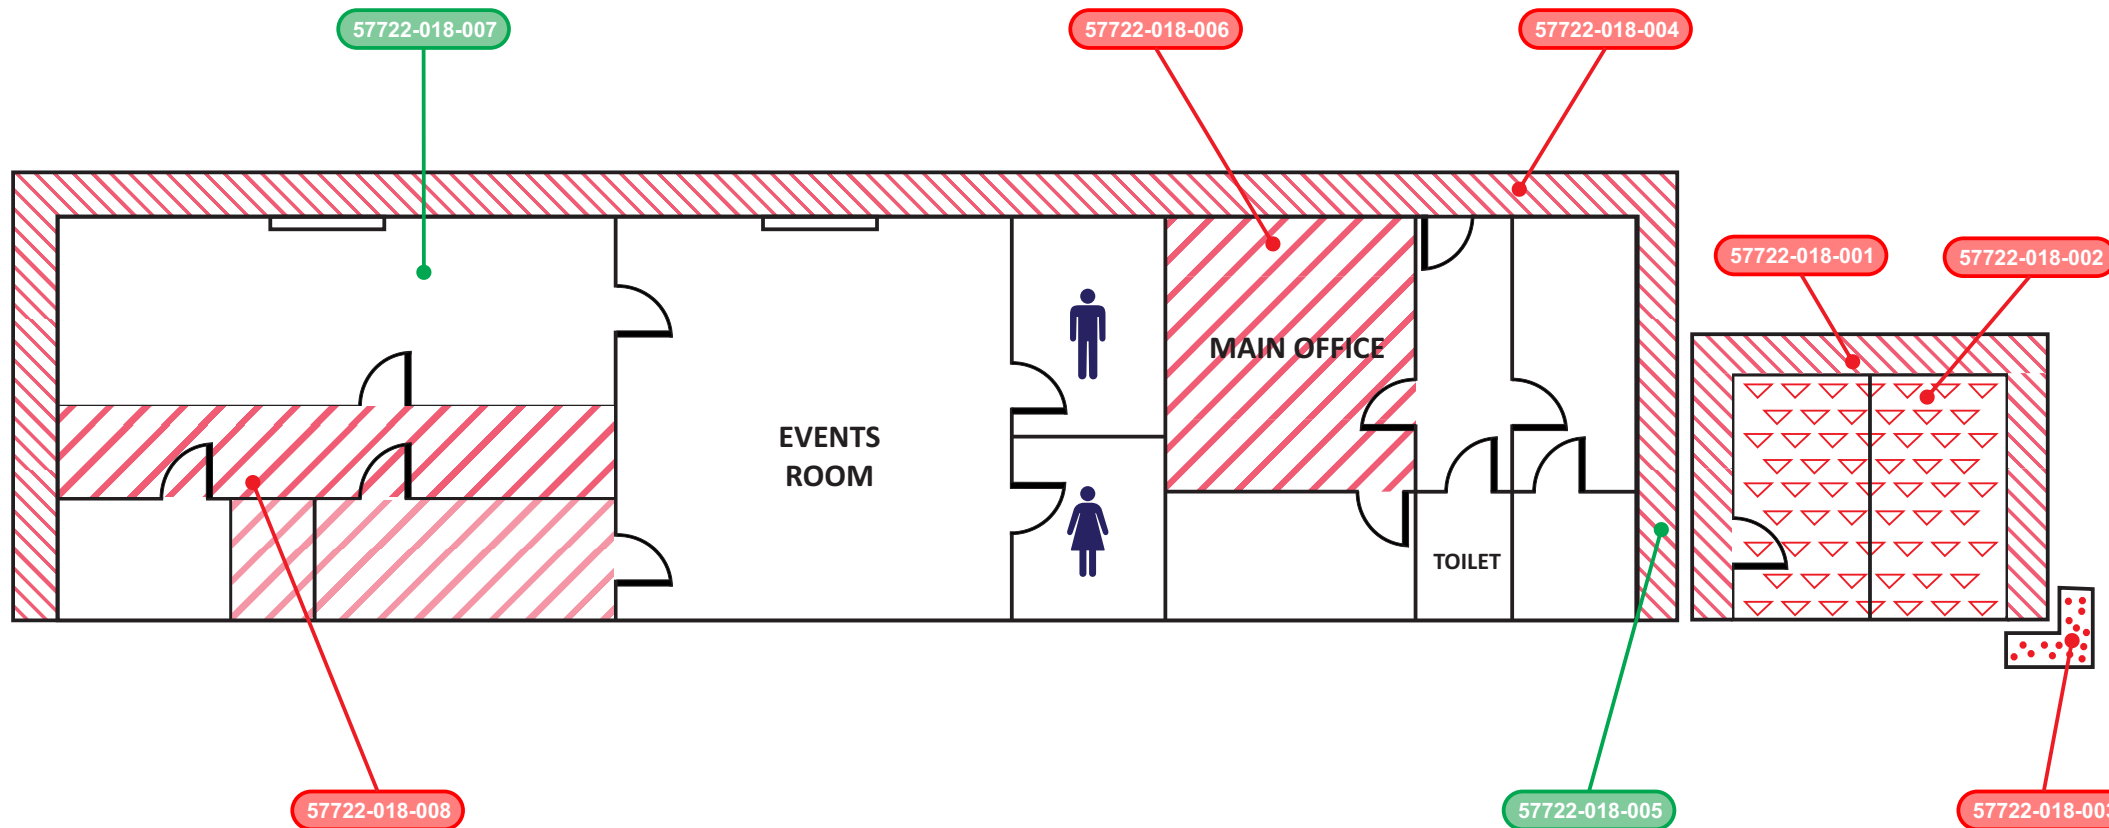
# Pratten Park Bowling Club, Ashfield Ground Level

*Only asbestos-containing materials (ACM) have been labelled on the attached site plan to prevent confusion and ensure that these materials are given priority for action. Therefore, other hazardous materials may be present within the building and the register attached in **Section 1** should be consulted prior to work commencing.*
