# Hazardous Building Materials Assessment

## Hoskins Park Toilets

531-565 Pigott Street  
Dulwich Hill NSW 2203

Inner West Council  
March 2018

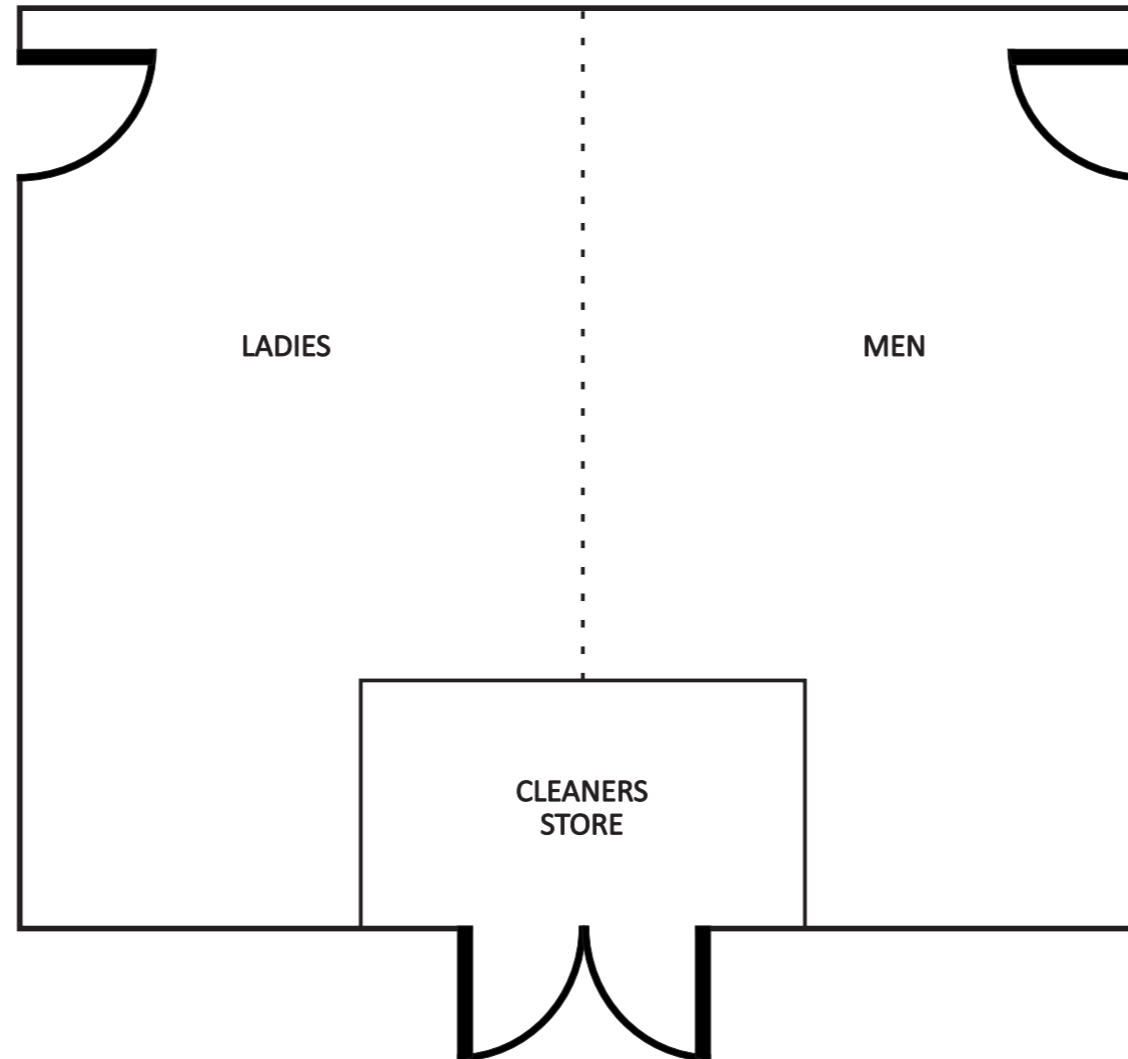
# Hoskins Park Toilets, Dulwich Hill - Ground Level

*Only asbestos-containing materials (ACM) have been labelled on the attached site plan to prevent confusion and ensure that these materials are given priority for action. Therefore, other hazardous materials may be present within the building and the register attached in **Section 1** should be consulted prior to work commencing.*
