Hazardous Building Materials Assessment

St Peters Depot Building C

15-17 Unwins Bridge Road,
St Peters NSW 2044

Inner West Council
April 2018

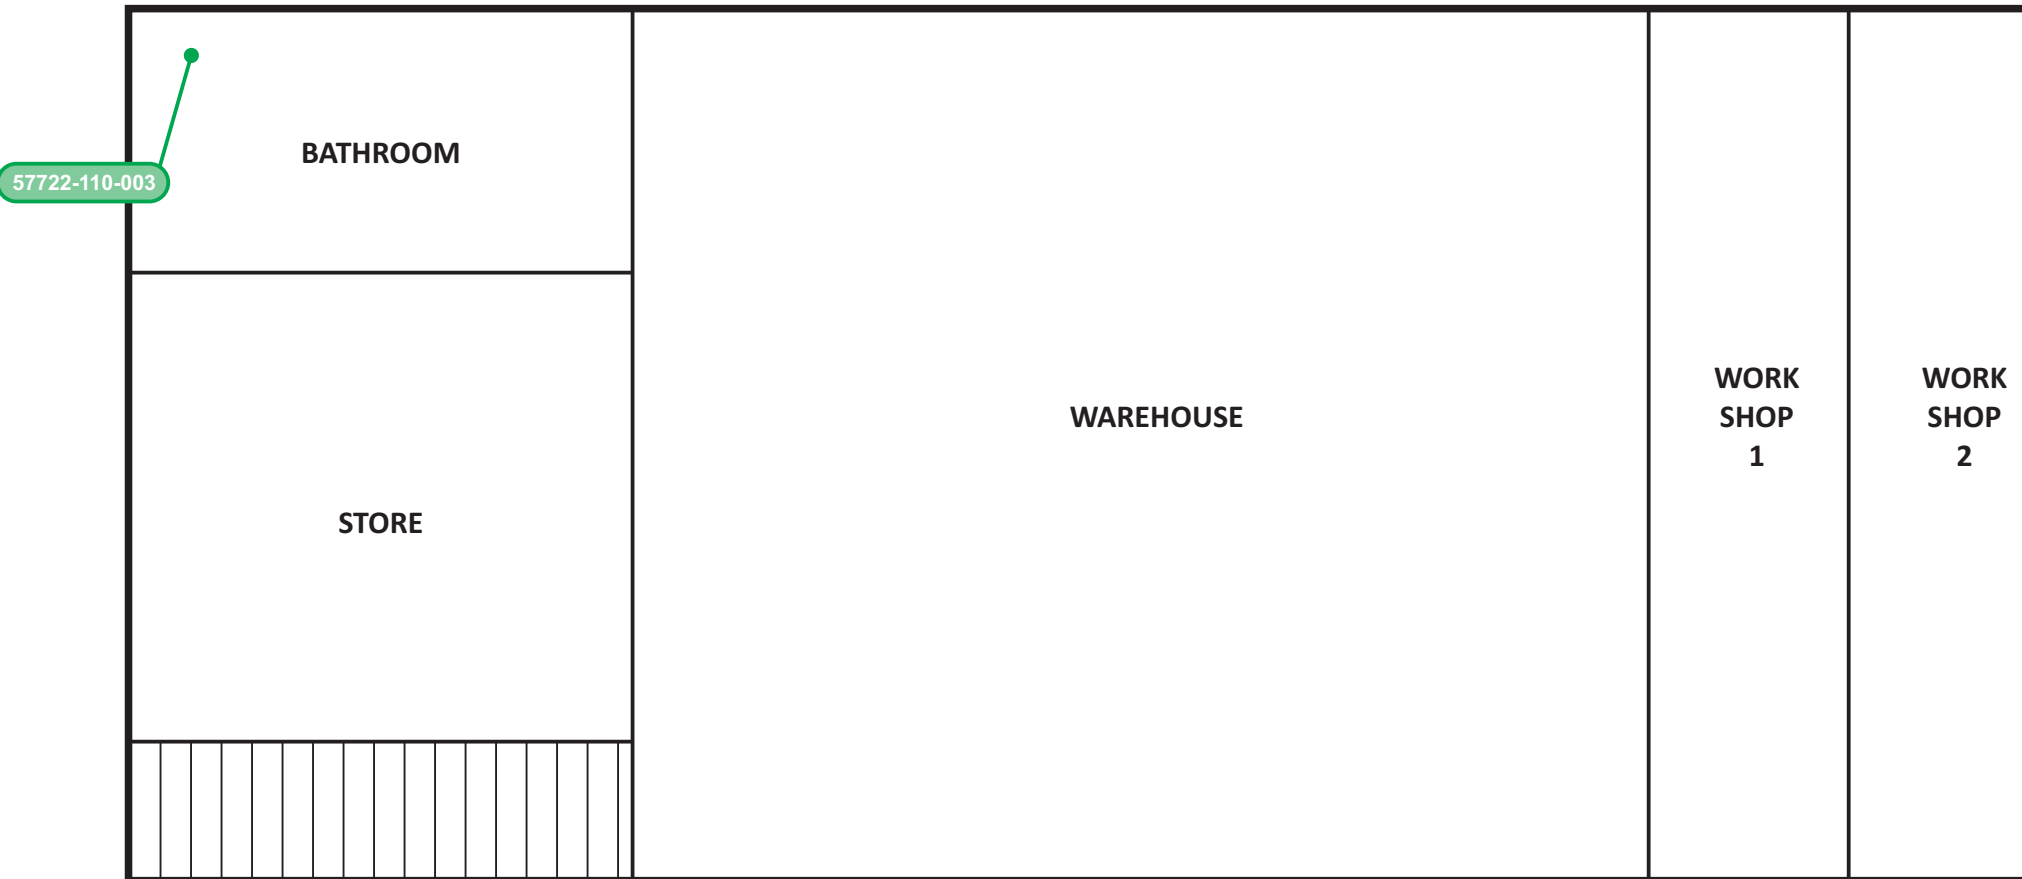
St Peters Depot Building C, St Peters - Ground Level

*Only asbestos-containing materials (ACM) have been labelled on the attached site plan to prevent confusion and ensure that these materials are given priority for action. Therefore, other hazardous materials may be present within the building and the register attached in **Section 1** should be consulted prior to work commencing.*

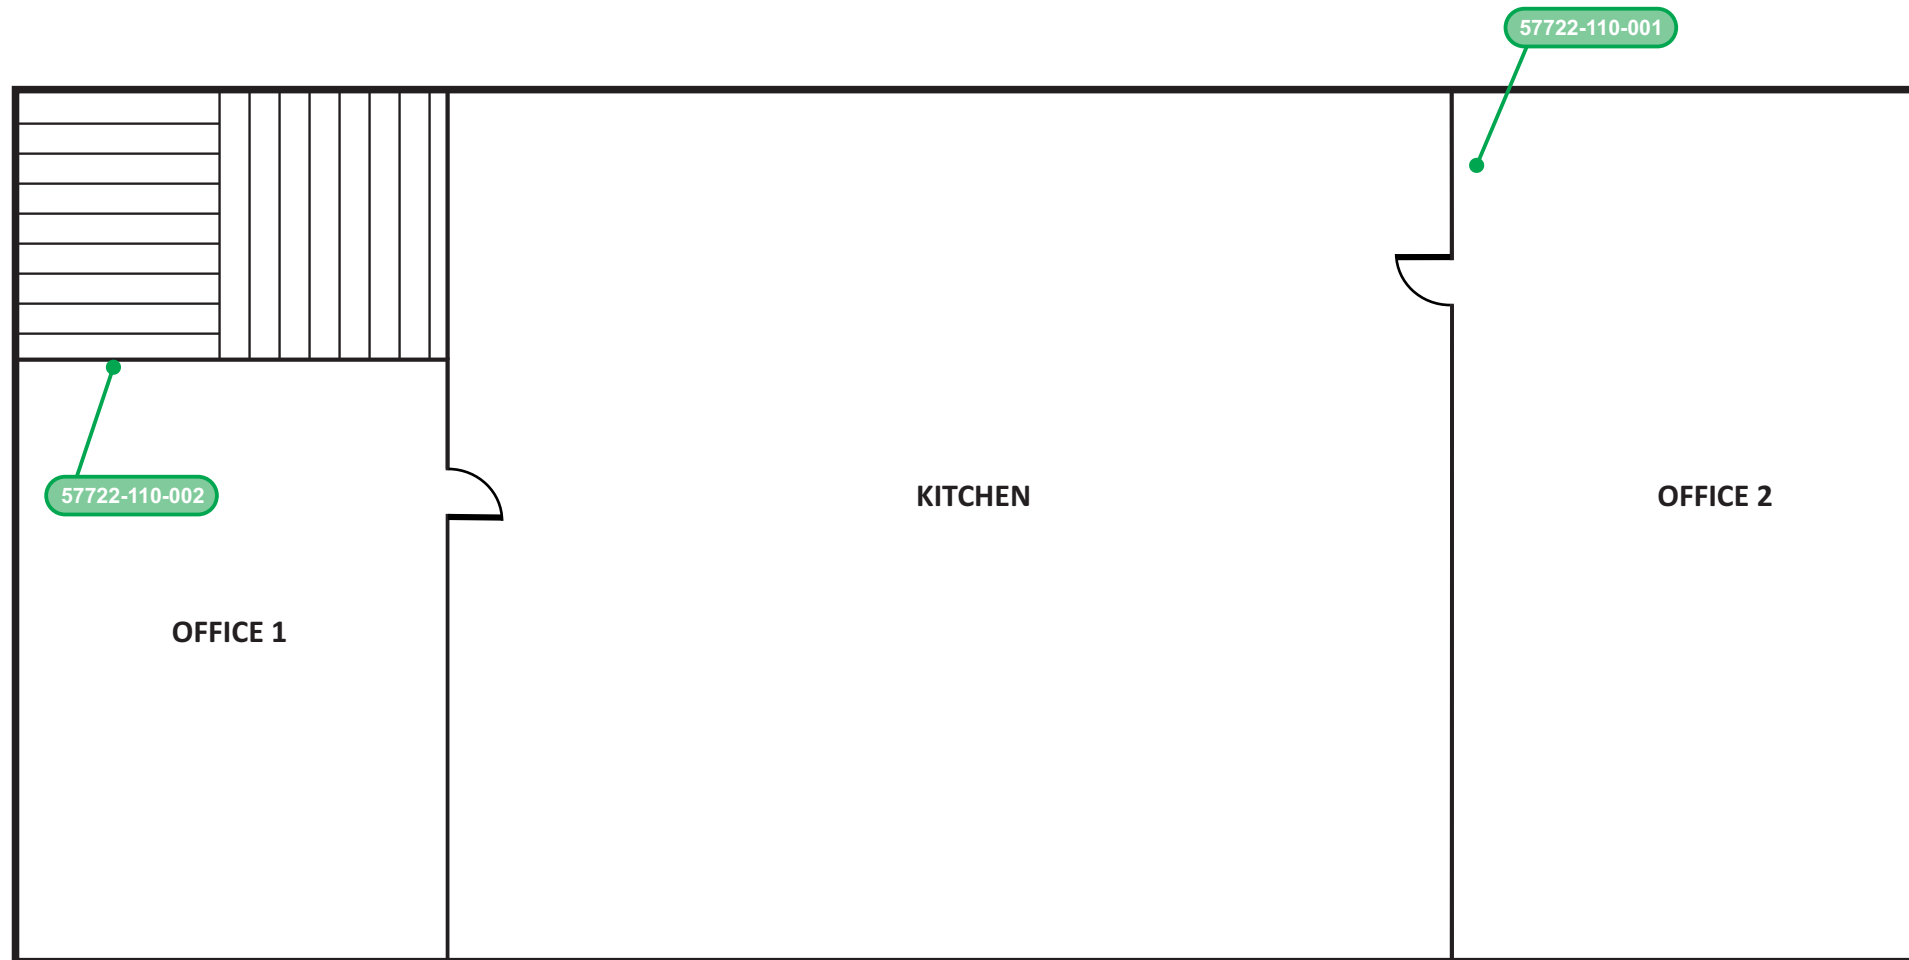
St Peters Depot Building C, St Peters - Mezzanine

Legend: 57722-110-XXX Negative Asbestos Sample
