# Hazardous Building Materials Assessment Cavendish Early Learning Centre 142 Cavendish Street, Stanmore NSW 2048

Inner West Council  
March 2018

Job No.: 57722-007

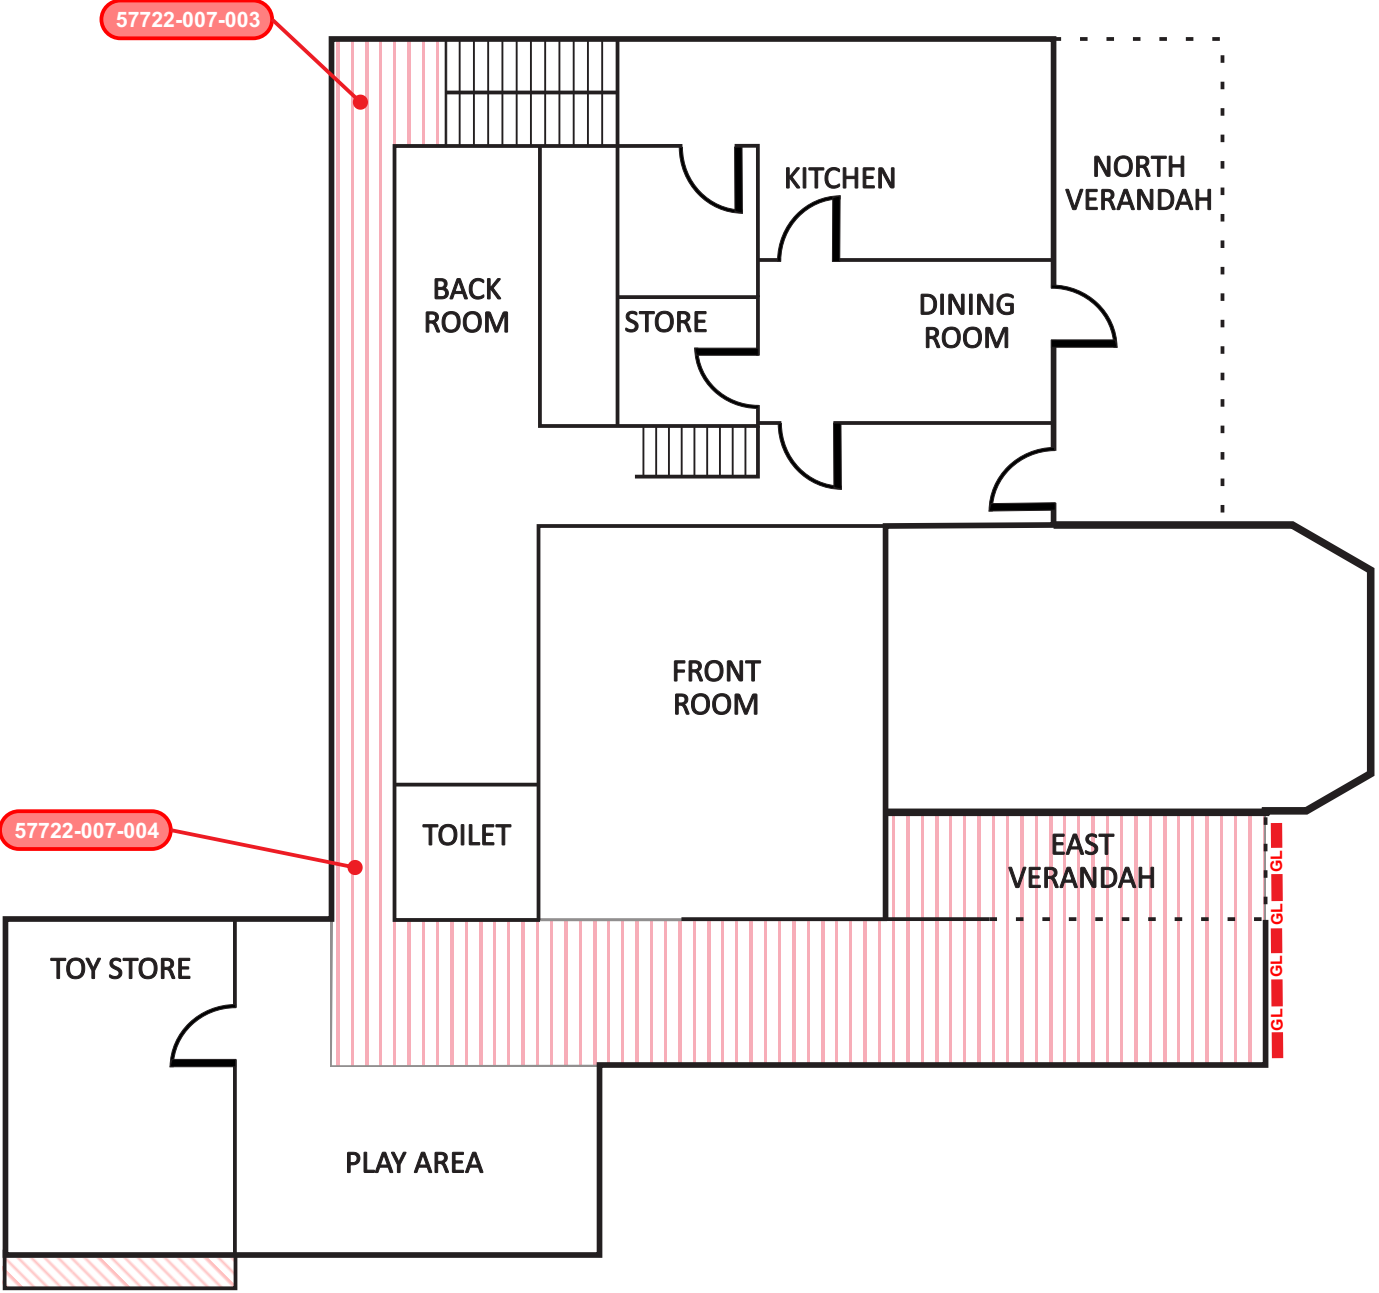
# Cavendish Early Learning Centre, Stanmore - Ground Level

*Only asbestos containing materials (ACM) have been labelled on the attached site plan to prevent confusion and ensure that these materials are given priority for action. Therefore, other hazardous materials may be present within the building and the register attached in section 1 should be consulted prior to work commencing.*
