Hazardous Building Materials Assessment Stanmore Branch Library Stanmore Reserve, Douglas Street, Stanmore NSW 2048

Inner West Council
March 2018

Executive Summary

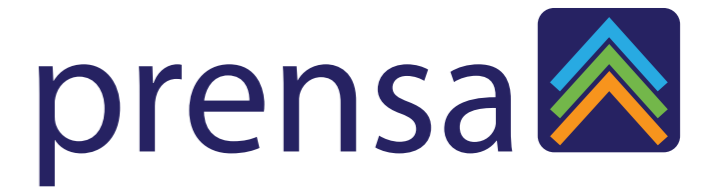
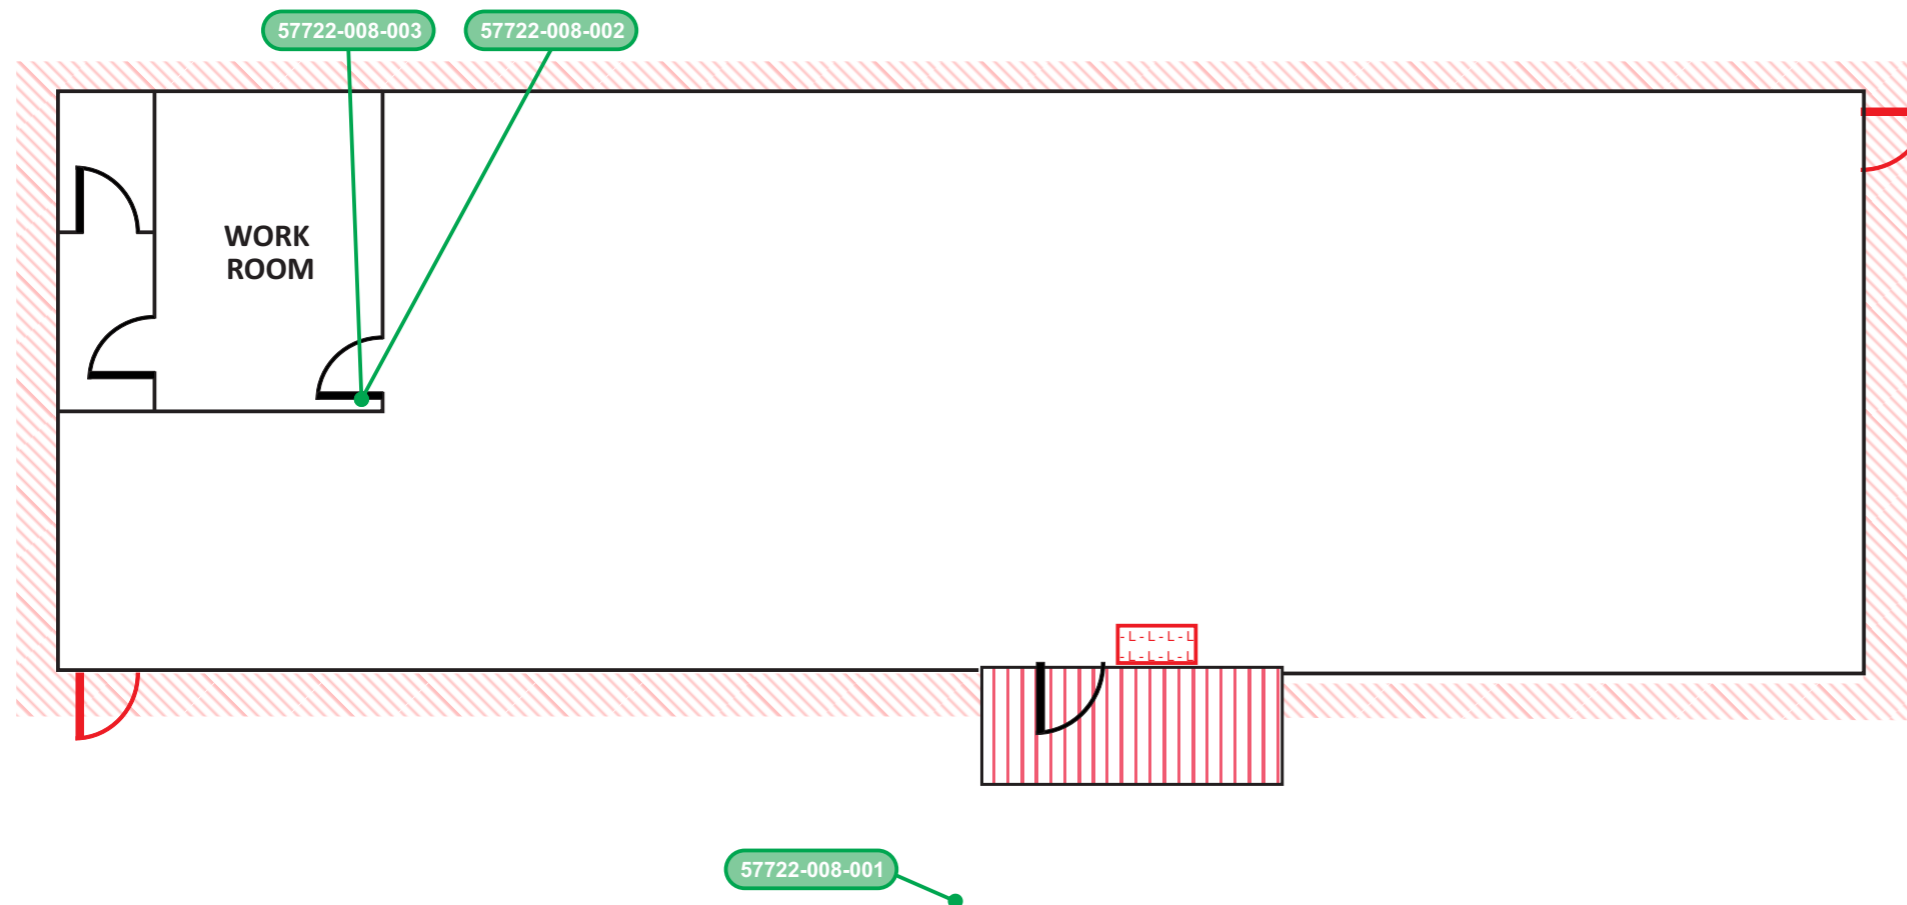
Stanmore Branch Library - Ground Level

*Only asbestos-containing materials (ACM) have been labelled on the attached site plan to prevent confusion and ensure that these materials are given priority for action. Therefore, other hazardous materials may be present within the building and the register attached in **Section 1** should be consulted prior to work commencing.*
