Hazardous Building Materials Assessment Annandale Town Hall & Community Centre 77-79 Johnston Street Annandale NSW 2038

Inner West Council
April 2018

Job No.: 57722-011

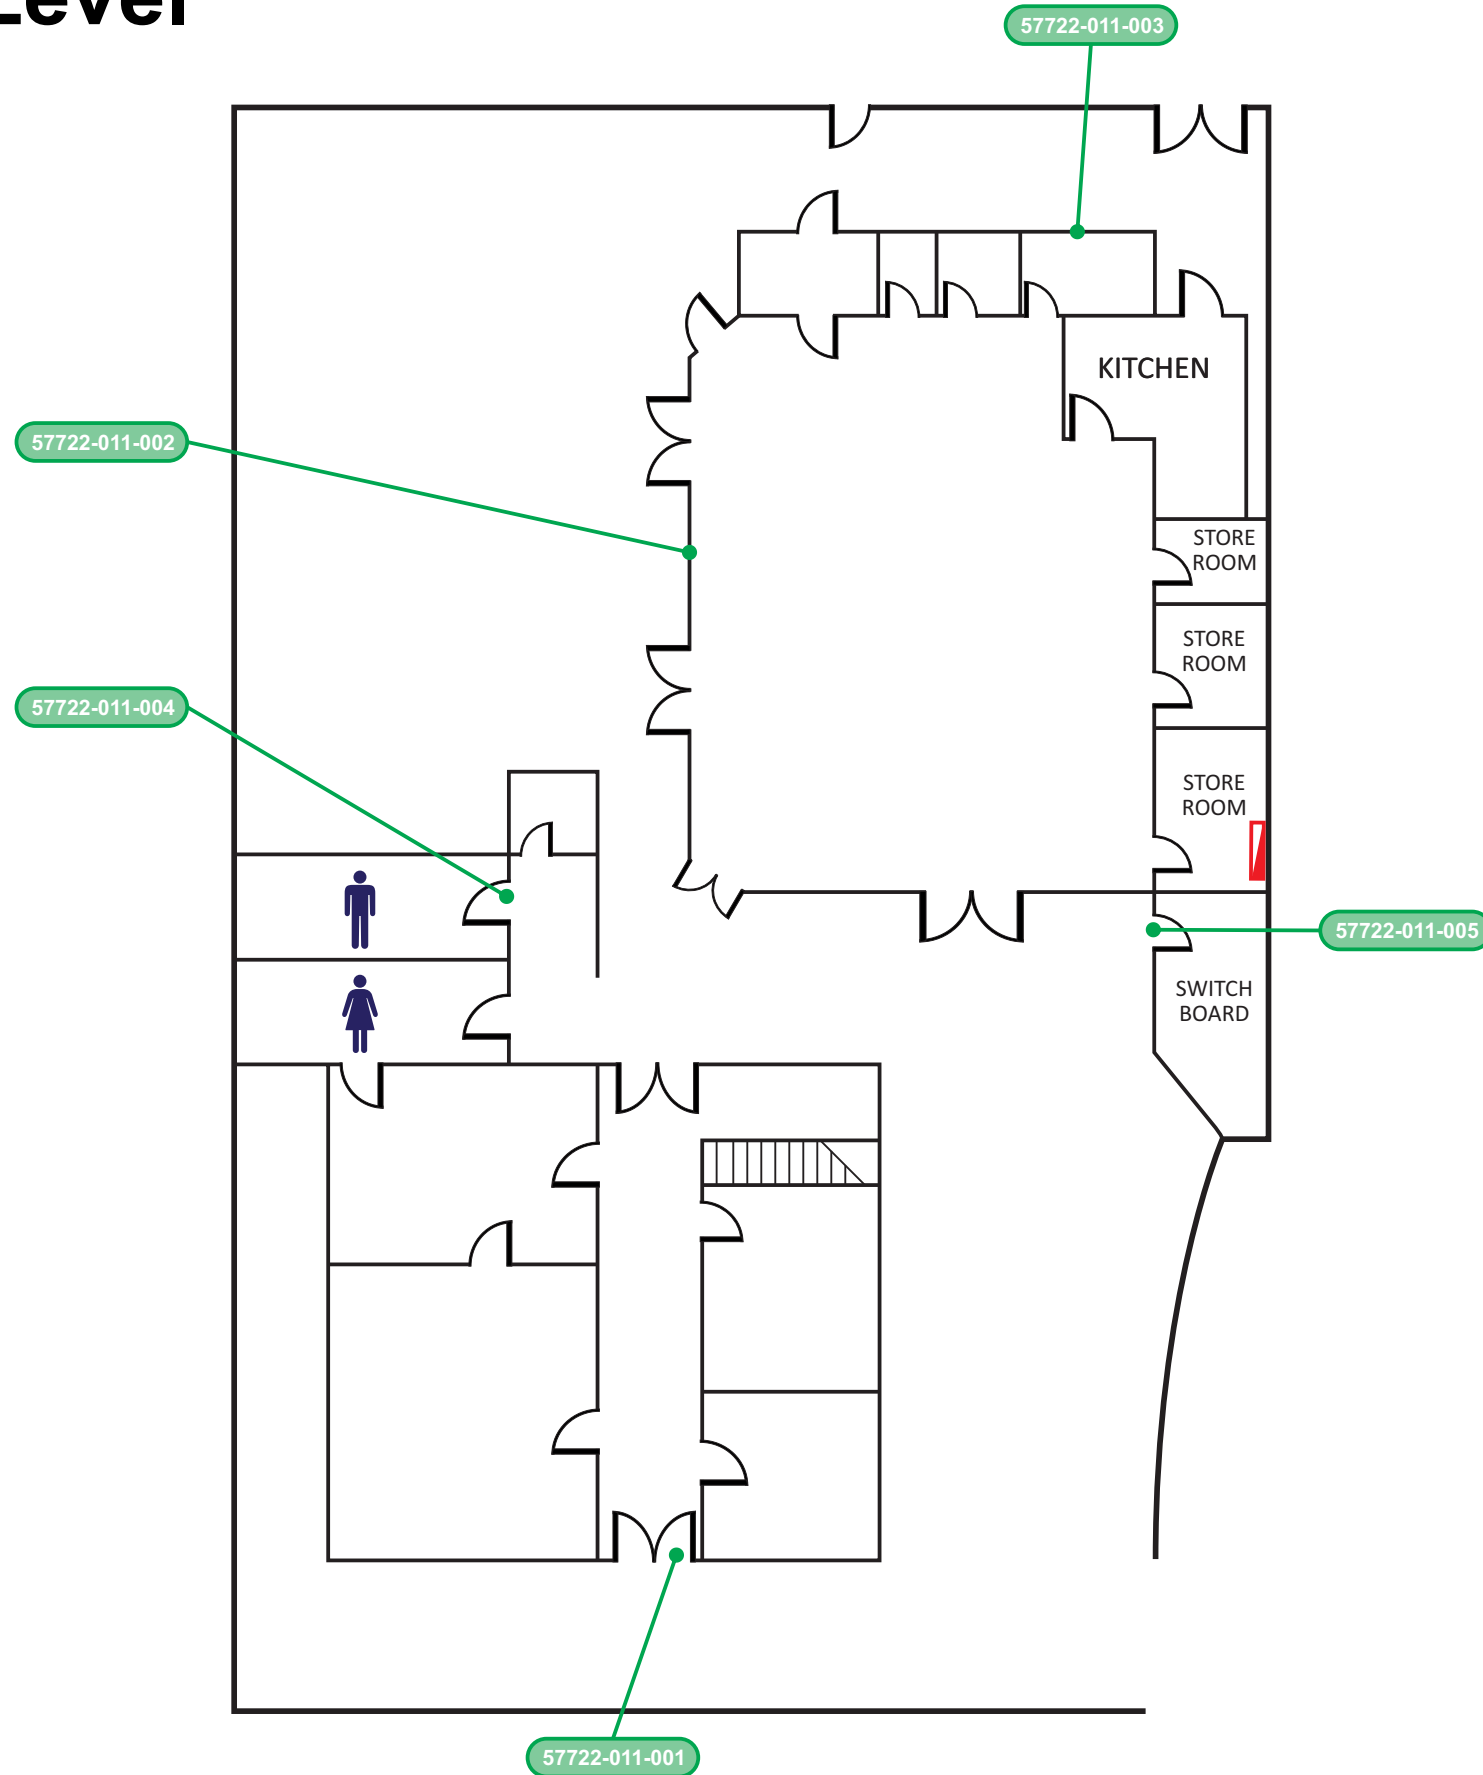
Annandale Town Hall/Community Centre Ground Level

*Only asbestos-containing materials (ACM) have been labelled on the attached site plan to prevent confusion and ensure that these materials are given priority for action. Therefore, other hazardous materials may be present within the building and the register attached in **Section 1** should be consulted prior to work commencing.*
