Hazardous Building Materials Assessment Gladstone Park Bowling Clubhouse Darvall Street, Balmain NSW 2041

Inner West Council
April 2018

Job No.: 57722-157

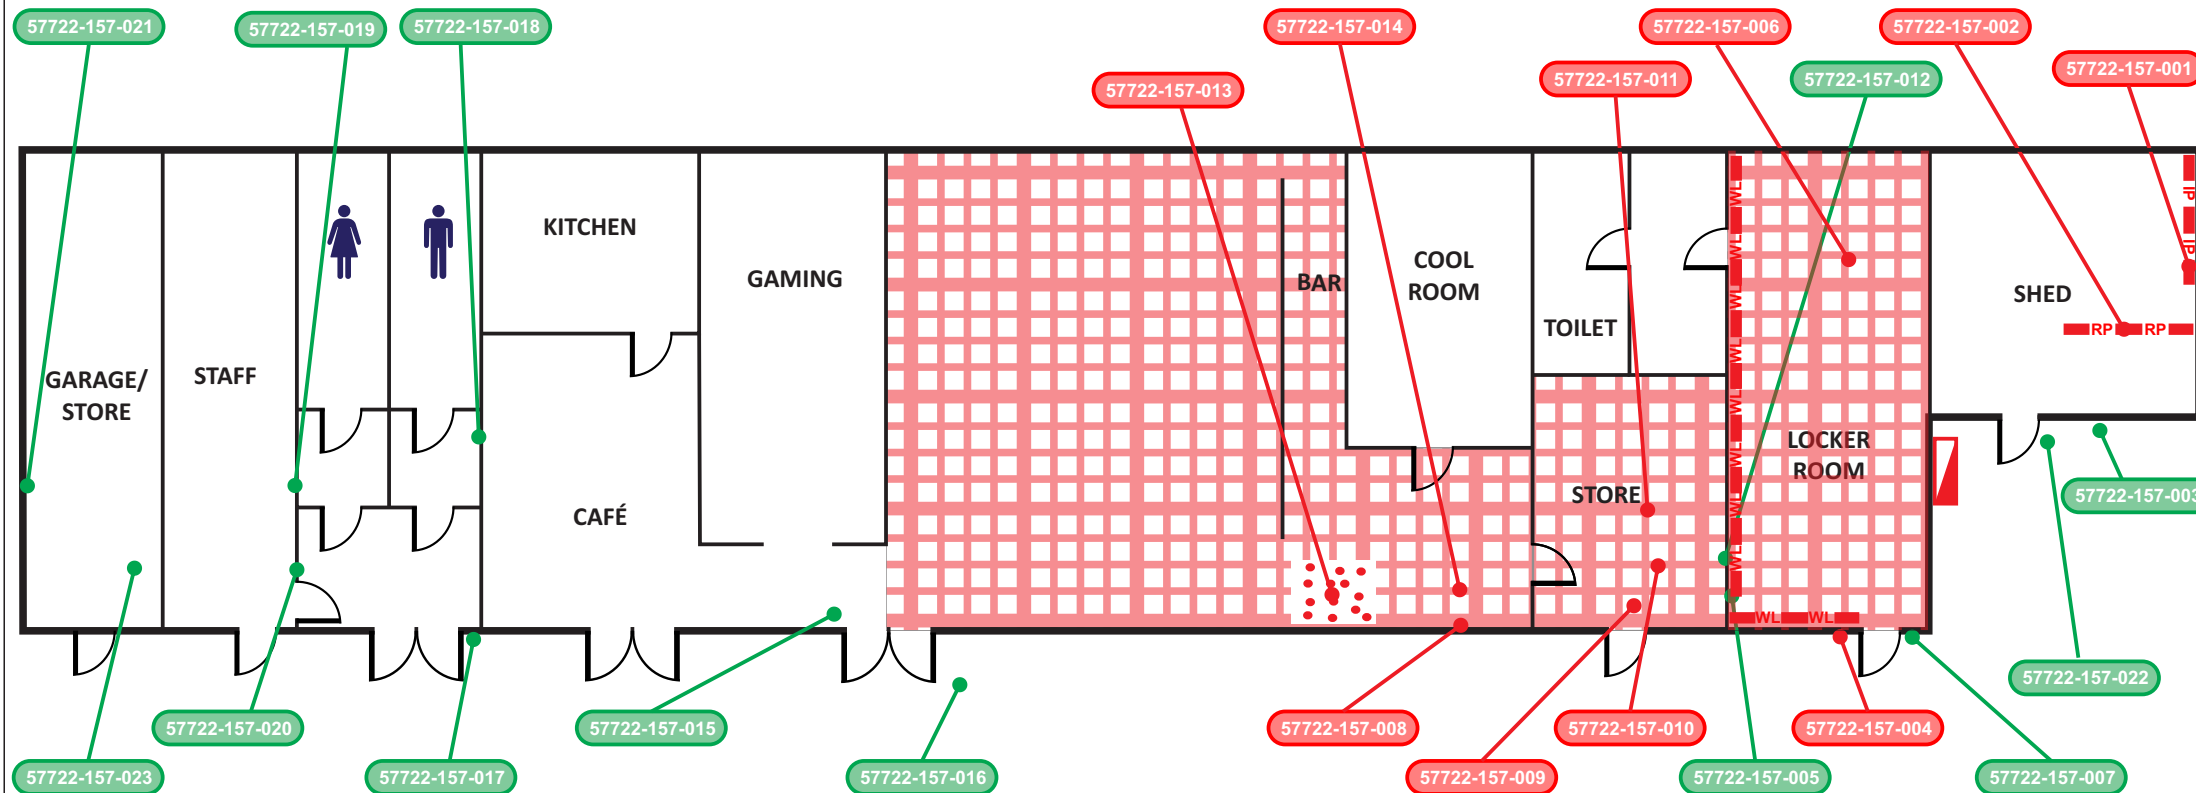
Gladstone Park Bowling Clubhouse, Balmain - Ground Level

*Only asbestos-containing materials (ACM) have been labelled on the attached site plan to prevent confusion and ensure that these materials are given priority for action. Therefore, other hazardous materials may be present within the building and the register attached in **Section 1** should be consulted prior to work commencing.*
