# Hazardous Building Materials Assessment

## Wharf Cafe

107 Elliot Street  
Balmain NSW 2041

Inner West Council  
April 2018

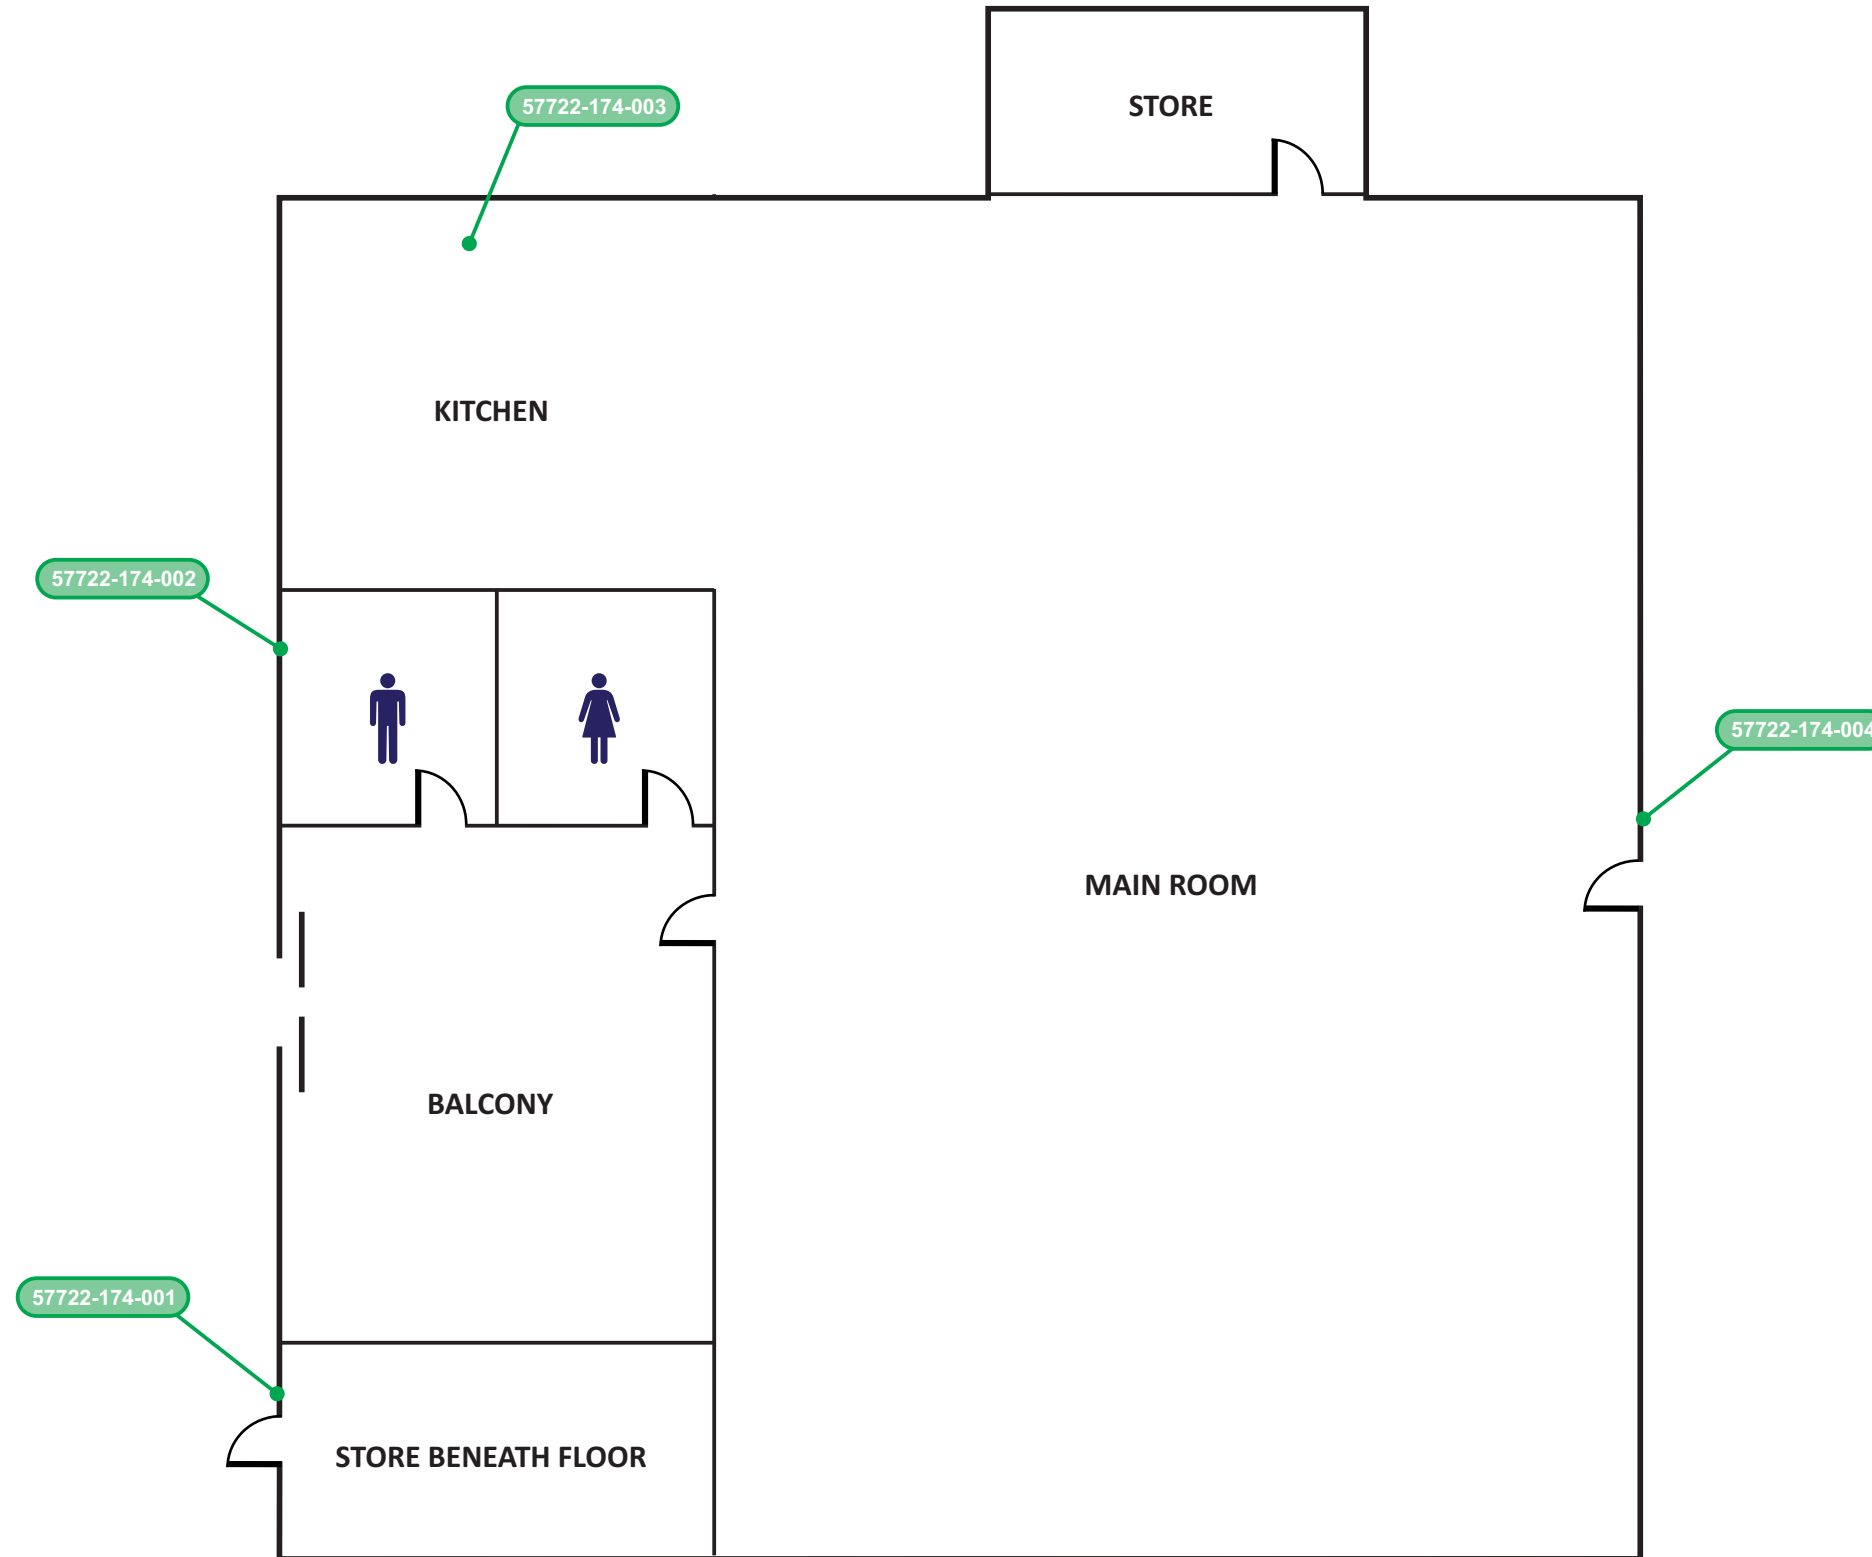
Client:	Inner West Council
Project:	Hazardous Building Materials Assessment
Address:	107 Elliot Street Balmain NSW 2041
Drawing Title:	Wharf Café, Balmain - Ground Level
Job No.:	57722-174
Client No.:	S0149
IWC Code:

*Only asbestos-containing materials (ACM) have been labelled on the attached site plan to prevent confusion and ensure that these materials are given priority for action. Therefore, other hazardous materials may be present within the building and the register attached in **Section 1** should be consulted prior to work commencing.*
