Hazardous Building Materials Assessment Elkington Park Caretakers Cottage Fitzroy Avenue, Balmain NSW 2041

Inner West Council

April 2018

Job No.: 57722-156

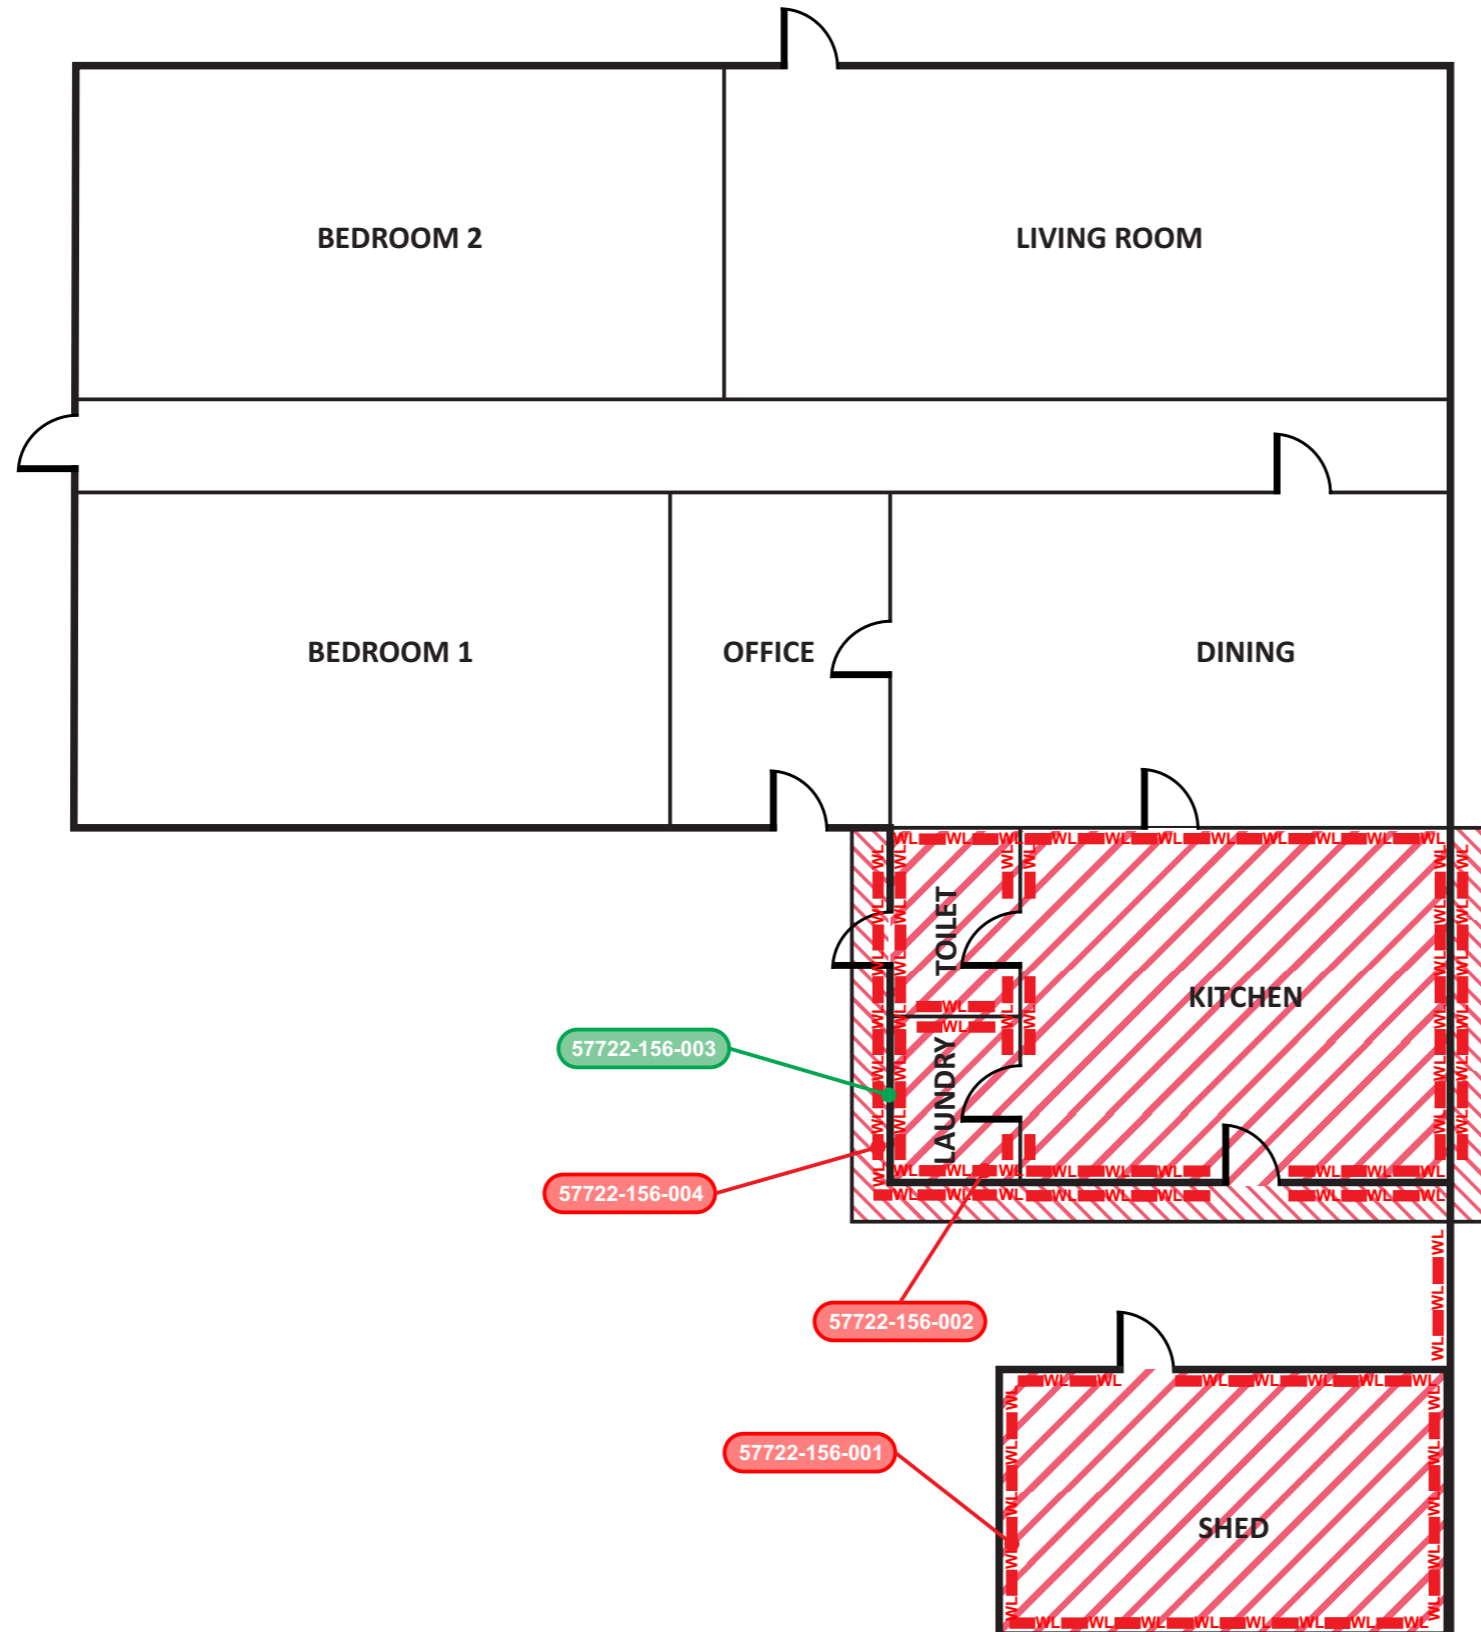
Elkington Park Caretakers Cottage, Balmain - Ground Level

*Only asbestos-containing materials (ACM) have been labelled on the attached site plan to prevent confusion and ensure that these materials are given priority for action. Therefore, other hazardous materials may be present within the building and the register attached in **Section 1** should be consulted prior to work commencing.*
