# Hazardous Building Materials Assessment

## Balmain Depot Administration and Store

35 Llewellyn Street  
Balmain NSW 2041

April 2018

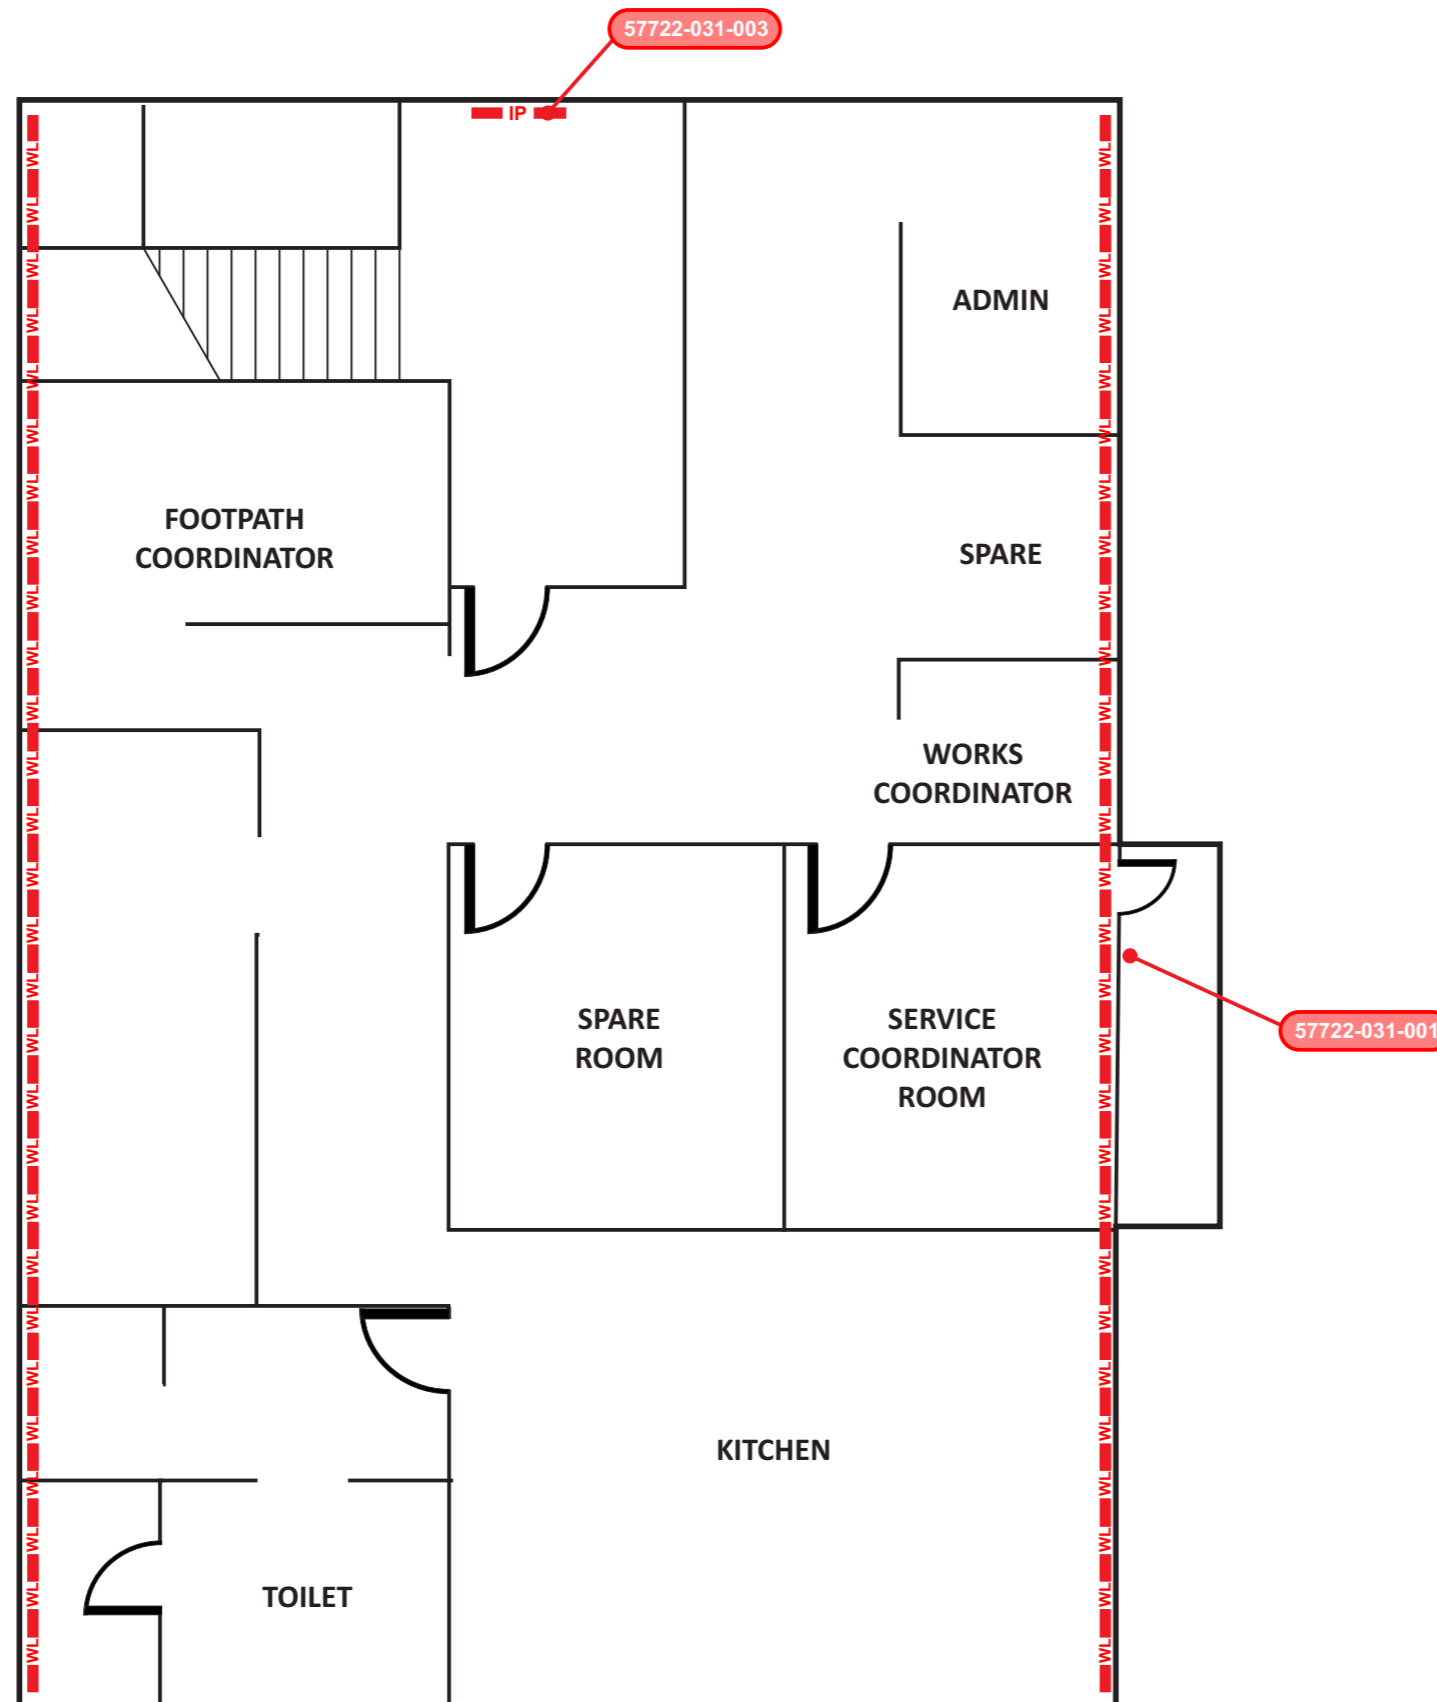
# Balmain Depot Administration/Office/Store Balmain - Level 1

Interior, level 1	Staircase	Ceiling space, redundant window position	Fibre cement sheeting	Asbestos	57722-031-003	Positive	Non-friable	Low	Fair	Medium	2 m <sup>2</sup>	Encapsulate exposed sections, label as containing asbestos and maintain in a good condition if to remain in-situ. Remove under controlled non-friable asbestos removal conditions prior to refurbishment or demolition works by a Class B (non-friable) licensed asbestos removal contractor.	P3	Feb-23	2
Interior, level 1	Office area	Ceiling	Fibre cement sheeting	Asbestos	57722-031-002	Positive	Non-friable	Medium	Good	Low	25 m <sup>2</sup>	Encapsulate exposed sections, label as containing asbestos and maintain in a good condition if to remain in-situ. Remove under controlled non-friable asbestos removal conditions prior to refurbishment or demolition works by a Class B (non-friable) licensed asbestos removal contractor.	P3	Feb-23	
Interior, level 1	Throughout	Ceiling space	Insulation material	SMF	-	Suspected Positive	Bonded	Low	Good	Low	60 m <sup>2</sup>	Maintain in current condition if to remain in-situ. Remove under controlled SMF conditions as per the Code of Practice for the Safe Use of Synthetic Mineral Fibres [NOHSC: 2006 (1990)].	-	-	7
