# Hazardous Building Materials Assessment

## Birchgrove Park Shed

Rose Street  
Birchgrove NSW 2041

Inner West Council  
April 2018

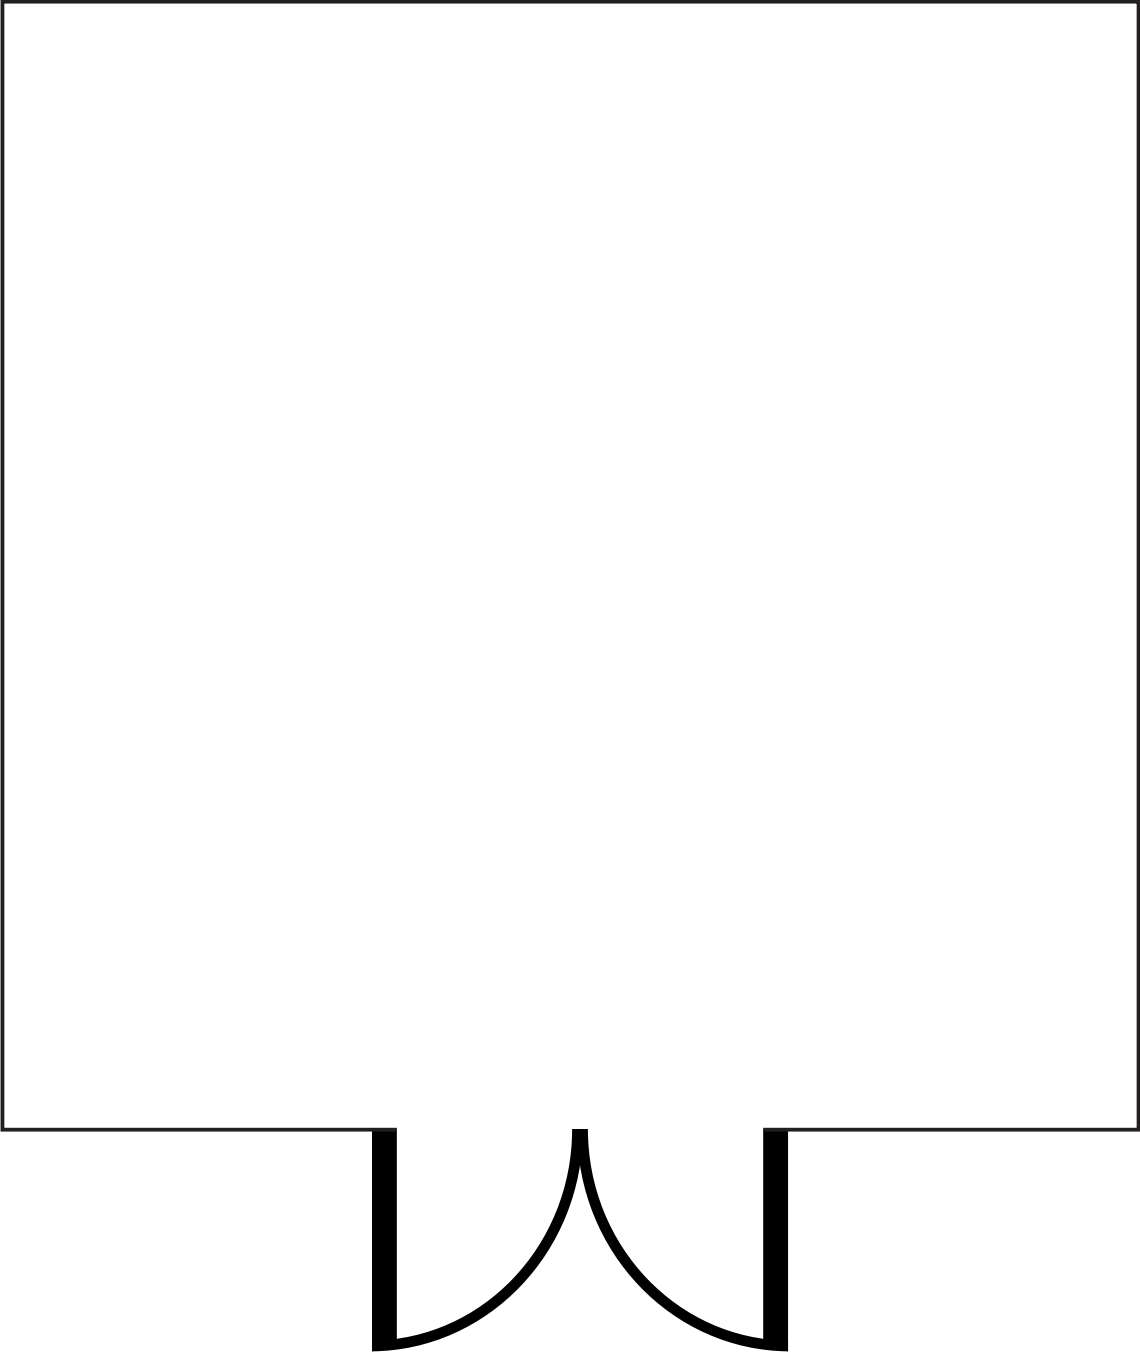
# Birchgrove Park Shed, Birchgrove - Ground Level

*Only asbestos-containing materials (ACM) have been labelled on the attached site plan to prevent confusion and ensure that these materials are given priority for action. Therefore, other hazardous materials may be present within the building and the register attached in **Section 1** should be consulted prior to work commencing.*
