Hazardous Building Materials Assessment

Australia Street Art Camp

24A Australia Street
Camperdown NSW 2050

Inner West Council
April 2018

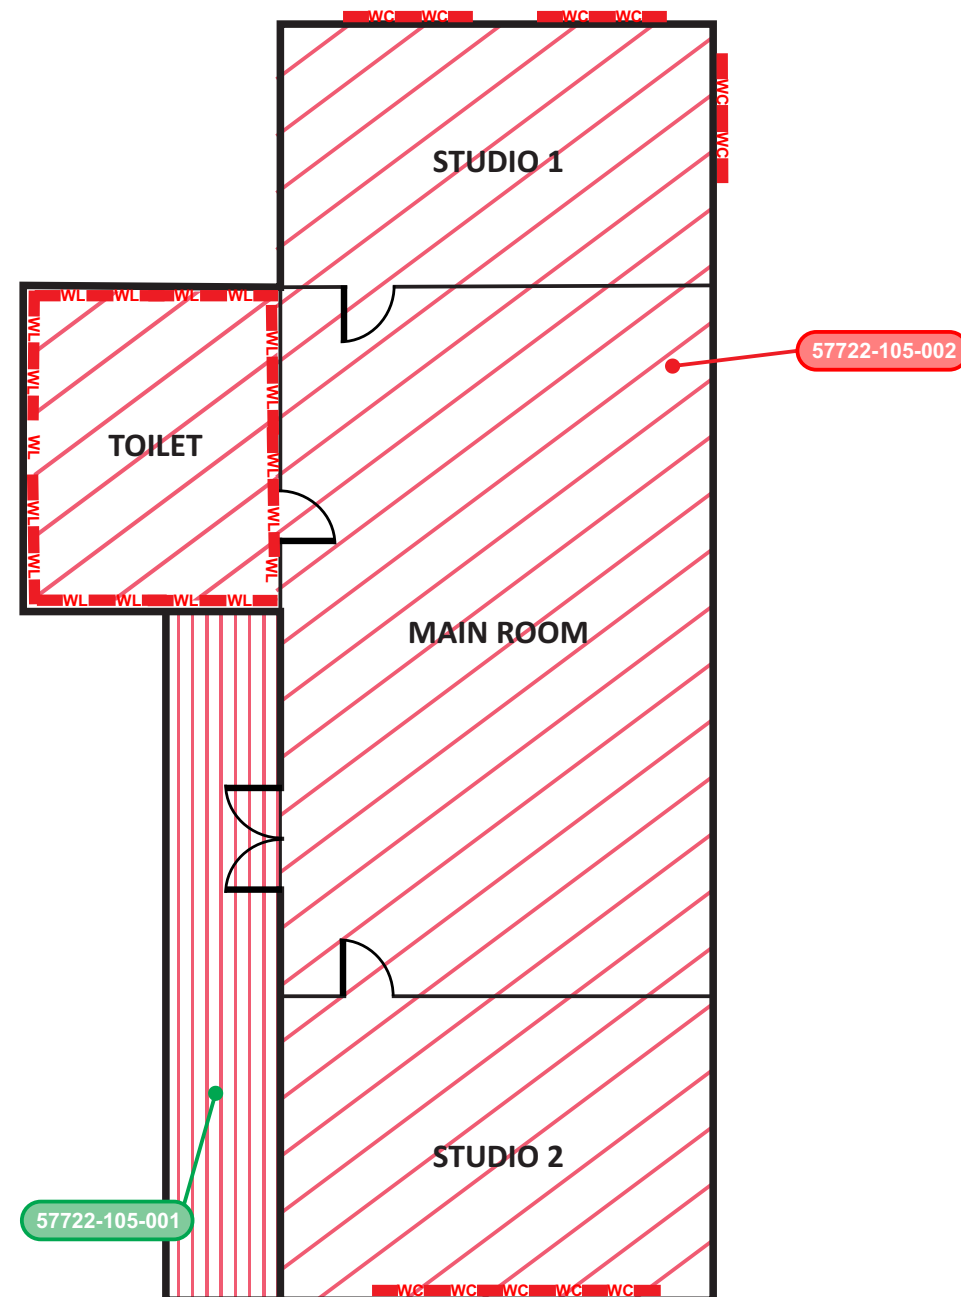
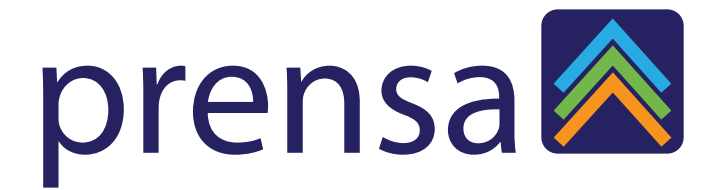
Australia Street Art Camp Camperdown- Ground Level

*Only asbestos-containing materials (ACM) have been labelled on the attached site plan to prevent confusion and ensure that these materials are given priority for action. Therefore, other hazardous materials may be present within the building and the register attached in **Section 1** should be consulted prior to work commencing.*
