# Hazardous Building Materials Assessment Portuguese Welfare Centre and Aldeas de Portugal

24A Australia Street,  
Camperdown NSW 2050

Inner West Council  
April 2018

Job No.: 57722-107

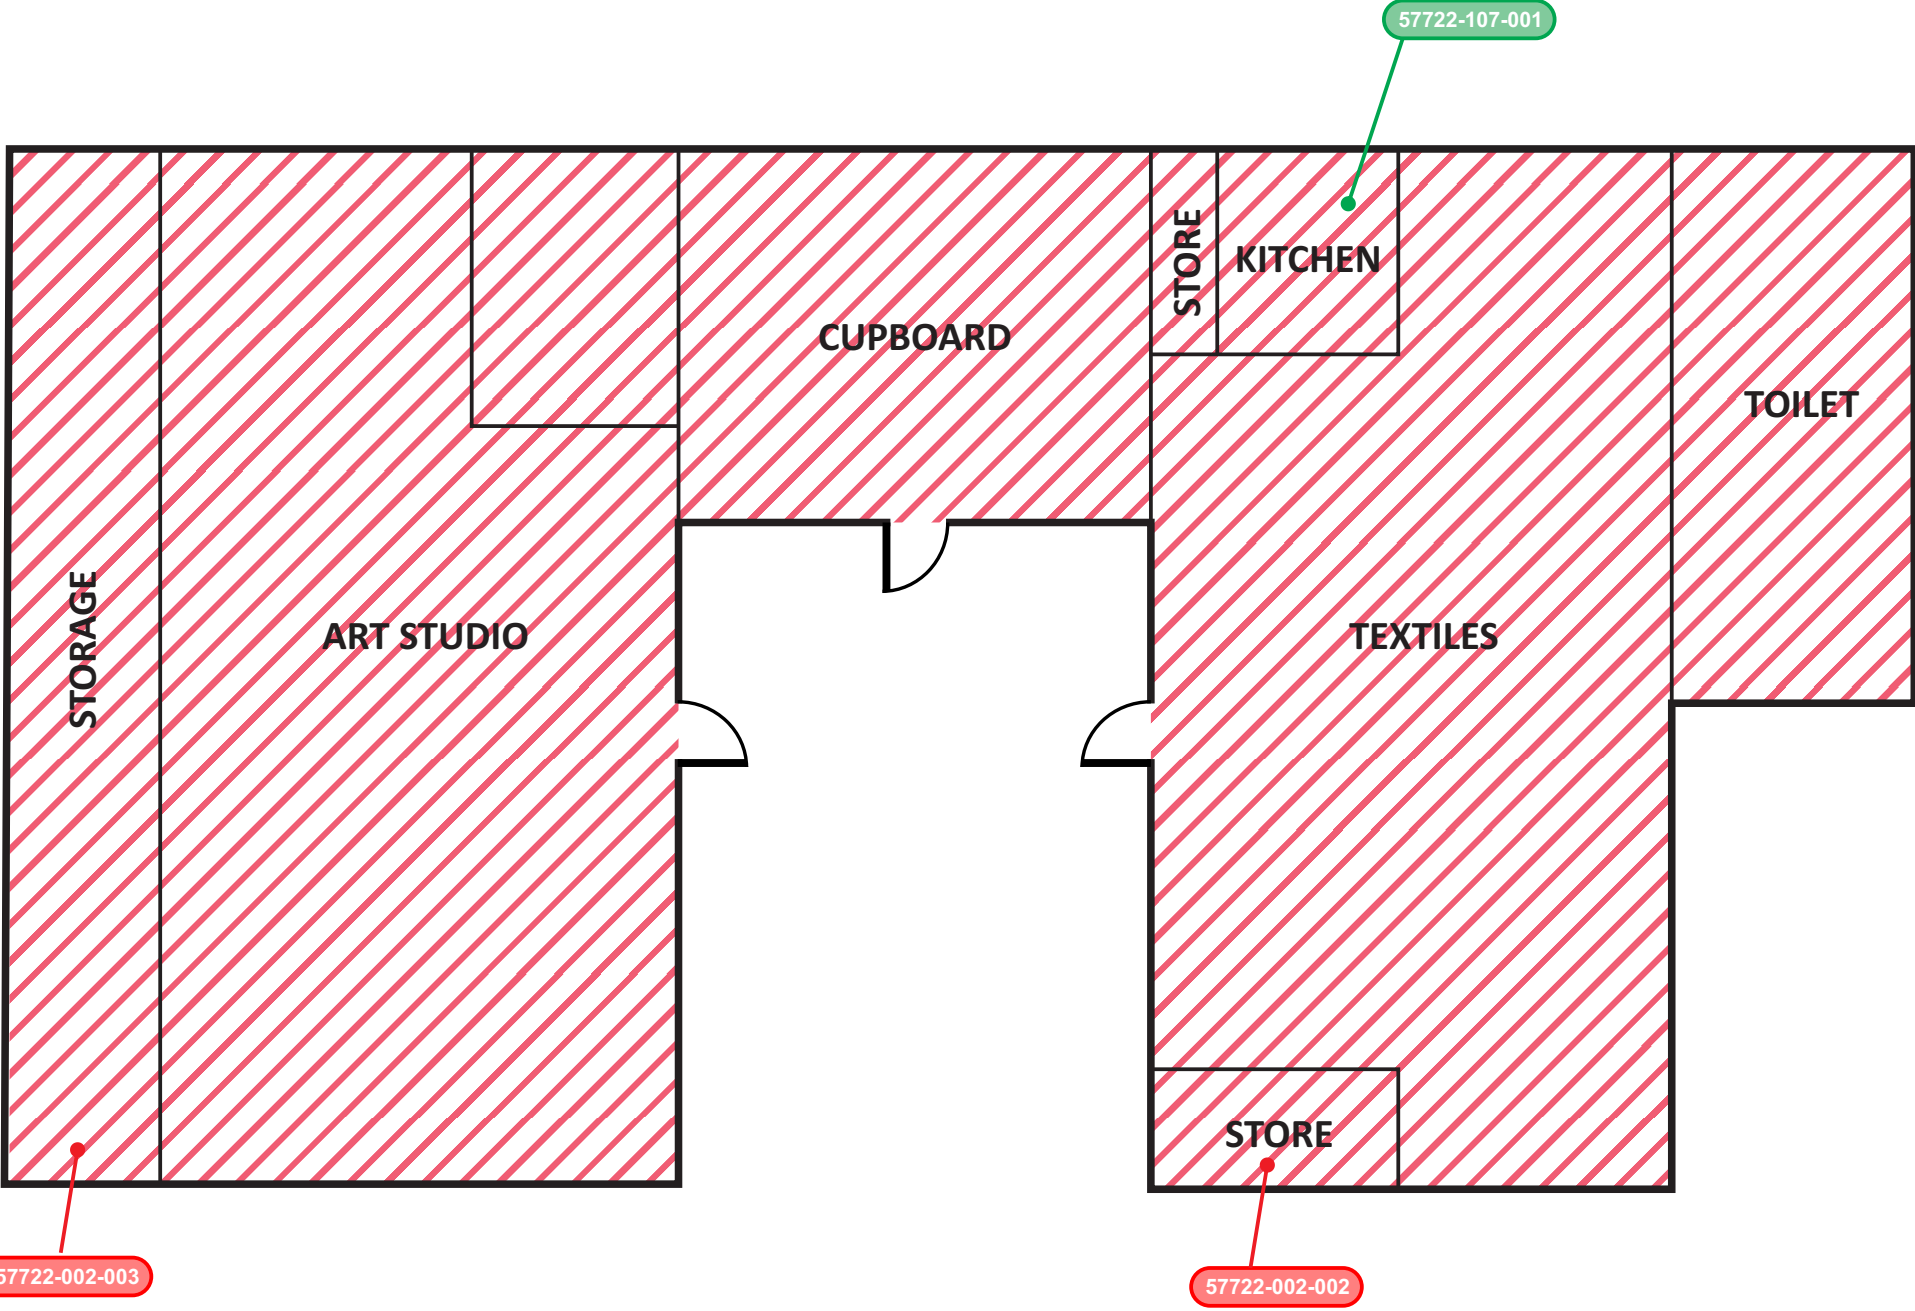
Client: Inner West Council  
Project: Hazardous Building Materials Assessment  
Address: 24A Australia Street, Camperdown NSW 2050  
Drawing Title: Portuguese Welfare Centre and Aldeas de Portugal  
Job No.: 57722-107 | Client No.: S0149  
IWC Code: CID 94

Interior	Store cupboard	Ceiling	Fibre cement sheeting	Asbestos	57722-107-002	Positive	Non-friable	Low	Good	Low	2 m <sup>2</sup>	Label as containing asbestos and maintain in current condition if to remain in-situ. Remove under controlled non-friable asbestos removal conditions prior to refurbishment or demolition works by a Class B (non-friable) licensed asbestos removal contractor.	P4	Feb-23	2
Interior	Kitchen	Floor coverings - brown	Sheet vinyl	Asbestos	57722-107-001A	Negative	-	-	-	-	-	-	-	-	3
Interior	Kitchen	Floor coverings - brown	Adhesive	Asbestos	57722-107-001B	Negative	-	-	-	-	-	-	-	-	-
Interior	Kitchen	Hot water heater	Insulation material - internal	SMF	-	Suspected Positive	Bonded	Low	Good	Low	1 unit	Maintain in current condition if to remain in-situ. Remove under controlled SMF conditions as per the Code of Practice for the Safe Use of Synthetic Mineral Fibres [NOHSC: 2006 (1990)].	-	-	4
