Hazardous Building Materials Assessment Camperdown Park Rotunda Australia Street, Camperdown NSW 2050

Inner West Council
April 2018

Job No.: 57722-079

Count ID: CID: 92

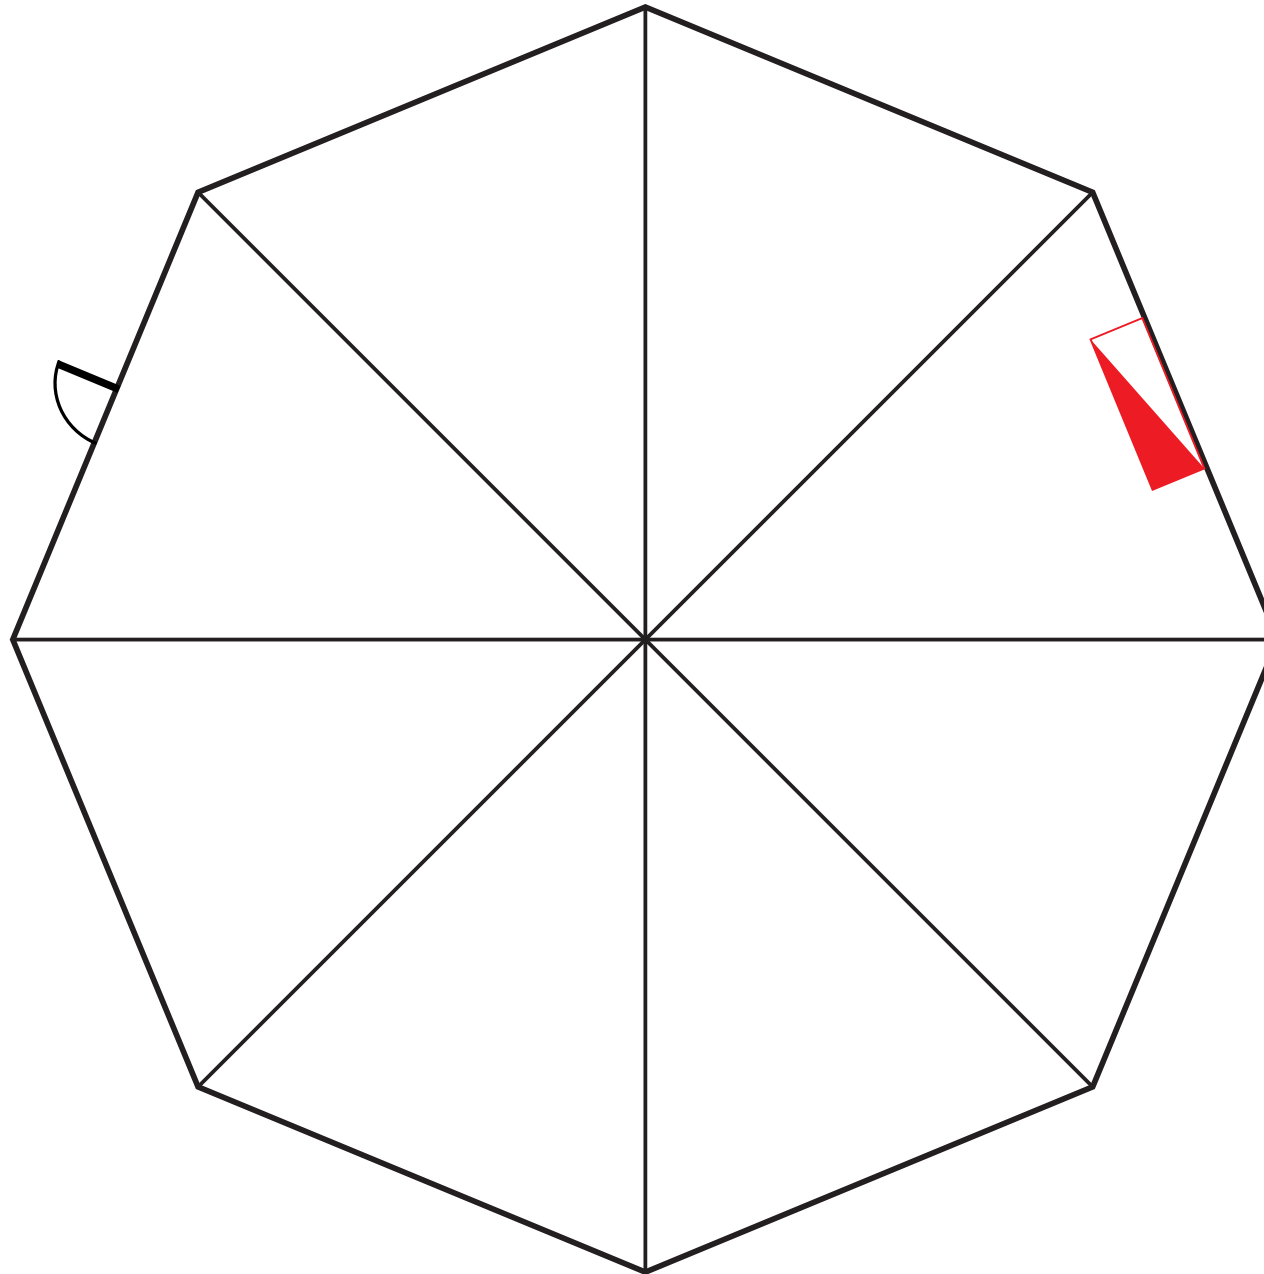
Camperdown Park Rotunda, Camperdown - Subfloor

*Only asbestos-containing materials (ACM) have been labelled on the attached site plan to prevent confusion and ensure that these materials are given priority for action. Therefore, other hazardous materials may be present within the building and the register attached in **Section 1** should be consulted prior to work commencing.*
