# Hazardous Building Materials Assessment

## Chrissie Cotter Gallery

Pidcock Street,  
Camperdown NSW 2050

Inner West Council  
April 2018

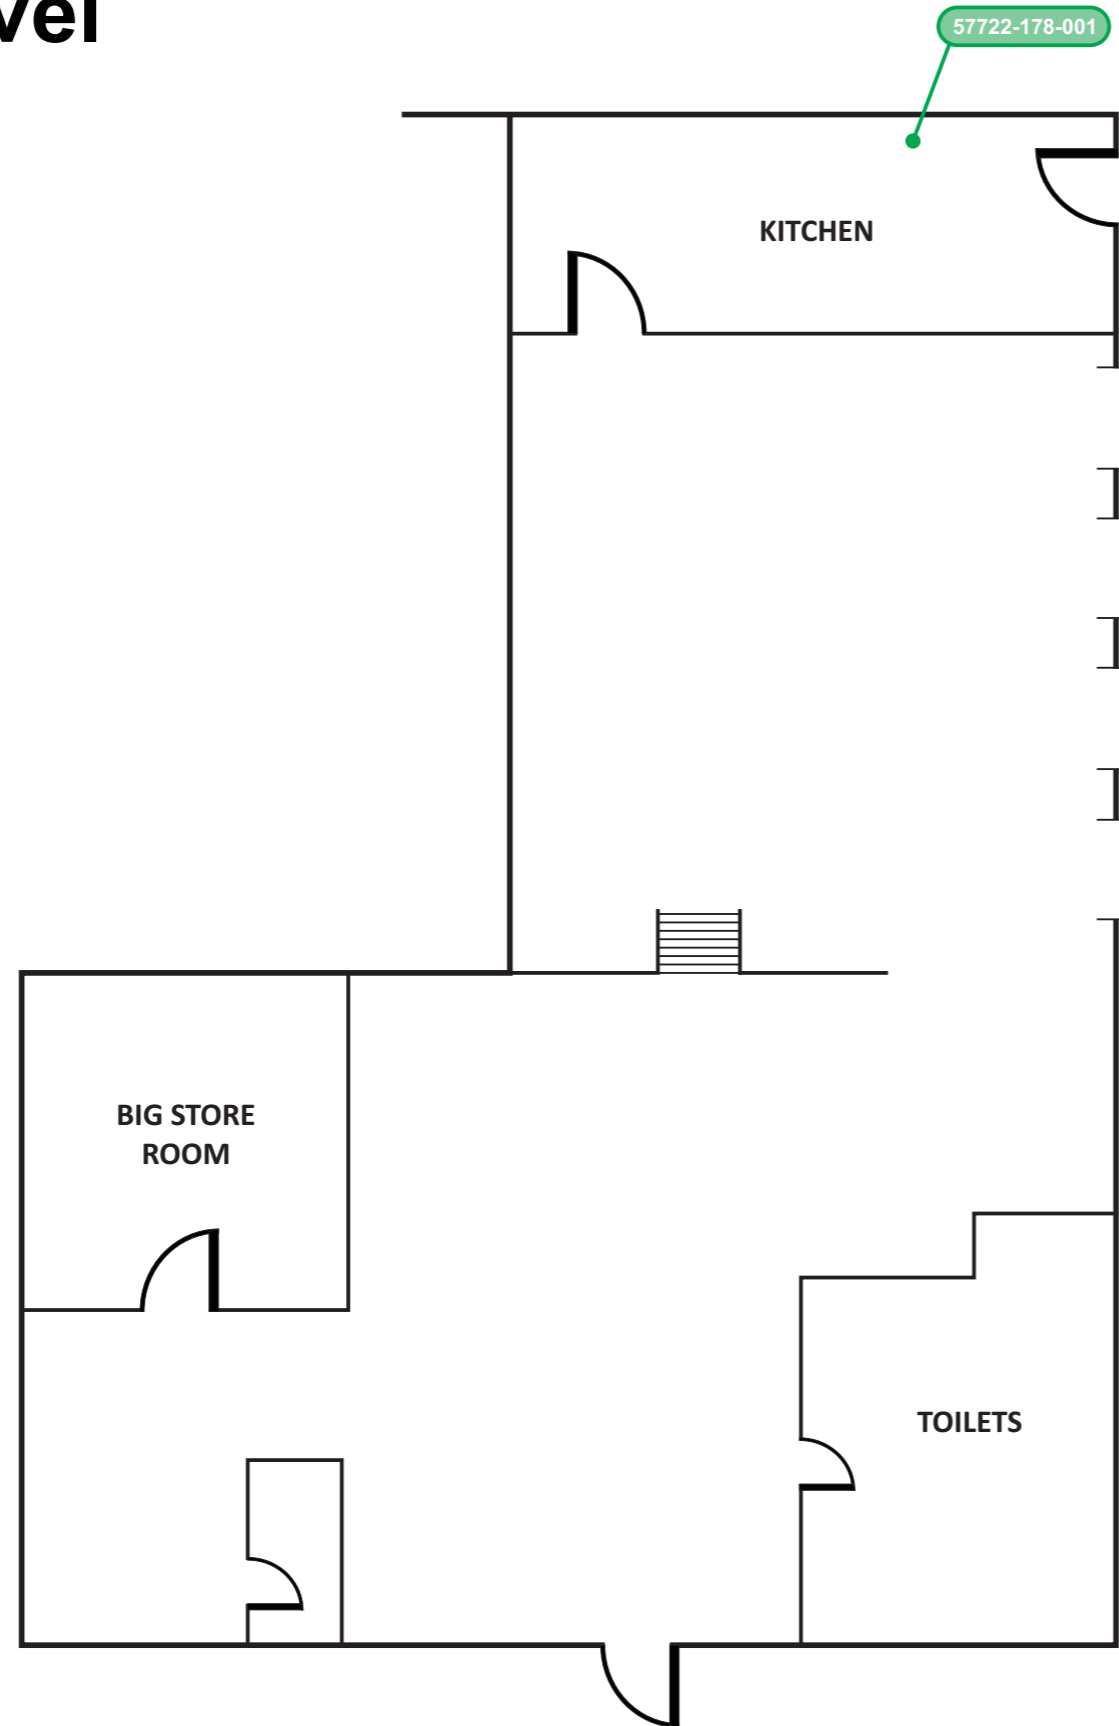
# Chrissie Cotter Gallery, Camperdown Ground Level

*Only asbestos-containing materials (ACM) have been labelled on the attached site plan to prevent confusion and ensure that these materials are given priority for action. Therefore, other hazardous materials may be present within the building and the register attached in **Section 1** should be consulted prior to work commencing.*
